ZT310-VX (EURO IV/V)

Service manual

2021/11/12

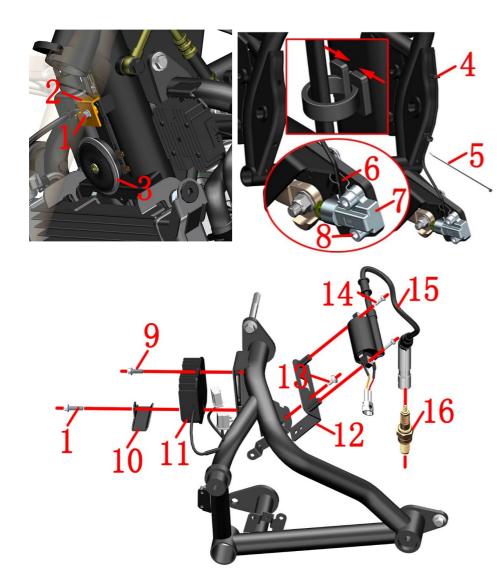
| Fig.2 FRA | ME&ELECTRONIC | Electronic parts COMPONENT-2 | CHK | 401 |

The plug strap (2) is a non-detachable structure and it is not recommended to cut it directly. It is difficult to remove the broken portion of the buckle that is forcibly removed from the frame triangular reinforcing plate.

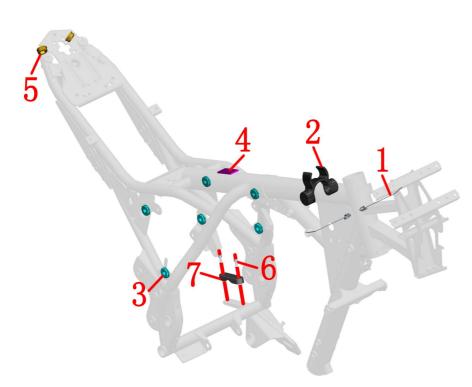
| Fig.3 FRAME&ELECTRONIC | | Frame plastic parts | CHK | (0) |

Wear block

Use a Phillips screwdriver to remove the 2 bolts (6) and then remove the wear block (7).

- It must be dismantled them first, such as the cushion, fuel tank cover, inner fuel tank, sider cover, tail dress and so on.
- All parts should be correctly assembled.
- The plug strap (1) is a non-detachable structure and it is not recommended to cut it directly. It is difficult to remove the broken portion of the buckle that is forcibly removed from the frame triangular reinforcing plate.

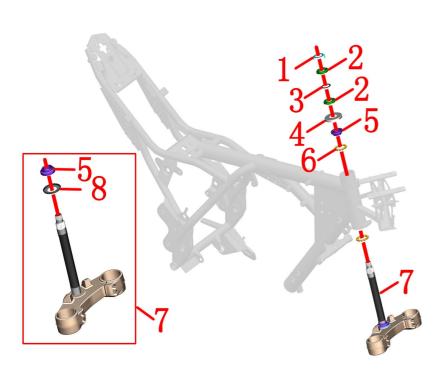
| Fig.4 FRAME&ELECTRONIC | | Steering rack component | CHK | 40) |

CAUTION:

- Remove the head part component, handlebarcomponent and front shock absorber component first.
- Please pay attentin to fix the awaiting repair motorcycles during disassembly, prevent dumping by accident.

- Please check whether the steel beads of the conjoined body have abnormal phenomena such as partial abrasion and rust. If YES, please buy the regular accessories on ZONTES official website, if not, please be sure to grease the old grease and repaint the lubricating grease on it.

- It must be to check whether the steel ball is available during reassembly.
- It must be reasonable to adjust the steering, too loose will cause the locomotive to brake slightly, and the locomotive will shake slightly, too tight can lead to inflexibility, resulting in safety hazards.

- If you have the ability and the right tool, you can change the shaft ring (5) and the dustproof cover (8). During the replacement process, pay attention to the protection of the lower connected plate. After replacement, it must be to check the parallelism of the column and the damping hole, the vertical degree of the vertical column and the lower connected plate.

When reassembling, the conjoined steel beads should be painted lubricating grease, attention to the dosage. The torque of rating nut which closes to upper dustproof cover is required to about 14N.m.so as to be able to rotate out of nimbleness.

The top adjusting nut only needs to rotate to the bottom of the nut groove alignment, not too tight to prevent the rubber pad (3) from deformation too large.

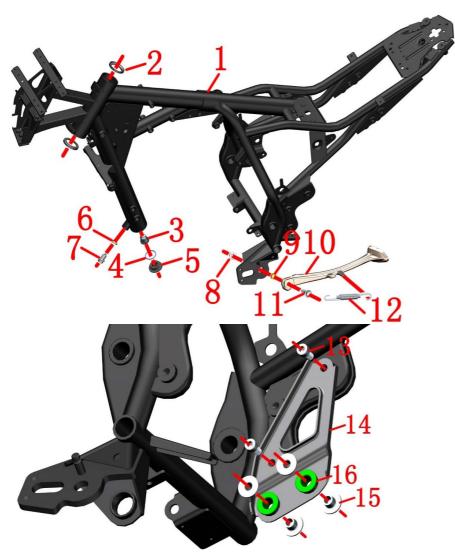
| Fig.5 FRAME&ELECTRONIC | | Frame, Side support, the operation of releasing engine | CHK | 40) |

CAUTION:

- Remove the wind deflector component, handle bar component, steering column component first.
- Paint the lubricating grease on the cushion ring to decrease the rotary resistance of front forklift.

Checking whether the cushion loop (2) is frayed, If there is one, it needs to be replaceds. fix the cushion loop well and paint the lubricating grease on it with appropriate tool.

Put the oil pan on the bottom and use the 21# sleeve to remove the oil cold joint (5), O ring (4), and oil filter screen (3). When replacing the oil filter screen (3), the O-ring (4) must be replaced at the same time. The oil cooling joint (5) must be tightened well when re-assembling which meets the standard torque value.

Put the oil pan at the bottom, use the 14 #sleeve to remove the oil bolts (7) and the sealing gasket (6), and remove the oil from the frame tube. Refer to the instructions for detailed steps to replace the oil. It is recommended that the engine oil should be replaced with oil bolts (7) and sealing gasket(6) to prevent oil leakage.

Use the cross screwdriver to remove the side support spring, and guard against the personal injury caused by spring contraction, remove the nuts (8) and bolts (11) with the 14 #sleeve. Remove the side support (10) and bush (9), paint the lubricating grease on the bush(9) when re-assembling ,then put it into the frame (1).

Remove 2 bolts (13) with 6# inner hexagon, and remove the connecting plate assembly. Remove 4 pieces of bushing (15) and 2 pieces of cushion rubber (16) from connecting plate (14).

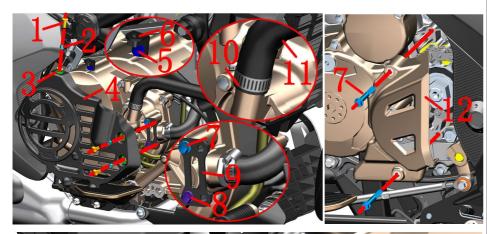
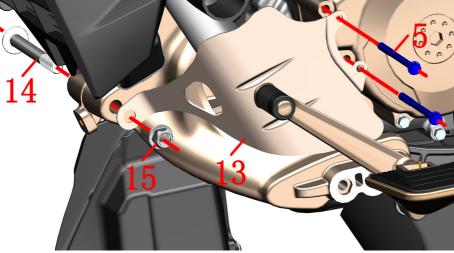
| PIC.1 FRAME&ENGINE | | Engine trim cover assy | CHK | 401 |

Using 4# inner hexagon socket disassemble 3 bolts (1) and take out the right trim cover components.Remove the bushing (2), buffer rubber (3) from the right trim cover components.Using 8# sleeve disassemble the bolts (5) and take out the bracket (6). Using 8# sleevedisassemble the bolts (7), (8)and take out the bracket (9).Use a screwdriver to loosen clamp (10), unplug the water inlet pipe (11)

Remove the lower shroud assembly first. Secure the head of the bolt (14) with a 14# sleeve and remove the nut (15) with a 14# sleeve. Grab the anti-scalding plate (13) and using 8# sleeve remove the 2 bolts (5) to remove it.

- The 3 M6 bolts of the engine trim cover bracket must be coated with thread fastening glue before reassembly, with a torque of 10N.m.
- The coolant should be drained before disassembly.
- Swallowing or inhaling the coolant can be harmful to the human body. Please thoroughly clean any exposed skin such as hands, face, etc. after each addition of coolant. Contact poison control center or hospital immediately if swallowed. If inhaled, please go to a ventilated environment immediately. In case of accidental splash into eyes, please immediately flush eyes with plenty of running water and seek medical treatment in time. Be sure to stay away from children and pets.

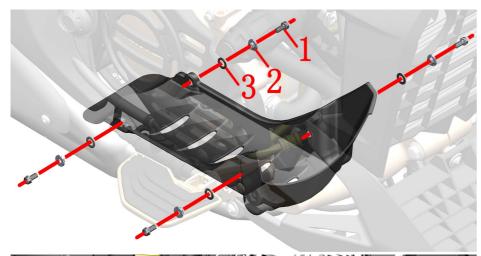
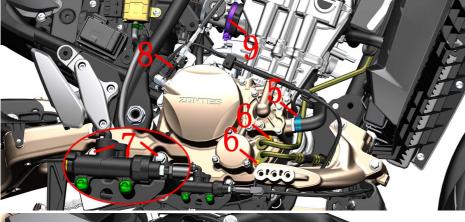
| Fig.2 FRAME&ENGINE | | Frame & Engine 1 | CHK | 401 |

Use a screwdriver to loosen the clamp (5), pull out the water pipe, remove the engine oil outlet pipe, and then insert the water pipe back.

After loosening the pipe clamp (9), pull out the throttle valve body assembly backward to separate it from the intake manifold.

Use the hoop pliers to loosen the hoop (10) and pull out the end of the water outlet pipe connected to the engine.

Unplug all wires connected to the engine, such as negative wire, water temperature sensor plug, gear sensor plug, etc.

- It is necessary to remove the seat cushion, fuel tank, side cover, pedal support, wind deflector, shift lever, muffler, radiator and pipe, cable, air filter joint, chain, engine negative pole, etc.
- The waste oil needs to be collected and returned to qualified institutions. It is forbidden to dump and pollute the environment and the source of water.
- The disassembly and assembly steps of the rear shock absorber connecting rod assembly are described in the "Rear shock absorber assembly" of the "Rear Wheel, Rear Flat Fork Assembly", and will not be repeated here.

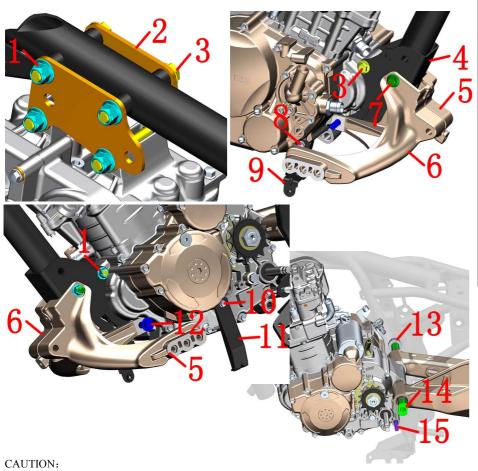
| Eig 2 EI | DAME & ENCINE | Frame & Engine 2 | CHK | 40) |
|---|---|--|---|---|
| Fig.3 FRAME&ENGINE | | Frame & Engine 2 | ADJ | 4 |

- It is necessary to remove the seat cushion, fuel tank, side cover, pedal support, wind deflector, shift lever, muffler, radiator and pipe, cable, air filter joint, chain, engine negative pole, etc.
- The waste oil needs to be collected and returned to qualified institutions. It is forbidden to dump and pollute the environment and the source of water.
- Use the appropriate tools to support the whole vehicle to prevent accidents caused by the dumping of the vehicle during the disassembly process; single operation is strictly prohibited.
- All standard parts must meet the standard torque value during reassembly, and re-add the oil according
 to the instructions

Fix the head of shaft (4) first, and remove nut (13) with a 30# sleeve. After supporting the engine, one person slightly shakes the rear fork assembly, and one person pulls out the shaft (14). Continue to support the engine and remove the bolts (3) and (7) remove the bracket (4). After removing the bolts (12) and (15), hold the engine to move to one side, and pay attention to safety during the movement. Place the engine on a flat ground.

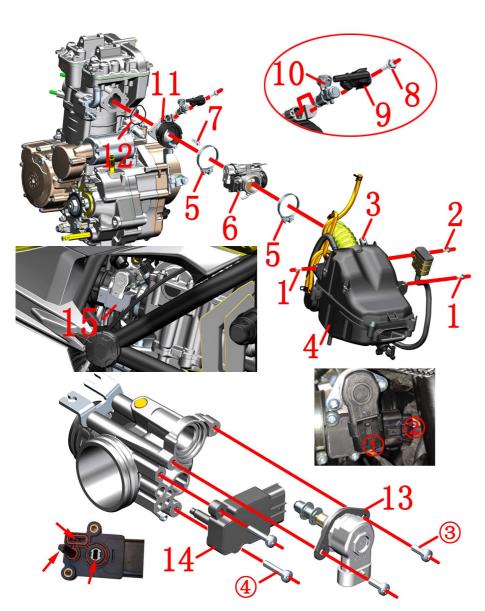
| FIG.1 IN | TAKE SYSTEM | Intake system component | CHK | 40) |

Remove the bolts (1), (2),loosen the hose clamp assembly (5) on the side of the air filter, clamp the clamp on the exhaust pipe with pliers and pull out the exhaust pipe connected to the exhaust port of the engine, and then use the rubber plug that was delivered with the bike. Plug it well to prevent foreign matter from entering and damaging the engine. Remove the air filter assembly and splint nut (3).

Use a 8# wrench to remove the bolts (7) and remove the throttle valve assembly. Loosen the pipe clamp (5) between the intake pipe assembly (1) and the throttle valve component (6), and remove them respectively. Remove the O-ring (12) from the intake pipe assembly. Remove the bolt (8) that fixes the injector holder (9) to remove the holder, and remove the injector (10).

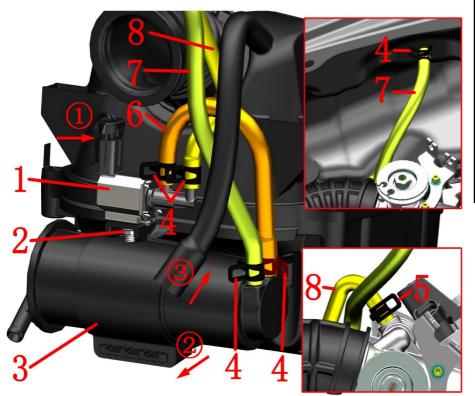
| Fig.2 INDUCTION | | Induction system component | CHK | 401 |

- Before reassembly, check the O-ring (12) for damage and replace it if any.
- When reinstalling the sensor (4), be careful to align the square holes; there must be no foreign objects; the sealing rubber gasket cannot be missing or misplaced. Do not touch the sensor head.
- The valve(6) and (5) can not be universal, the corresponding throttle line is also different need to pay attention to distinguish. Through the throttle line tumtable in the motorcycle forward direction of hte left or rihgt to distinguish.

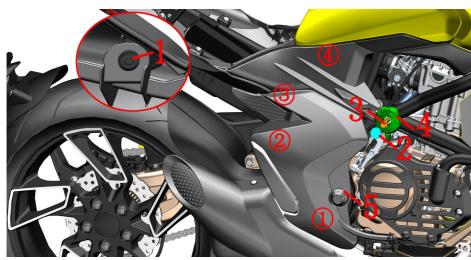
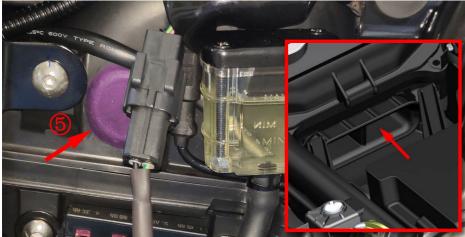
| | Fig.3 IN | DUCTION | Maintain the filter element of the air filter | CHK | (0) |

First remove the connector 1 of the carbon tank solenoid valve(1), Then using 10# sleeve remove the nut (2) with the sleeve; remove the solenoid valve assembly. Loosen the hoop (4) and pull out the intake pipe (6) and the outlet pipe (8).

- It needs to remove the seat cushion, side cover, oil tank cover, bladdar and so on.
- Regularly check whether the filter element of the carbon tank and air filter is not ventilated, otherwise it may cause the oil supply to affect the driving experience.
- It should be no crimp, entanglement and other phenomena.

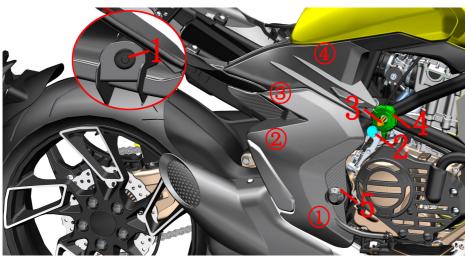
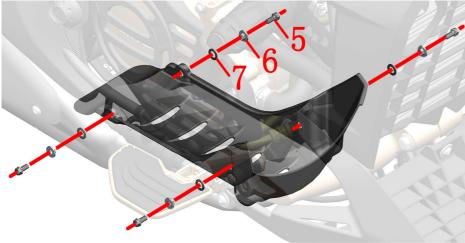
| | _ | DUCTION M COMPONENT | Replace the air filter element 1 | CHK ADJ | Q |

- In the dusty environment, the frequency of cleaning or replacing the filter element needs to be increased.
- Air filter is blocked by dust, which will increase the intake resistance, resulting in insufficient engine intake and fuel consumption or engine damage.
- The filter element or maintenance should be replaced every 10000km under normal conditions. After each rapid maintenance, you can continue to ride or repair the filter after 4000km.
- Expansion nail: Figure ① is not installed; Figure ② is assembled; Figure ③ is disassembled.

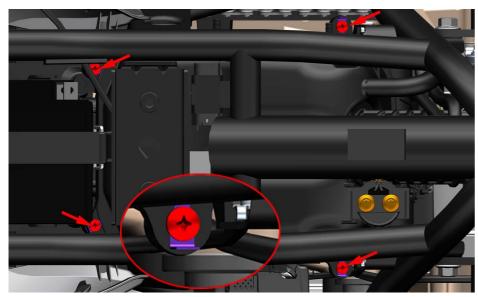
| Fig.6 INDUCTION SYSTEM COMPONENT | | Replace the air filter element 3 | СНК | Q |

Place a rag under the air filter and use a needle-nose pliers to pull out the waste tubing at the bottom.

- Always keep the disc brake oil cup cover facing up.
- When pulling out the tube, you should not directly clamp it with a nipper pliers to prevent leakage or oil leakage.

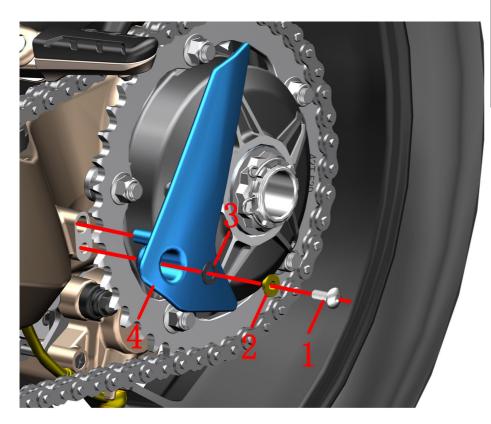
| Fig.2 Rear wheel, swinging arm assembly | | Sprocket baffle | CHK | Q |

Use a 21# sleeve to loosen the bolt (4).

Use a special hook wrench to turn the eccentric chain adjuster at the arrow indication. The counterclockwise direction is to tighten the chain, and the clockwise b direction is loose.

The chain sag is 18~25mm. If it is too large, it will cause the chain to be accidental or damage the engine. If it is too small, it will aggravate the wear of the chain and sprocket.

- The upper bolt can only be removed after holding the rear mud plate assembly; Do not pull the cable
- The torque of the bolt (4) is 100N.m.
- The chain must be checked regularly for excessive wear; the chain should be cleaned and properly lubricated regularly.

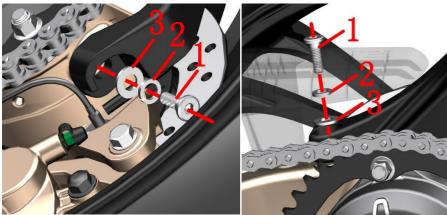
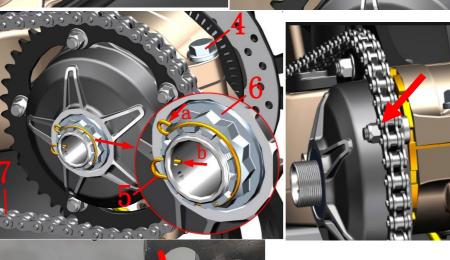
| Fig.3 Rear wheel, swinging | | Sprocket assembly 1 | CHK | (0) |

• When reassembling, pay attention to the limit boss on the sprocket baffle to be inserted into the limit hole of the rear fork.

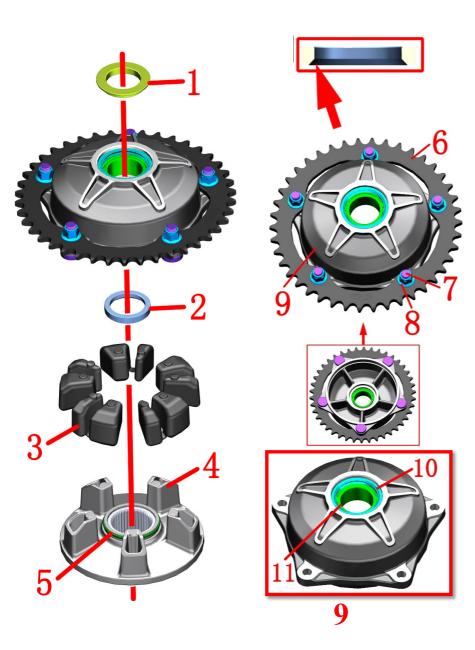
| Fig.4 Rear wheel, swinging | | Sprocket assembly 2 | СНК | (0) |

• The upper bolt sits only after the rear mud plate assembly needs to be dragged down; you can't pull the cable.

Using 14# sleeve remove the 5 nuts(8), remove the 5 bolts(7), and remove the sprocket(6). When reassembling, pay attention to the sprocket with the word one facing outward.

- The notch position of the bolt (7) is facing inward.
- The sprocket seat housing assembly(9) already contains an oil seal and bearings. The distance from the upper end surface of the bearing to the upper end surface of the outer casing is 7.9 to 8.0 mm.

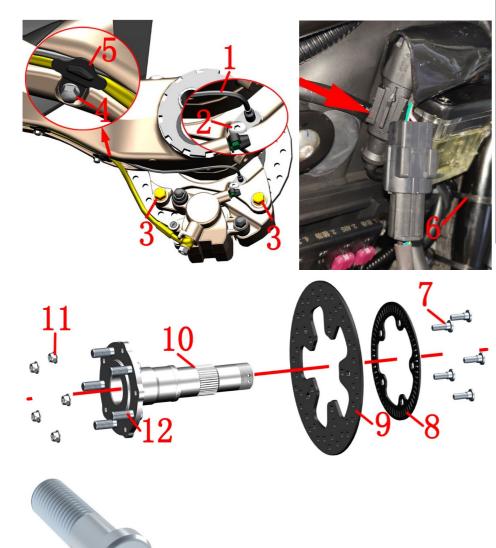
| Fig.6 Rear wheel, swinging arm component | | Rear axle assembly | CHK | 40) |

Tire: Check regularly the tire on cracks and air pressure. If the tire is ware to the marker, change the tire with same specification. See details in user manual. Ingradiant of tire include semi hot melt rubber. Area with too high temperature is not suitable. If temperature of outdoor is too low, storing the motorcycle in warm place or indoor is suggested in order to avoid frost crack. Normal temperaturestandard 250kPa.

Rim: Check if the rim has deformation or crack. Support the rim horizontally and check if it can rotate smoothly. Disc brake plate: Thickness can not be less than 4mm. If not, change it.

- Be careful while disassembling the tire and rim in case of damages on the components.
- After changing the tire, check air proof performace and dynamic balance.
- Disqualified tire repair liquid might corrode the rim and cause safety risk.
- Not enough tire pressure can cause abnormal wear and tare. Too high pressure in summer might have possibility of tire bursting.

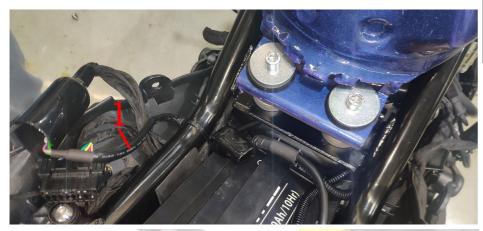
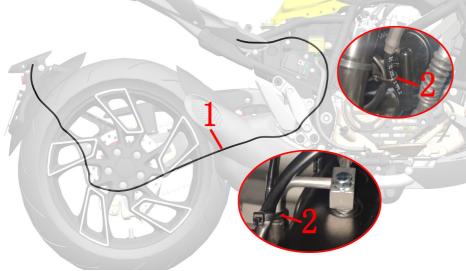
| Fig.7 Rear wheel, swinging | | Rear auxiliary mud plate component 1 | CHK | |

• The replacement of the bolts (12) separately must be secure and reliable.

Carefully pull the auxiliary mudboard adapter cable out of the motorcycle from the vicinity of the battery and remove it to the rear auxiliary mudboard assembly, then roll up the adapter cable and tie it with a rope.

- The seat cushion, left side cover, etc. must be removed in advance.
- Do not pull the cable hard when removing the sub-mud switch.

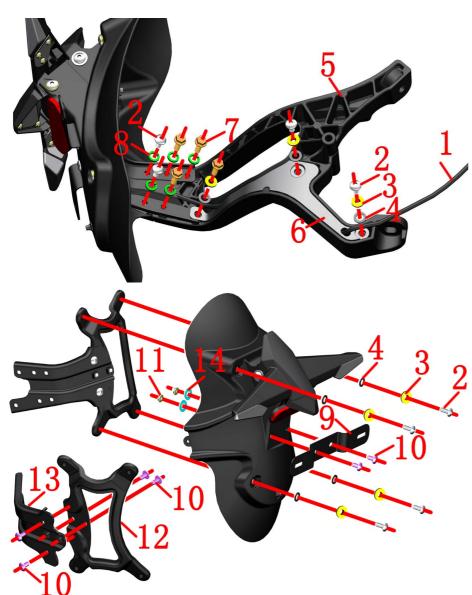
| Fig.8 Re | ar wheel, swinging | Rear auxiliary mud plate component 2 | CHK | 40) |

Use 4# inner hexagon to remove 4 bolts (10), and separate the rear part (12) and the front part (13) of the iron bracket.

- Do not pull the cable hard when removing the vice fender connecting cable.
- When reassembling, first check if there is any pressure on the wire to prevent short circuit when tightening the
- •2 pcs GB97.1φ8 have been added to motorcycle manufactured by July 2021. Early production can add by yourself.

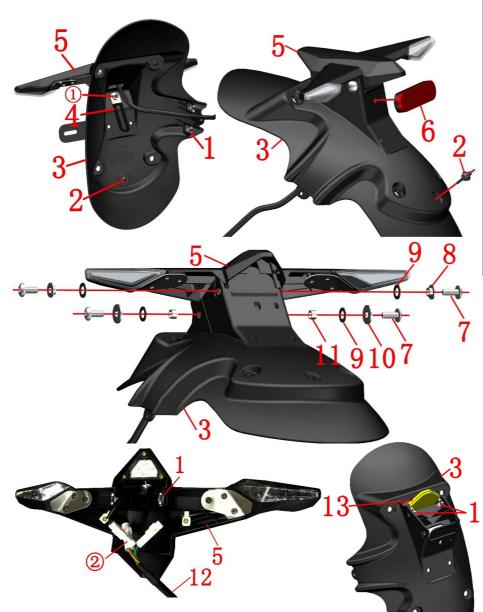
| Fig.9 Rear wheel, swinging arm assembly | | Rear auxiliary mud plate component 3 | CHK ADJ | |

Remove the 2 plywood nuts (1) from the turn signal (5). Remove the 3 joints of (2) and remove the sub-mud switch cable (12).

- Do not pull the cable hard when removing the sub-mud switch.
- When reassembling, check if there is any pressure on the wire to prevent it from tightening. Short circuit caused by bolts. Pay attention to the lamp connector, do not insert the wrong, turn leftGreen + orange; right turn signal is green + blue; license plate light is green + pink.

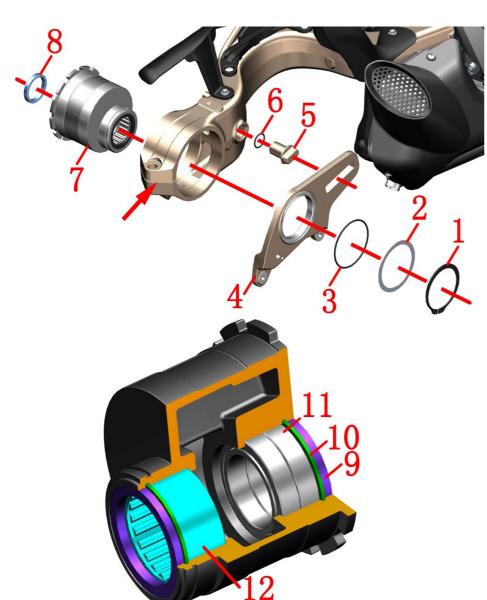
| Fig.11 Rear wheel, swinging arm assembly | | Chain adjuster assembly | CHK | 401 |

It is recommended to inspect, maintain and clean the bearings every 6,000 km. After removing the chain adjuster assembly according to the previous steps, clean the bearings inside with gasoline or diesel. Carefully check the bearings for damage, smooth rotation, and noise. After confirming the pass, wipe it with a clean, lint-free cloth and re-apply the grease evenly on the bearing.

- It is recommended to inspect, maintain and clean the bearings every 6,000 km.
- If the disassembled chain adjuster assembly is inspected before the reassembly, carefully check whether the oil seal is damaged; the bearing needs to be pressed into place.

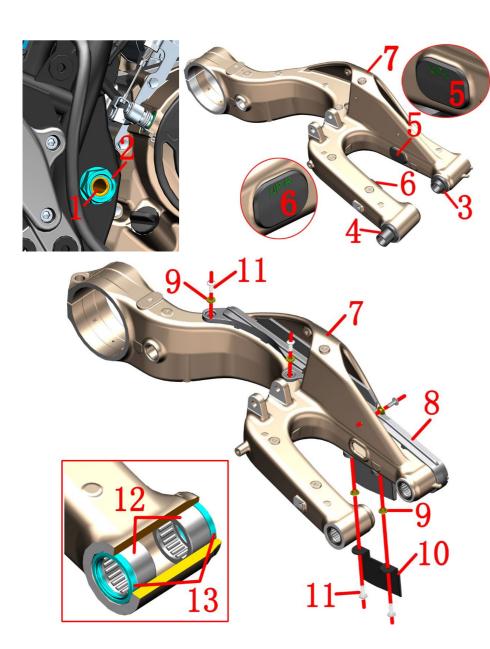
| Fig.16 F | Rear wheel, | Rear wheel assembly | CHK | 401 |

• Appropriate amount of grease can be added to reduce resistance at the needle bearing.

The oil seal (3) and the needle bearing (2) are used for interference compression. Please ensure that they have the ability to disassemble and disassemble.

- Remove the rear shock-absorbing linkage assembly, rear inner mud plate, rear wheel assembly, side cover, seat cushion, etc. in advance.
- It is strictly forbidden to hit the threaded part of the rear axle with a hammer.
- The left dust-proof rubber plug is stamped with "UP-L", and the right dust-proof rubber plug has "UP-R"; pay attention to the installation direction.

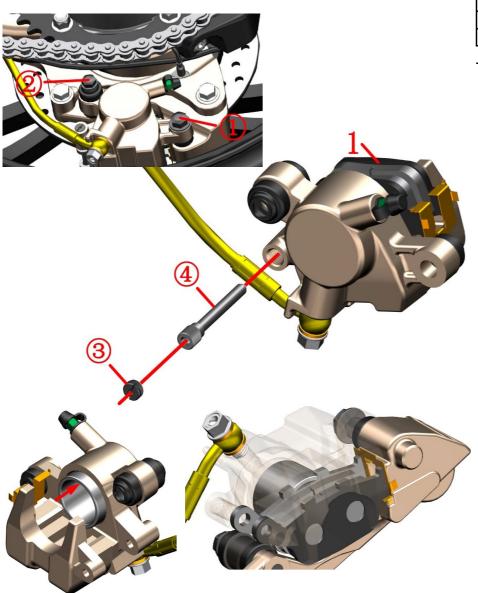
| Fig.17 Rear wheel, | | Change rear brake arresters | CHK | Q |

Step on braking pedal several times until braking force is recovered.

- Check regularly the arrester and disc brake plate status.
- To change arresters in qualified mainenance spot are suggested.
- After changing the arrester, adjust the height of braking pedal according to "Foot pedal, gear shift rod assembly" if necessary.
- It needs running-in for about 300km after changing new arresters. During this period, leave enough braking distance while riging.

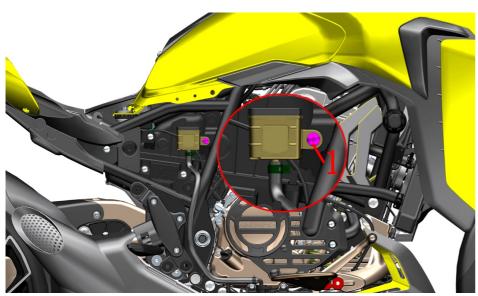
| Fig.18 Rear wheel, | | Rear disc brake main pump adding braking liquid | CHK | |

Step gently on the pedal constantly. Do not ride the motorcycle until the braking force is recovered.

- Support the motorcycle well on flat ground before checking.
- Check regularly if the braking liquid surface is between "UPPER" and "LOWER".
- If liquid surface is below "LOWER", check the arrester status and confirm if the braking system is leaking.
- If the braking liquid is accidently swallowed, contact intoxication center or hospital immediately. If it gets into the eye, wash it away with clean water then see the doctor.
- Keep the braking liquid far away from children and pets.
- Flush the oil cup directly with high pressure water is prohibited.
- Mixing water, dust, impurity and liquid of silicic acid or petrol series into the braking liquid is prohibited. Otherwise, the braking system would be damaged.

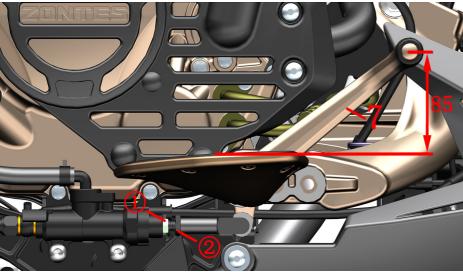
| Fig.1 FOOT PEDAL COMPONENT | | Adjust the hight of foot pedal | CHK ADJ | Q |

Use an 10# open-end wrench to loosen the nut (3) ,and nut (5) respectively. Use 8# open spanner to adjust the gear shift rod (4) adjustment bolt until the height becomes suitable. Then tighten the nuts. If the above-mentioned method can not adjust the gear shift rod to a satisfying position, take off bolt (1) and adjust gear shift rod spline of rocker arm (2) with a straight screwdriver by shoving a little bit the groove in the middle while dragging it out. Reassemble after the height is suitable. Pay attention to the aligning of the groove in the middle.

Use an 10# open-end wrench to loosen the nut②. Spin the adjustment rod bolt① and adjust the brake pedal(7) to 85mm up to the top pedal (8). Fix the adjustment rod bolt① and tighten Nut②.

- Ensure the motorcycle is well supported during manipulation. Avoid falling accident.
- The height of gear shift rod should be ajusted to a suitable range. Otherwise the riding experience would be influenced.
- The height of brake pedal should be ajusted to a suitable range. Otherwise the durance of braking shoe and plate would be influenced. In severe case, ineffective braking is possible.

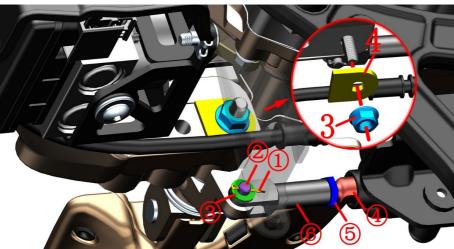
• Front right pedal bracket assembly

Use a short 14# sleeve or torx wrench to fix the head of bolt (1), and then use a short 14# sleeve or torx wrench to loosen the nut (2), and remove the nut (2) incompletely.

Use a 10# open-end wrench to fix the screw ④ and use a 14# open-end wrench to loosen the lock nut ⑤. Adjust the brake pedal to a suitable height with one hand and fix it. With the other hand, turn the fork joint ⑥ toward the front of the car to a suitable position, and then install the pin ③, gasket ② and cotter pin ①; Bend both feet to the sides.

- Ensure the motorcycle is well supported during manipulation. Avoid falling accident.
- The height of brake pedal should be ajusted to a suitable range. Otherwise the durance of braking shoe and plate would be influenced. In severe case, ineffective braking is possible.

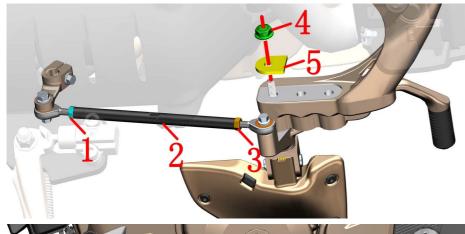
| Fig.4 FOOT PEDAL | | Front left pedal mounting position adjustment | CHK | |

First use 8# open-end wrench fasten the groove in the middle of adjustment screw(2), and use the 10# open-end wrench to loosen the nut (1) and (3), and remove the adjustment screw (2).

Rotating the adjustment screw and adjustment shift lever to the suitable position and lock the nut (1) and (3).

- Ensure the motorcycle is well supported during manipulation. Avoid falling accident.
- The height of gear shift rod should be ajusted to a suitable range. Otherwise the riding experience would be influenced.

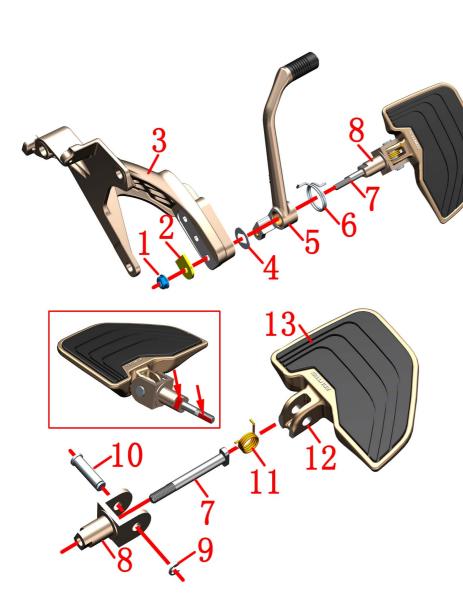
| Fig.5 FOOT PEDAL COMPONENT | | Front right footrest component | CHK | 40) |

Remove the circlip (9), remove the pin (10), and separate the foot support (8), torsion spring (11), non-standard bolt (7) and the front right foot pedal assembly. Remove the rubber pad (13) from the right pedal (12).

- The bearing washer and the boss of the support should be placed and assembled.
- Pedal fixed film, the pedal torsion spring and the brake pedal torsion spring pay attention to the installation direction.
- You can watch the video tutorial in "ZT310-V1 Foot Rest Assembly Video Tutorial" in the assembly video.

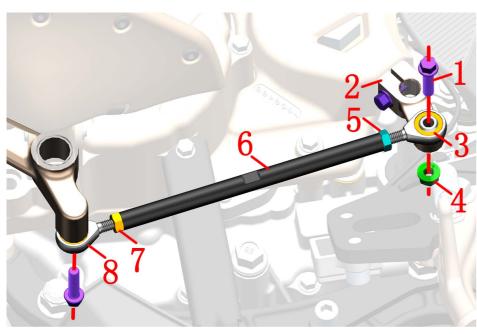
| Fig.6 FOOT PEDAL COMPONENT | | Shift lever assembly | CHK | (0) |

Use the 10# open-end wrench to loosen the nut (5) and nut (7), use the 8# open-end wrench to rotate the groove of adjustment screw (6) and take it off. Take off the nut (5) and nut (7). Using the 10# open-end wrench to fix the nut (4) then using the 8# sleeve remove the bolts (1), take off the bearing(3). Using the 8# sleeve remove the bolts (1) at the shift lever step rocker, take off the bearing (8). Using the 8# sleeve remove the bolts (1), then using a flat-blade screwdriver to pull the spline rocker arm (2) in the middle slot slightly and pull it out.

- Support the motorcycle properly while disassembling in case it falls down.
- Pay attention to distinguishing the nuts at both ends of the knuckle bearing and the adjustment screw.

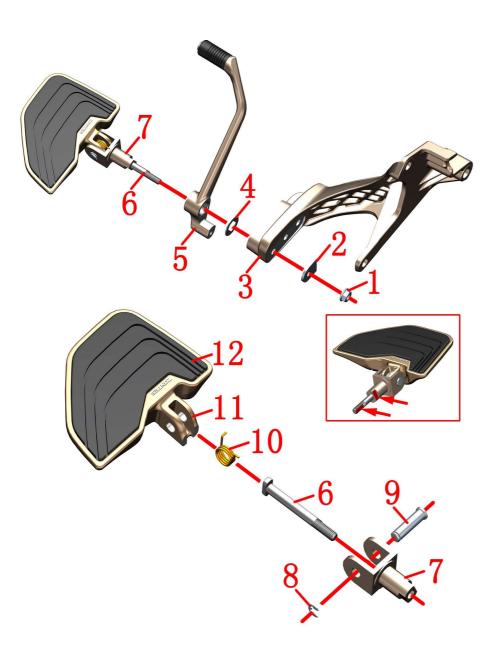
| Fig.7 FOOT PEDAL COMPONENT | | Front left footrest component | CHK | (0) |

Remove the circlip (8), remove the pin (9) and separate the pedal support (6), torsion spring (10), non-standard bolt (6) and the front left pedal assembly. Remove the rubber pad (12) from the left pedal (11).

- The bearing washer and the boss of the support should be placed and assembled.
- Pedal fixed film, the pedal torsion spring pays attention to the installation direction.
- You can watch the video tutorial in "ZT310-V1 Foot Rest Assembly Video Tutorial" in the assembly video.

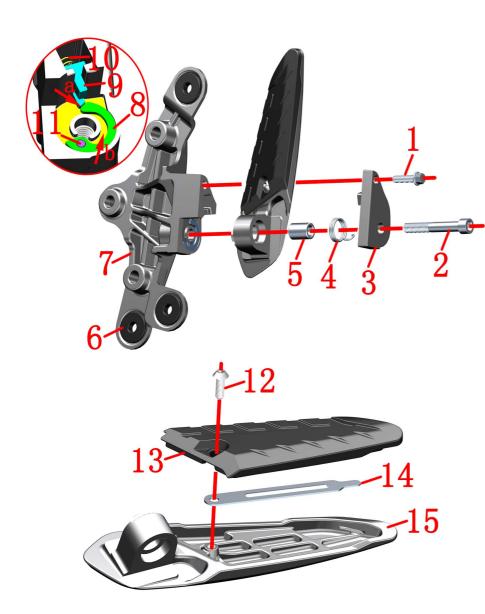
| Fig.9 F | OOT PEDAL | Rear right pedal bracket components | CHK | 401 |

The rubber sleeve fixing piece (14) is withdrawn from the pedal rubber sleeve (13).

- When reassembling, apply a proper amount of grease to the yellow surface indicated by arrow b. Note that the slider top sheet needs to hold the slider.
- Reassembly is to tighten the bolt (1) first, then pre-tighten the bolt (2). The bolt (2) head should be coated with a proper amount of thread fastening glue. After tightening the bolt (2), it is necessary to confirm whether the pedal rotation is flexible or not.

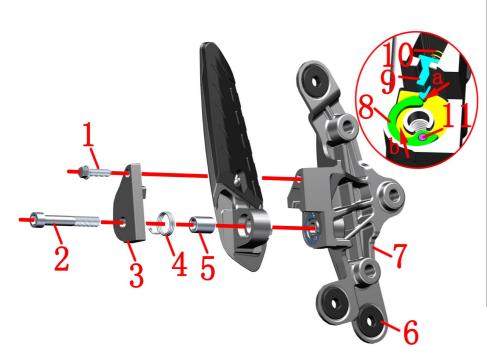
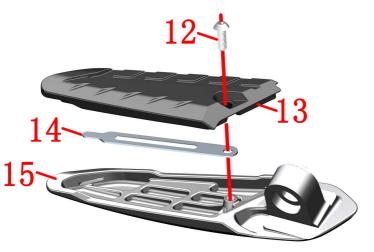
| 0 | FOOT PEDAL | Rear left pedal bracket components | CHK | (0) |

The rubber sleeve fixing piece (14) is withdrawn from the pedal rubber sleeve (13)

- When reassembling, apply a proper amount of grease to the yellow surface indicated by arrow b. Note that the slider top sheet needs to be held against the slider as indicated by arrow a.
- Reassembly is to tighten the bolt (1) first, then pre-tighten the bolt (2). The bolt (2) head should be coated with a proper amount of thread fastening glue. After tightening the bolt (2), it is necessary to confirm whether the pedal rotation is flexible or not.

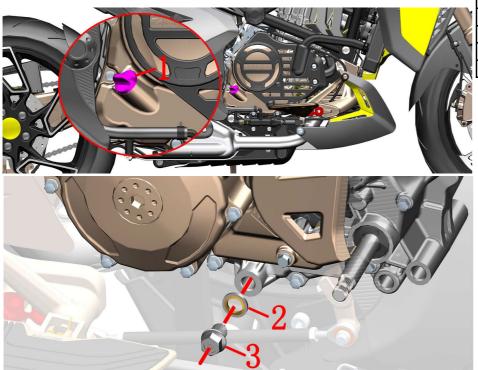
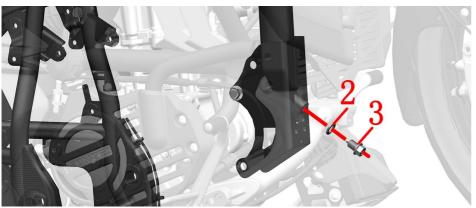
| F | Fig.1 COOLING SYSTEM | | Change engine oil | CHK | 40) |

The frame oil drain bolt is in the gap between the front foot pedal bracket and the ABS pilot control unit cover. Wipe off the dirty oil with clean nonwovens. Be sure that the surface of oil draining bolt and sealing gasket are not scratched and has no inpurity before reassembling. Torque on bolt is 24±4N.m. Too strong will damage the thread. Too week will cause leakage of oil.

Start the engine and test it under different rotation speed for 2 minuts. Check if the engine oil leaks.

Run the engine at idling speed for 5 minuts than shut down the engine for 3 minuts. Check the engine oil level gauge. If oil level is lower than minimum mark, add more engine oil until liquid surface reaches maximum mark. Follow the steps above-mentioned and check again if engine oil leaks.

- Disassembling the cooling system while the motorcycle is hot is prohibited. Wait until the engine and muffler cool down thoroughly for the manipulation.
- Wasted engine oil should be collected and hand over to qualified facilities for further treatment. Do not pour the oil anywhere and avoid pollution of environment and water source.
- Changing the draining bolt and sealing gasket every time when changing the engine oil is suggested.
- As the crankshaft connection rot has bearing bush, whild changing the engine oil, make sure the engine has at least 1L before starting the engine. If not, the bearing bush can be damaged or the crankshaft can be seized.

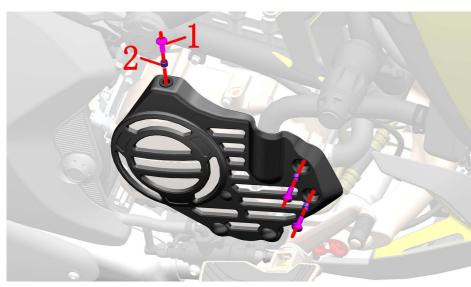
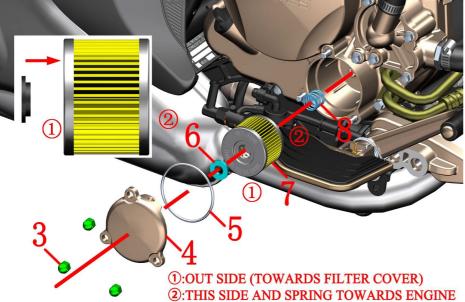
| Fig.2 C COMPC | OOLING SYSTEM DNENT | Change engine oil filter | CHK ADJ | Q |

Disassemble nut (3) with 10# sleeve. Rotate slightly engine oil refined filter cover (4) and take it off when it is loosen.

Check if seal ring (5) is broken. Change the seal ring (3) along with engine oil filter is suggested.

- Ensure every component is well assembled.
- To change engine oil filter and seal ring(5) at the same time is suggested.
- Engine oil filter can not be turned over when assembling.
- Note that the seal ring (6) is facing the fine filter with the "OUT SIDE (TOWARDS FILTER COVER)" side. It is forbidden to install reverse or leak.
- 【1】The ZT180 refined filter seal component already included oil filter、55×2.5 O-ring (5) and ZT180MN Engine oil refined filter seal ring(6).

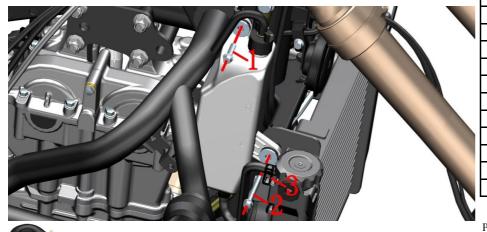
| | Fig.5 C | OOLING SYSTEM | Vice water tank components | CHK | 401 |

After wearing the waterproof rubber gloves, put the sub tank assembly upside down (the sub water tank cover down) into a plastic container.

Clamp the clamp on the leak pipe (4) with pliers and pull it out. Subsequent production of motocycles will reduce the clamps for leak pipe.

Remove the sub tank bracket (9) after pulling out the bolt (10).

- Disassembling the cooling system while the motorcycle is hot is prohibited. Wait until the engine and muffler cool down thoroughly for the manipulation.
- Cooling liquid should be collected and hand over to qualified facilities for further treatment. Do not pour the oil anywhere and avoid pollution of environment and water source.
- Be sure to wipe the connecting surface with clean nonwoven before reassembling.

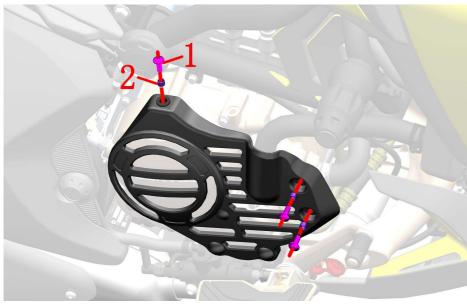
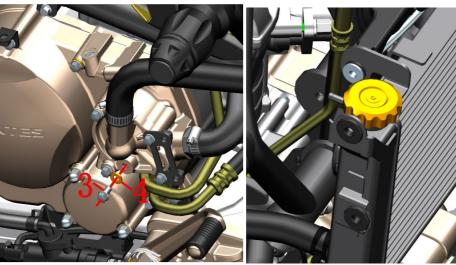
| Fig.7 COOLING SYSTEM COMPONENT | | Draining cooling liquid | CHK | |

After wearing waterproof gloves with both hands, remove the bolts (3) with a 8# sleeve and remove the combination seal (4).

Wipe out all of the cooling liquid on surface every component with a clean cloth.

- Motorcycle should be well supported.
- Manipulation should start after the engine is completely cooled down.
- Cooling liquid is toxic. Avoid strictly eye or skin contact.

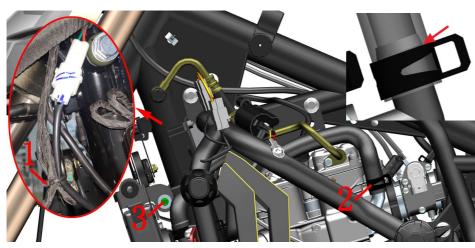
Pull out the water pipe after wearing the waterproof gloves. Remove the hoop (2).

Use a flat-blade screwdriver to loosen the three clamps (5) and remove the boss indicated by the arrow.

Remove the main tank assembly.

- Motorcycle should be well supported. Manipulation should start after the engine is completely cooled down.
- Manipulation should start after the engine is completely cooled down.
- Cooling liquid is toxic. Avoid strictly eye or skin contact.
- Do not disassemble the hoop with too strong force. If not, it will cause permanent deformation and lose elasticity, which will lead to leakage of cooling liquid.
- When reassembling, be careful that the clamps and hoops should be prevented from loosening on the inside of the boss.

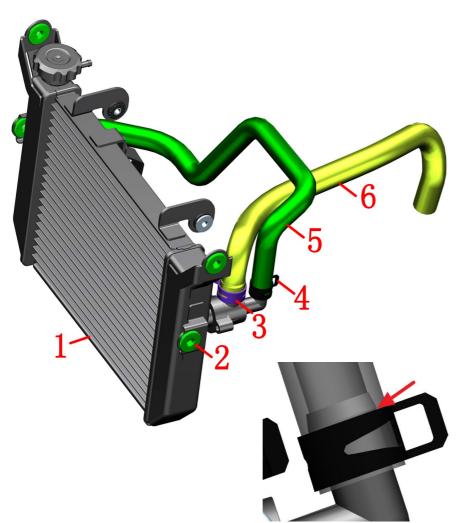
| Fig.9 COOLING SYSTEM | | Main water tank assembly 2 | CHK | (0) |

After wearing the waterproof gloves, clamp the hoop with pliers (4) and remove the hoop after removing the anti-slip boss.

Remove the outlet pipe (6) and the hoop (3) as previously described.

- Cooling liquid is toxic. Avoid strictly eye or skin contact.
- Do not disassemble the hoop with too strong force. If not, it will cause permanent deformation and lose elasticity, which will lead to leakage of cooling liquid.

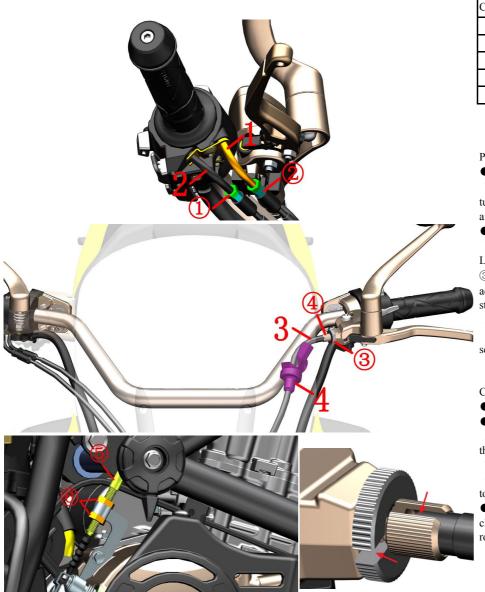
| Fig.1 FRONT FORK COMPONENT | | Throttle/clutch cable clearance adjustment | CHK | |

Use an 10# open-end wrench to loosen the lock nut 1 on the throttle refueling line 1 or the return line 2, and turn the adjustment screw 2 to adjust the clearance to 2 to 4 mm. Use 8# open-end wrench to tighten the nut 1 after adjustment.

Lift the protective rubber sleeve (4) on the clutch rocker arm to the elbow of the clutch cable (3), loosen the nut ③ with pliers, rotate the adjustment screw ④, finally lock the nut ③, and then reset the dust jacket. After adjusting, pay attention to the nut ③, the adjustment screw ④ and the groove of the rocker seat should be staggered to prevent the cable from coming out.

If fine adjustment cannot be achieved, loosen the nuts® with an 14# open-end wrench, rotate the adjustment screw ⑤, and finally tighten the nuts ⑥.

Checking the engine idle speed should be performed under the condition of a heat engine and should be at 1500 to 1700 rpm.

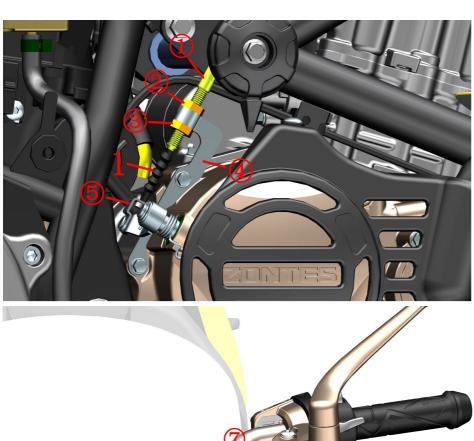
| Fig.3 FRONT FORK | | Replacement clutch cable | CHK | Q |

Finally, reset the protective rubber sleeve (2).

- The motorcycle support should be fixed during disassembly to prevent accidents caused by incline.
- Before replacing the clutch line, it is necessary to disassemble the seat cushion, fuel tank, liner, side cover, etc.

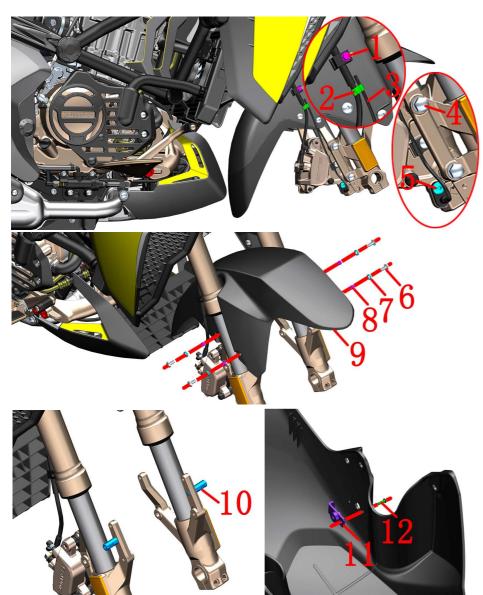
| Fig.9 FRONT FORK | | Front mudguard & wheel speed sensor component | CHK | 40) |

Rim: Check the rim for any deformation, cracks, etc. Rotate the rim horizontally to check for stuck, oscillating, etc.Rim seal φ 42 × φ 28 × 7; bearing model: 6004-2RS.

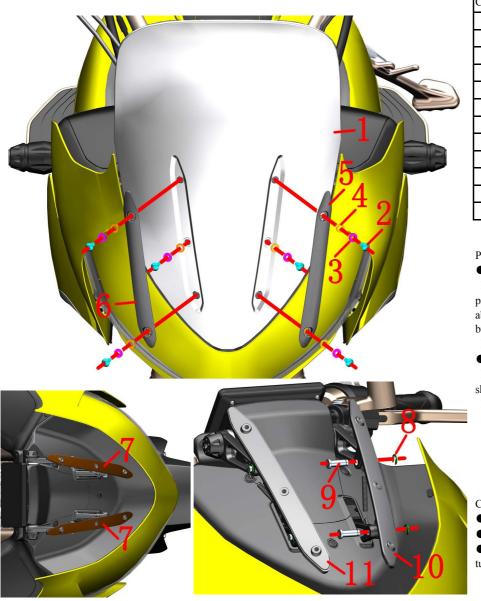
| Fig.10 FRONT FORK COMPONENT | | Windshield components 1 | CHK | 40) |

Remove the right pressure block (11) according to the above steps.

- The windshield should be protected from scratches during disassembly.
- The circlip is small, please keep it well during disassembly and prevent it from falling into the vehicle.
- You can search "ZT310-VX Headlight Replacement Video" in the assembly video to watch the detailed video tutorial.

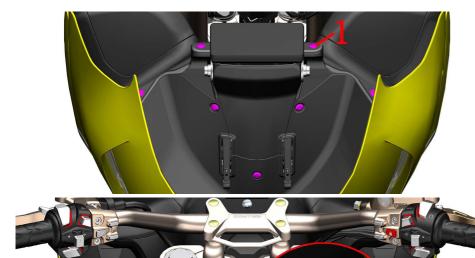
| Fig.12 Fl | RONT FORK | Headlight assembly 1 | CHK | Q |

• You can search "ZT310-VX Headlight Replacement Video" in the assembly video to watch the detailed video tutorial.

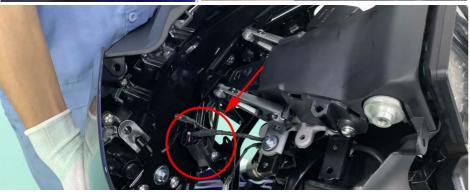
| Fig.14 F | RONT FORK | Headlight assembly 3 | | |

Grasp both sides of the headlight assembly of the headlight cover and pull it forward for a certain distance; unplug the cable plug of the headlight before removing the headlight assembly of the headlight cover.

- You can search "ZT310-VX Headlight Replacement Video" in the assembly video to watch the detailed video tutorial.
- The parts should be protected during the disassembly process to prevent damage to the paint surface.
- When removing the buckle, pay attention to the strength to prevent damage to the buckle.

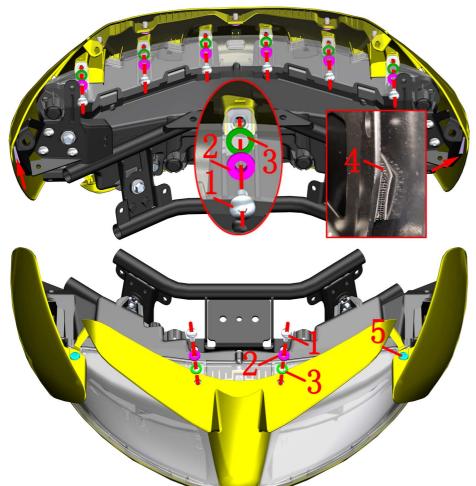
| Fig.15 F | RONT FORK | Headlight assembly 4 | CHK | |

Separate the headlight assembly and headlight cover assembly.

- You can search "ZT310-VX Headlight Replacement Video" in the assembly video to watch the detailed video tutorial.
- The parts should be protected during the disassembly process to prevent damage to the paint surface.
- When removing the buckle, pay attention to the strength to prevent damage to the buckle.

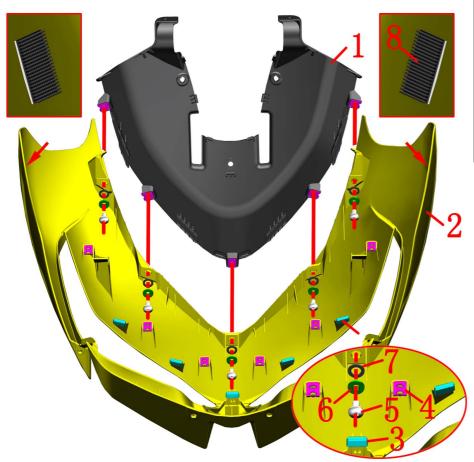
| Fig.16 F | RONT FORK | Headlight assembly 5 | CHK | (0) |

The mushroom buckles (8) on both sides of the inside are respectively pasted on the headlight cover with double-sided tape.

- The parts should be protected during the disassembly process to prevent damage to the paint surface.
- When removing the buckle, pay attention to the strength to prevent damage to the buckle.

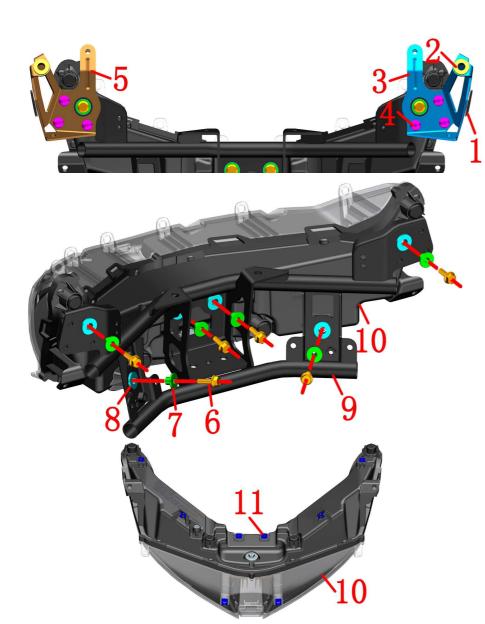
| Fig.17 F | RONT FORK | Headlight assembly 6 | CHK | 40) |

- You can search "ZT310-VX Headlight Replacement Video" in the assembly video to watch the detailed video tutorial.
- The parts should be protected during the disassembly process to prevent damage to the paint surface.
- When removing the buckle, pay attention to the strength to prevent damage to the buckle.

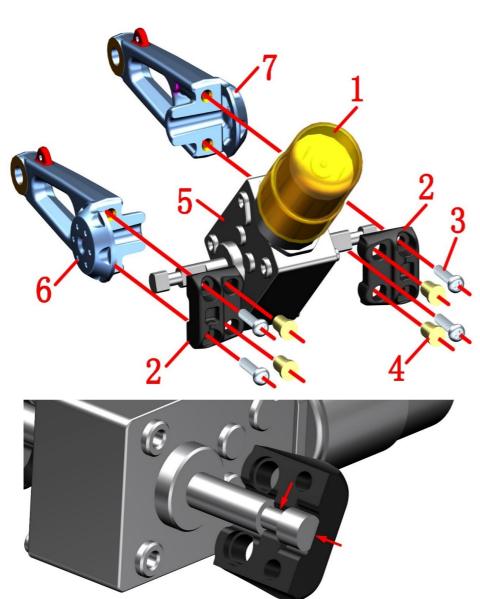
| Fig.19FF COMPC | RONT FORK ONENT | Windshield motor sub-assembly | CHK ADJ | Q |

Grab the lower right rocker arm(7). Remove the 2 screws(3) with a Phillips screwdriver and remove. Remove the rocker arm clamp (2).

- Do not pull the cable directly when pulling the plug.
- Pay attention to the limit plane and limit groove of the motor and rocker clamp when reassembling.

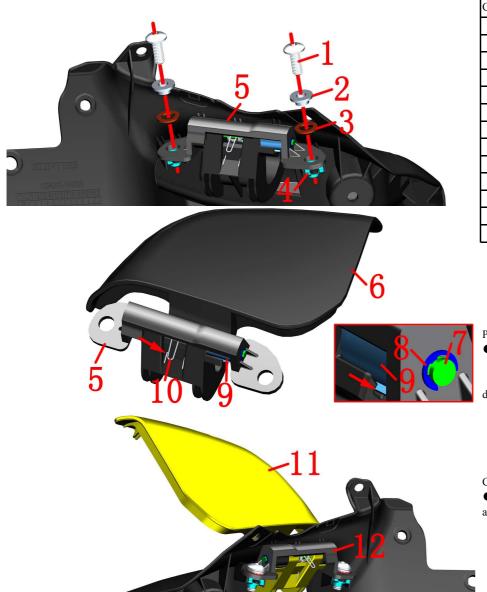
| Fig.22FI | RONT FORK | Storage box, rear surrounding components 2 | CHK | 40) |

● When reinstalling, make sure that the spring (9) is inserted into the upper hole of the storage box cover; the anti-rotation slot of the damper (8) should be aligned with the storage box cover.

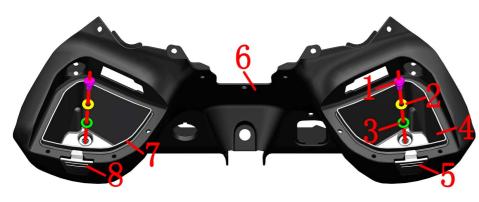
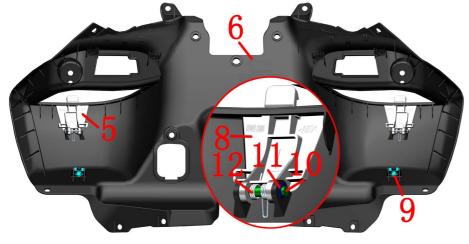
| Fig.23 F | FRONT FORK | Storage box, rear surrounding components 3 | СНК | 40) |

• When reassembling, make sure that the spring (12) should be inserted into the hole of the storage box switch.

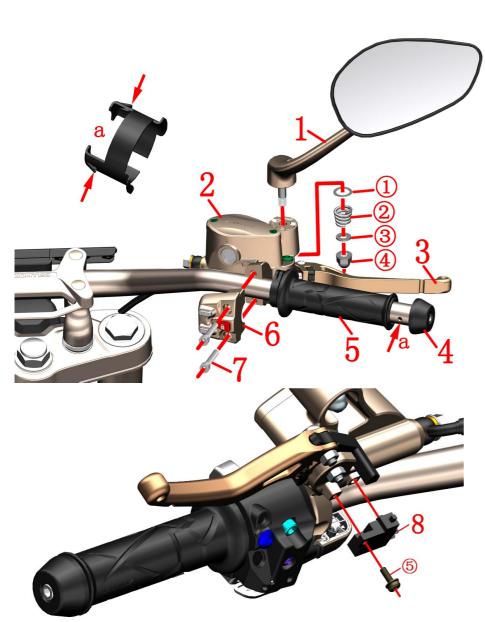
| Fig.24 FRONT FORK COMPONENT | | Right handlebar component | CHK | |

Remove the bolt ⑤ attached to the front brake main pump and replace the front brake switch. Note that the boss on the brake switch is aligned with the limit hole at the arrow indication of the front brake main pump.

- The motorcycle should be fixed after horizontal support.
- Periodically check that the fluid level of the brake fluid is between 3/4 of the observation window.
- Do not flush the cup directly with high pressure water.
- When assembling the balance block, align the protruding parts at both ends of the shrapnel with the fixing holes on the handle and then insert the direction into the holes.
- The small spacer of the rear view mirror anti-rotation limit slot needs to be aligned with the slot on the mirror bar bolt.
- The right handlebar refers to the switch to replace the throttle line.
- The joint between the front disc brake main pump and the half cover should be aligned with the right hand to match the triangle on the switch.
- The old model will be discontinued; the old switch can be replaced directly with the new one.

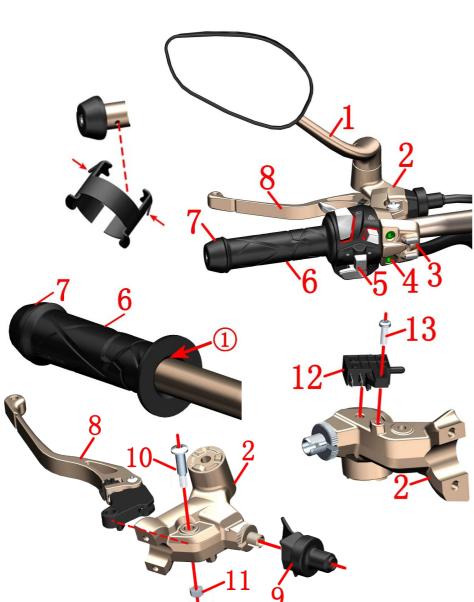
| Fig.25 F | RONT FORK" | Left hand component | CHK | (2) |

Remove the clutch line by referring to the "Replace Clutch Line" procedure. Remove the left rear view mirror (1), rocker base(2), left sub switch(3), bolt(4), left switch(5), and rocker arm(8) by referring to the steps in "Right" Handle Assembly" and "Add Brake Fluid, Adjusting Rocker Arm".

• Press during reassembly: the left hand grip rubber sleeve - balance block - switch - left hand rocker arm - left'rear view mirror. Note the triangle symbol on the rocker arm assembly and the half cover seam alignment switch.

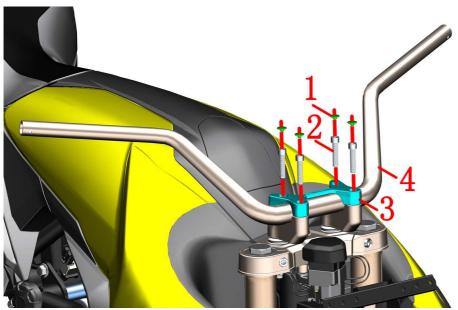
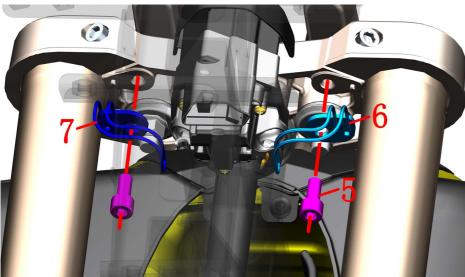
| Fig.26 FRONT FORK COMPONENT | | Direction handle&TFT Instrument | CHK | (0) |

Remove the bolt (5) with a 6# inner hexagon, and then remove the left wiring support (6) or the right wiring support (7).

- When assembling the clamping block, please tighten the two bolts at the front first, and then tighten the bolts at the rear (close to the fuel tank side). Wrong sequence or diagonal locking may break the briquette.
- The parts should be protected during the disassembly process to prevent damage to the paint surface.
