ZT310-VX (EURO IV/V)

Service manual

2021/11/12

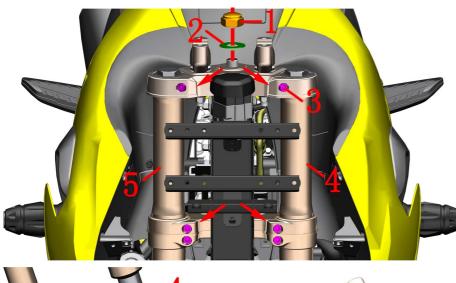
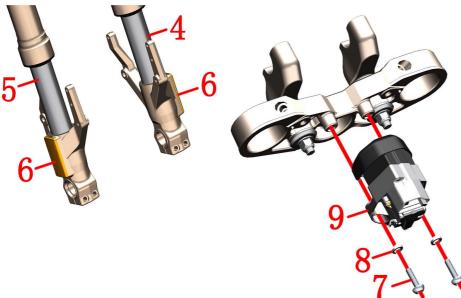
| Fig.27 FRONT FORK COMPONENT | | Front shock absorber, upper plate component | CHK | 40) |

Reflective sheets are sold separately for sale (no replacement shock absorption). The heat-reflecting sheet can be moved back and forth by a hot air blower to reduce the viscosity of the double-sided adhesive after being heated, and the residual glue should be cleaned after removing the reflector.

Remove bolt (7) with 6# inner hexagon, and remove spring washer (8) and faucet lock (9).

- Use a flat-blade screwdriver to enlarge the gap between the upper and lower joint plates without applying excessive force to avoid damage.
- The vehicle support should be fixed during the disassembly process to prevent accidents caused by dumping.
- For the disassembly of the lower board components, see "Steering Adjustment" above, which will not be repeated here.
- Switch to improved from June 4,2021.Older models requires two shocks switch to an improved version.

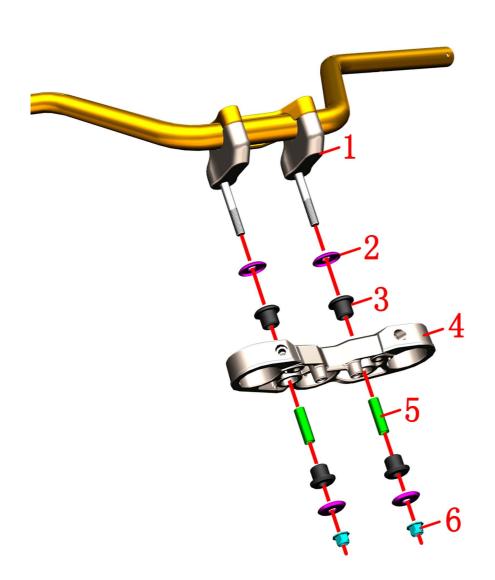
| Fig.28 FRONT FORK | | Uplink plate, direction handle block component | СНК | |

The spacer(1), the upper clamp and the direction handle are disassembled.

- Protect protective measures to prevent scratching the appearance of parts.
- When reassembling, it is necessary to use the direction to ensure that the center and direction of the spacers on both sides are coaxial with the center. First install 4 pieces of cushioning rubber into the upper plate and then install the bushing separately. Make sure that the bushing is flush with the cushioning rubber, otherwise it should be reassembled. When tightening the nut, ensure that the torque is 40N.m. Check the buffer for spillage and reassemble if necessary.

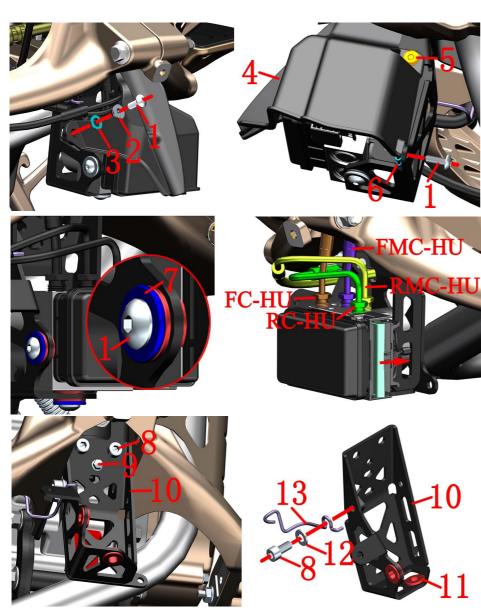
| Fig.29 Fl | RONT FORK | ABS brake system—1 | CHK | |

Refer to the previous step of adding brake fluid to remove the upper cover, cover and sealing gasket of the front and rear disc brake main oil cups. Place the oil pan underneath. After wearing the waterproof gloves, pull out the hydraulic control unit and tilt it to the right side. Use an open-end wrench to loosen the nut joints of the four oil pipes. After the brake fluid is discharged, remove the hydraulic control unit and wipe off the oil. Be careful not to let the brake fluid come into contact with the cable connector to prevent poor contact due to corrosion. RC-HU is connected to the hydraulic control unit and rear brake caliper; RMC-HU is the rear disc brake main pump; FC-HU is the front disc brake caliper; FMC-HU is the front disc brake main pump. The torque standard of the 4 oil pipe nut joints of the hydraulic control unit is 18N.m.

Remove the bolt (8) with a 6# inner hexagon, then remove the gasket (12), and then remove the hook (13).

- Be sure to disassemble the muffler and engine after they have cooled down completely. The horizontal support of the vehicle should be fixed before disassembly and assembly work.
- The precautions for brake fluid are described in the previous section.

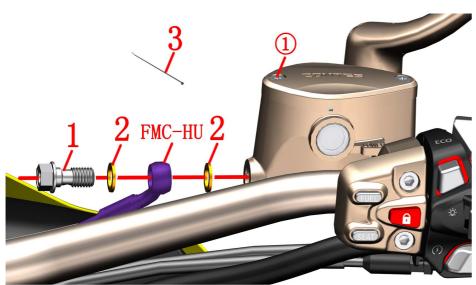
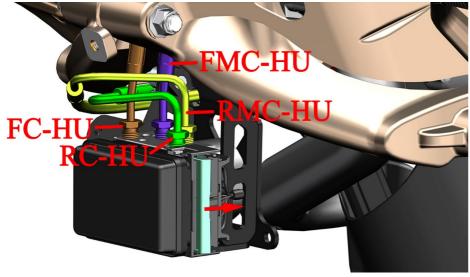
| Fig.30 FRONT FORK | | ABS brake system – 2 | CHK | Q |

After wearing the waterproof gloves, remove the bolts (1) with a 12# sleeve; remove the copper washers (2).Remove the FMC-HU tubing. It is recommended to replace the two copper washers (2) at the same time when replacing the tubing. The bolts (1) can be replaced if they are not damaged.

Wipe the end faces of the bolt (1) and the front disc brake main pump before replacing the FMC-HU tubing. After installing the tubing, add DOT4 brake fluid and vent the brake system. Detailed steps can be found in Adding Brake Fluid.

- Be sure to disassemble the muffler and engine after they have cooled down completely. The horizontal support of the vehicle should be fixed before disassembly and assembly work.
- The precautions for brake fluid are described in the previous section.
- The torque standard of the four tubing nut joints at the pilot unit is 18N.m

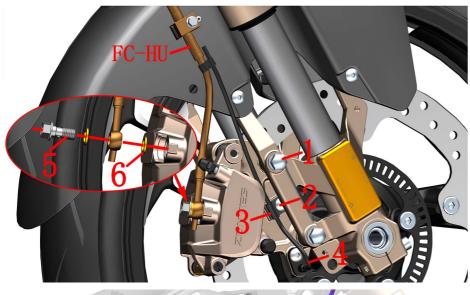
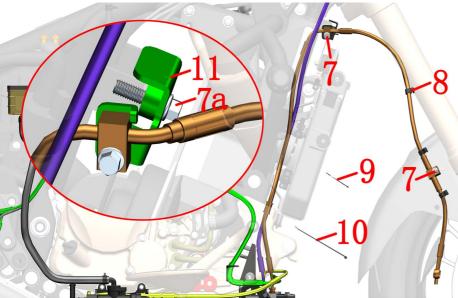
| Fig.31 F | RONT FORK | ABS brake system — 3 | CHK | 401 |

After wearing the waterproof gloves, remove the bolts (5) with a 12# sleeve; remove the copper washers (6). Using 14# sleeve remove the two bolts (1) and remove the front disc brake caliper from the front shock absorber.

Cut the straps (9) and (10); remove the 3 clips (8). Then remove the FC-HU tubing. If you need to replace the FC-HU tubing, it is recommended to replace the two copper washers (6) at the same time; the bolts (5) can be replaced if they are not damaged.

If you only need to replace the oil pipe, you do not need to remove the oil pipe bracket (11). If you need to remove it, remove the bolt (7) at the front(a) to remove the bracket.

- Be sure to disassemble the muffler and engine after they have cooled down completely. The horizontal support of the vehicle should be fixed before disassembly and assembly work.
- The torque standard of the four tubing nut joints at the pilot unit is 18N.m.
- It is recommended to replace the two copper washers (6) at the same time when replacing the oil pipe. The bolts (5) can be replaced if they are not damaged.

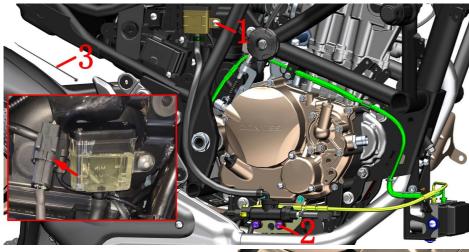
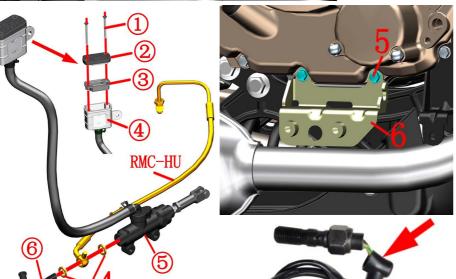
| Fig.32 FRONT FORK COMPONENT | | ABS brake system —4 | CHK | |

Remove the bolt ① with a Phillips screwdriver after wear waterproof gloves.

Using 8# sleeve remove the two bolts (5) and remove the bracket (6).

- Be sure to disassemble the muffler and engine after they have cooled down completely. The horizontal support of the vehicle should be fixed before disassembly and assembly work.
- The precautions for brake fluid are described in the previous section.
- It is recommended to replace the two copper washers (4) at the same time when replacing the oil pipe, rear brake switch wire or disc brake main pump.
- The rear brake switch wire is prohibited from rotating the rubber cap at the arrow indication. Replace this switch wire. Be careful not to wrap the cable around the tool.
- The torque of the four oil pipe nut joints at the pilot unit is 18 N.m.

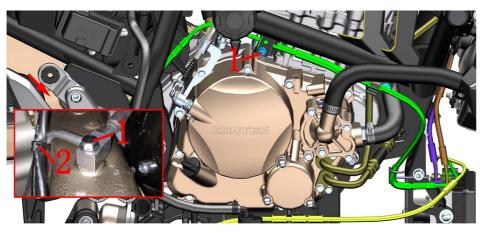
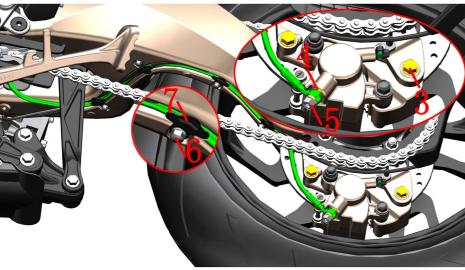
| Fig.33 FRONT FORK | | ABS brake system - 5 | СНК | (2) |

In the previous step, release the brake fluid. Loosen the nut connecting the RC-HU oil pipe and the hydraulic control unit.

After wearing the waterproof gloves, remove the bolts (5) with a 12# sleeve; remove the copper washers (4),If you need to replace the RC-HU tubing, it is recommended to replace the two copper washers (4) at the same time;the bolts (5) can be replaced if they are not damaged.

Use a 14# sleeve to remove 2 bolts (3) to take off the rear disc brake caliper.

- Be sure to disassemble the muffler and engine after they have cooled down completely. The horizontal support of the vehicle should be fixed before disassembly and assembly work.
- The precautions for brake fluid are described in the previous section.
- The torque of the four oil pipe nut joints at the pilot unit is 18 N.m.

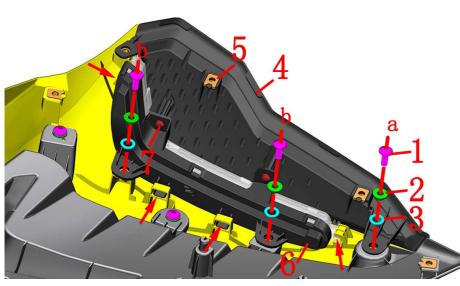
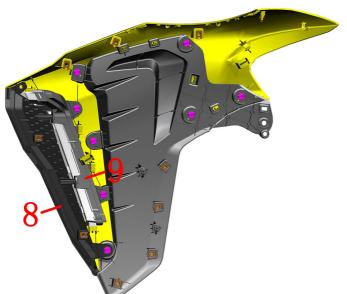
| \mathcal{C} | UEL TANK | Fuel tank trim cover assembly 4 | CHK | (0) |

Use a 4# inner hexagon to remove the bolt (1) at a, and remove the bush (2) and the cushion rubber (3). Loosen the bolt (1) with a 4# inner hexagon socket b and remove the 2 self-tapping screws (7) with a cross screwdriver. Remove the left grid (4) of the decorative cover. Remove 2 pieces of splints (5) from the left grid (4).

Remove the right grid (8) and the right turn signal (9) according to the above steps.

- The parts should be protected during the disassembly process to prevent damage to the paint surface.
- When removing the buckle, pay attention to the strength to prevent damage to the buckle.
- When recovering, the screw (7) should make the screw axis perpendicular to the installation surface, and can not be tightened too tightly to prevent damage to the pin on the grid.

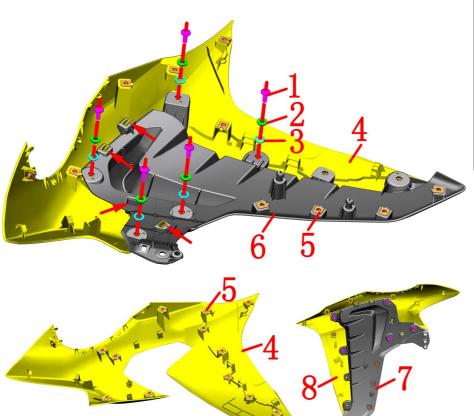
| Fig. 8 F | 8 FUEL TANK Fuel tank trim cover assembly 5 | | CHK | (0) |

- The parts should be protected during the disassembly process to prevent damage to the paint surface.
- When removing the buckle, pay attention to the strength to prevent damage to the buckle.

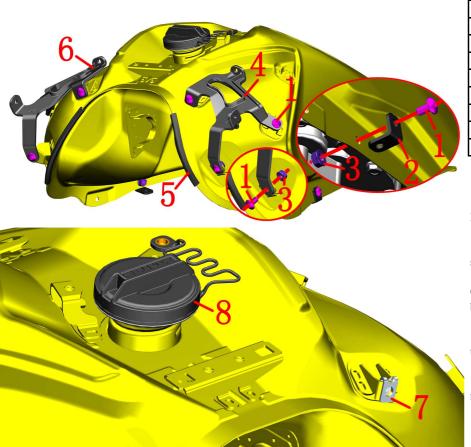
| Fig. 10 FUEL TANK COVER COMPONET | | Fuel tank decorative cover bracket | CHK | (0) |

Rotate the fuel tank cap (8) counterclockwise, remove the fuel in the fuel tank as much as possible. Be careful not to pull the nylon rope during disassembly.

- The parts should be protected during the disassembly process to prevent damage to the paint surface.
- Before disassembling the fuel tank assembly, it is recommended to use the oil pump to pull out the fuel or use off the fuel
- Fireworks, telephone calls should not be allowed near the motorcycle -removal workshop to prevent accidents.

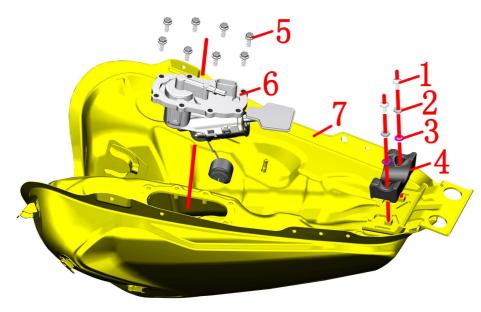
| Fig. 11 FUEL TANK COVER COMPONET | | Oil pump | CHK | (0) |

When the fuel pump (6) is removed, the float connecting rod cannot be bent to avoid inaccurate oil display. After removing the fuel pump, it is recommended to temporarily seal the oil pump port to prevent something falling into the tank.

- Before disassembling the fuel tank assembly, it is recommended to use the oil pump to pull out the fuel or use off the fuel
- Fireworks, telephone calls should not be allowed near the motorcycle -removal workshop to prevent accidents.
- When reassembling the fuel pump, be sure to clean the joint surface of the fuel pump sealant and the tank liner. When locking the bolt, the position should be locked to ensure uniform deformation of the seal gasket.

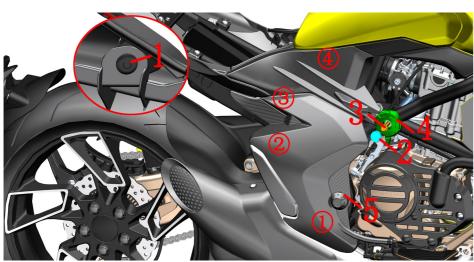
| | Fig.1 SIDE COVER COMPONENT | | SIDE COVER COMPONENT | CHK | 40) |

First remove the seat cushion and then remove the expansion screw (1) at the joint between the right side cover (5) and the tail cover.Remove the water stopper (2) and loosen the bolt (3) with the T12 socket without completely removing it.Pull the decorative ball (4) out and turn it clockwise, stagger the groove on the right side cover.Pull out the right side cover in the order of ①-②-③-④.

Remove the left side cover (6) using the same steps as above.

● When inserting, install the staples by ④-③-②-①; finally install the expansion screw.

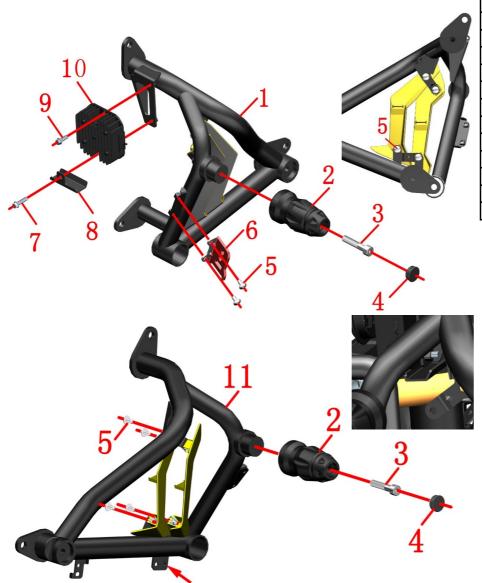
| Fig.3 GUARD BAR COMPONENT | | Guard bar assembly 3 | CHK | 401 |

Follow the steps above to remove the right bumper (11).

- Protect the engine decorative cover paint to prevent scratches.
- The disc brake lock bracket is only suitable for TOP DOG disc brake lock RE008 and TOP DOG disc brake lock RE0081 two models, other models are not adapted.
- When reassembling, pay attention to the radiator outlet pipe below the outlet pipe bracket.

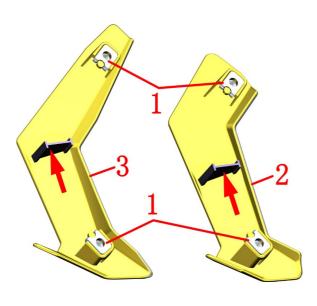
| Fig.4 GUARD BAR COMPONENT | | Engine decorative cover components | CHK | |

- Left engine decorative cover assembly
- 1.Remove the two nuts (1) from the left front decorative cover (2) of the engine.
- 2. The same method remove the nuts (1) from the left back decorative (3), the right front decorative cover (4), and the right back decorative cover (5).

- Protect the engine decorative cover paint to prevent scratches.
- Before replacing the engine decorative cover, check whether the clip indicated by the arrow has been cut short, if not, cut it first and then assemble it on the bumper.

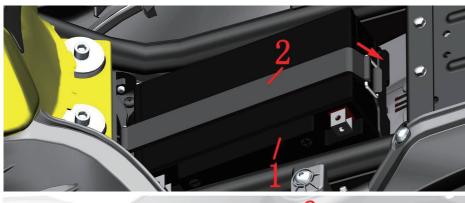
| Fig.1 RI | EAR COVER | ZT310 battery assembly | CHK | 40) |

Pull the battery strap (1) pull down to loosen the metal buckle, remove the battery strap (1), unplug the black negative protective cap of the main wiring harness, and remove the bolts that come with the battery with a cross. Remove the battery negative wire first, and then remove the positive wire, then the battery(2) can be removed.

- The material should be protected during discomponent to prevent damage to the paint.
- Be careful not to overcharge the charging time. About the use and maintenance of the battery see the instructions.

- A qualified lead-acid battery charger (output: DC14.5, 4A) must be used. If the battery is damaged by using a low-quality charger, it is not within the scope of the three packs.

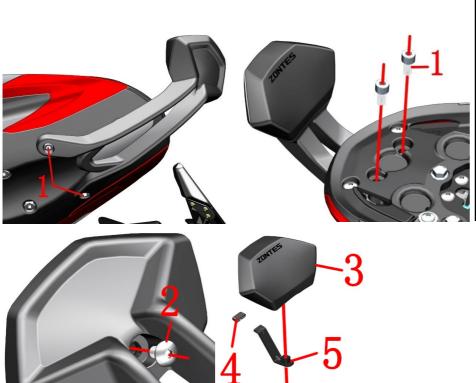
| Fig.2 REAR COVER COMPONENT | | Backrest assembly componen | CHK | 401 |

- Remove the side cover, seat cushion, and cover decoration cover in advance.
- The material should be protected during discomponent to prevent damage to the paint.

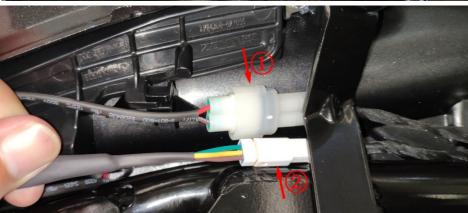
| Fig.3 REAR COVER | | Tail skirt taillight component 1 | CHK | |

- The tail light plug
- ① it is not necessary to pull out the cushion lock plug if the cushion lock is not removed.
- ② is the tail light plug, need to be pulled out first, convenient back to remove the tail skirt components.

- When heating, it is forbidden to heat at a fixed position all the time, and it is necessary to move the heating back and forth.
- Do not pull the cable directly when unplugging the plug.

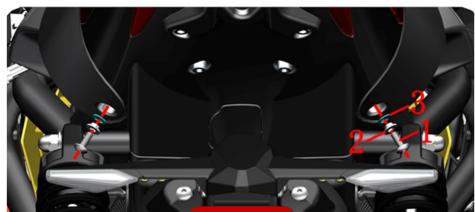
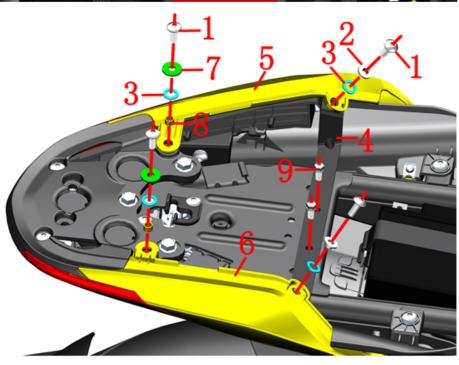
| Fig.4 RI | EAR COVER | Tail skirt taillight component 2 | CHK | 40) |

Using 4# inner hexagon socket remove the bolt (1) on the bottom left side and remove the bushing (2) and cushion rubber (3).

• The material should be protected during discomponent to prevent scratching the lamp.

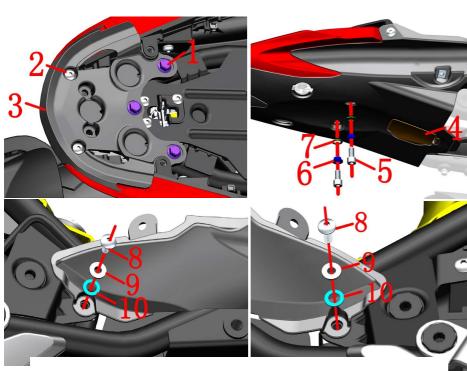
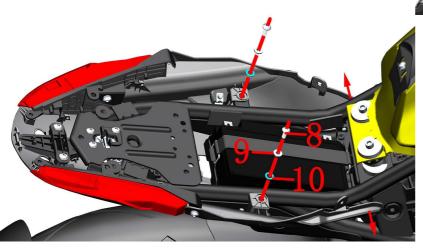
| Fig.5 REAR COVER COMPONENT | | Tail skirt taillight component 3 | CHK | 40) |

Pull out the nail in front of the tail light assembly and the trim cover then remove it.

- The material should be protected during discomponent to prevent scratching the lamp.
- Never pull the cable directly.

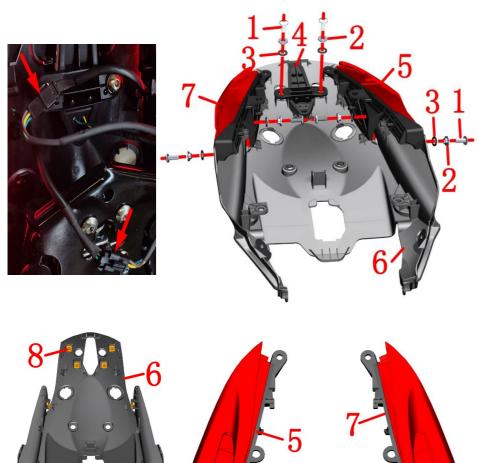
| Fig.6 REAR COVER | | Tail skirt taillight component 4 | СНК | (0) |

Respectively from the left tail lamp (5) and right tail lamp once each took a piece of nut.

- The material should be protected during discomponent to prevent scratching the lamp.
- Never pull the cable directly.

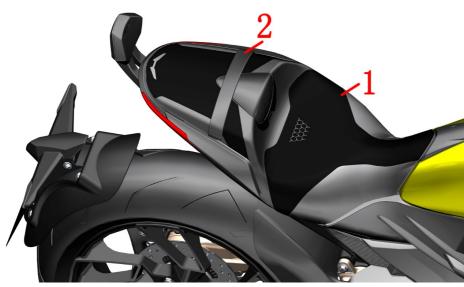
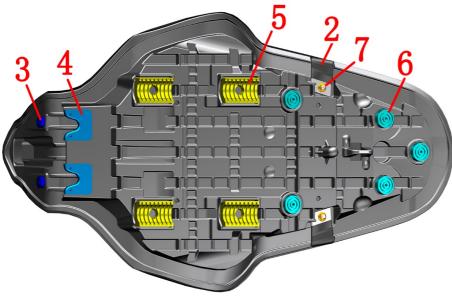
| Fig.1 CUSHION | | Cushion component | CHK | |

If the cushion rubber aging or excessive wear of the belt can be purchased on the Zontes official website. The corresponding installation position is shown in the lower left figure.

- The motorcycle should be fixed before operation.
- [1] Cushion(1) contains all cushion rubber and the seat belt, nuts.
- Cushion can cause accidents if it is not installed properly.

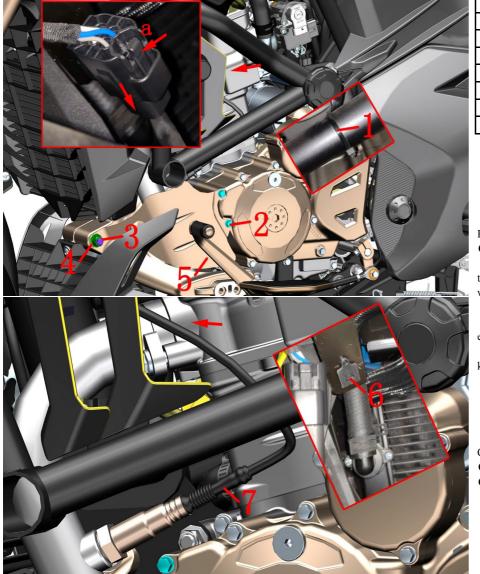
| Fig.1 MUFFLER COMPONENT | | LSF oxygen sensor | CHK ADJ | Q |

If you need to remove the line card nail (6), you can pull it out directly.

- The material should be protected during disassembly to prevent damage to the paint.
- The muffler should be completely cooled before it is disassembled.

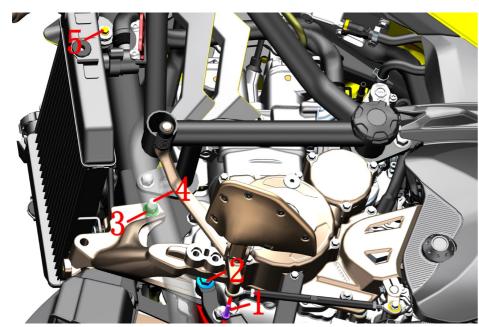
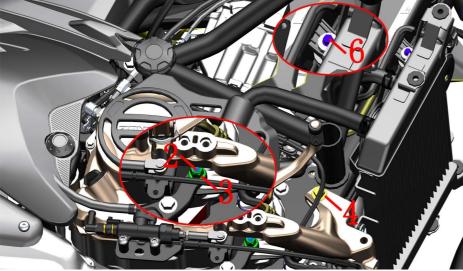
| Fig.2 MUFFLER | | Muffler component 1 | СНК | |

- The material should be protected during disassembly to prevent damage to the paint.
- The muffler should be completely cooled before it is disassembled.

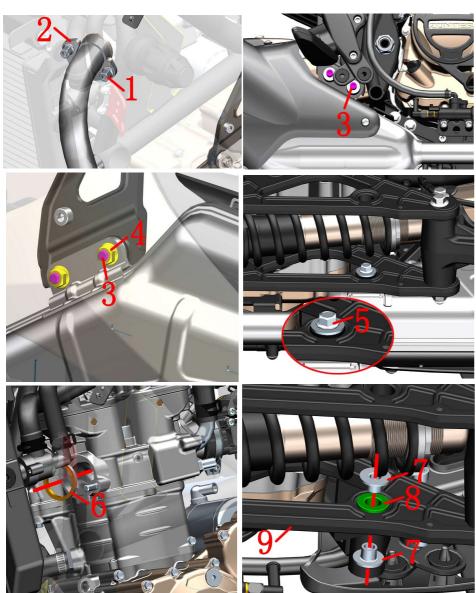
| Fig | Fig.3MUFFLER COMPONENT | | Muffler component 2 | CHK | Q |

Remove the bushing (7) and cushion rubber (8) from the right reinforcing plate (9).

- The muffler should be completely cooled before it is disassembled.
- Remove first by referring to the steps of removing the right side cover and rear shock-absorbing connecting rod plate.

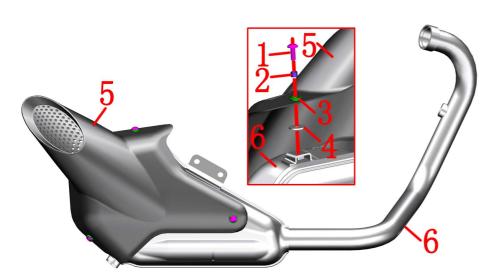
| Fig.4MUFFLER COMPONENT | | Muffler component 3 | CHK ADJ | Q |

Remove the bushing (2) and the cushion rubber (3) from the decorative cover (5).

- Prevent foreign matter from entering the muffler or engine interior.
- Be careful not to omit asbestos pads when reinstalling.

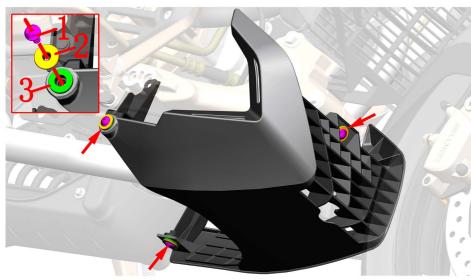
| Fig.1 LOWER SHROUD | | Lower shroud component-1 | CHK | (0) |

Separate the left part of the lower air deflector assembly from the middle part of the lower air deflector assembly according to the above steps.

- The motorcycle support should be fixed during disassembly to prevent accidents caused by incline.
- The shroud should be supported during disassembly to prevent fracture due to uneven force.

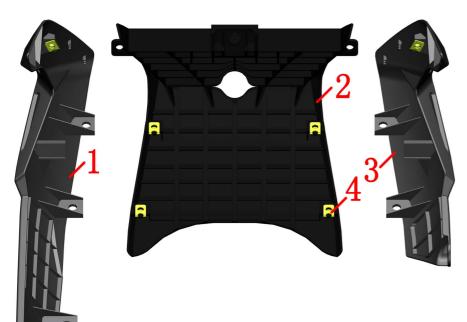
| Fig.2 LOWER SHROUD COMPONENT | | Lower shroud component 2 | CHK | 1 |

● The shroud should be well protected during disassembly to prevent breakage or paint scratches caused by uneven force.
