# ZT350-VX (EURO V&EURO +)

Service manual

2025/04/08

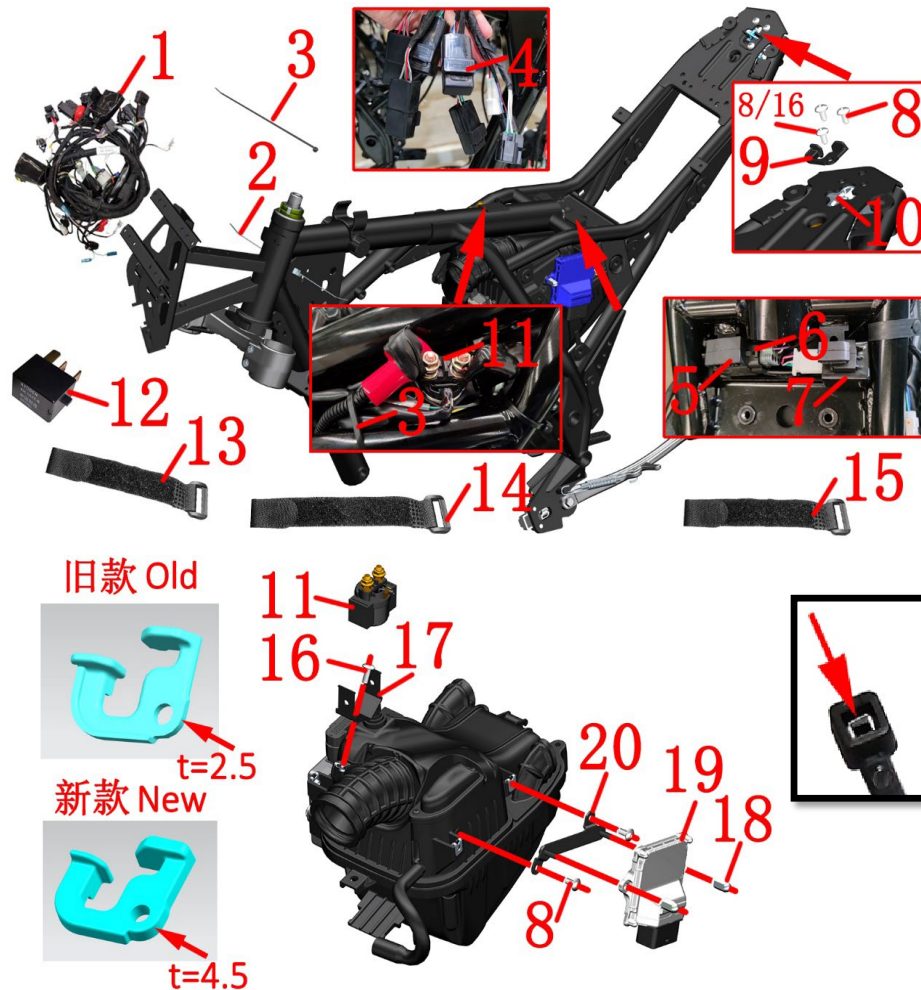
● Main harness

Different plug-in methods are different, please unplug all the electrical components connected to the main thread according to the actual operation. It needs to use a screwdriver, forceps, scissors and other tools to assist. The binding (3) can be picked out by using scissors.

● Seat lock

Take off the plug of the seat lock, and cut off binding (3). Use a 4# inner hexagon to remove the front bolt (8) or (16), and remove the guide block (9). The old model of seal lock block used with 6\*12, the new model used 6\*16. remove the 2 rear bolts and remove the electronic cushion lock (10) and the rear tail skirt bracket (11).

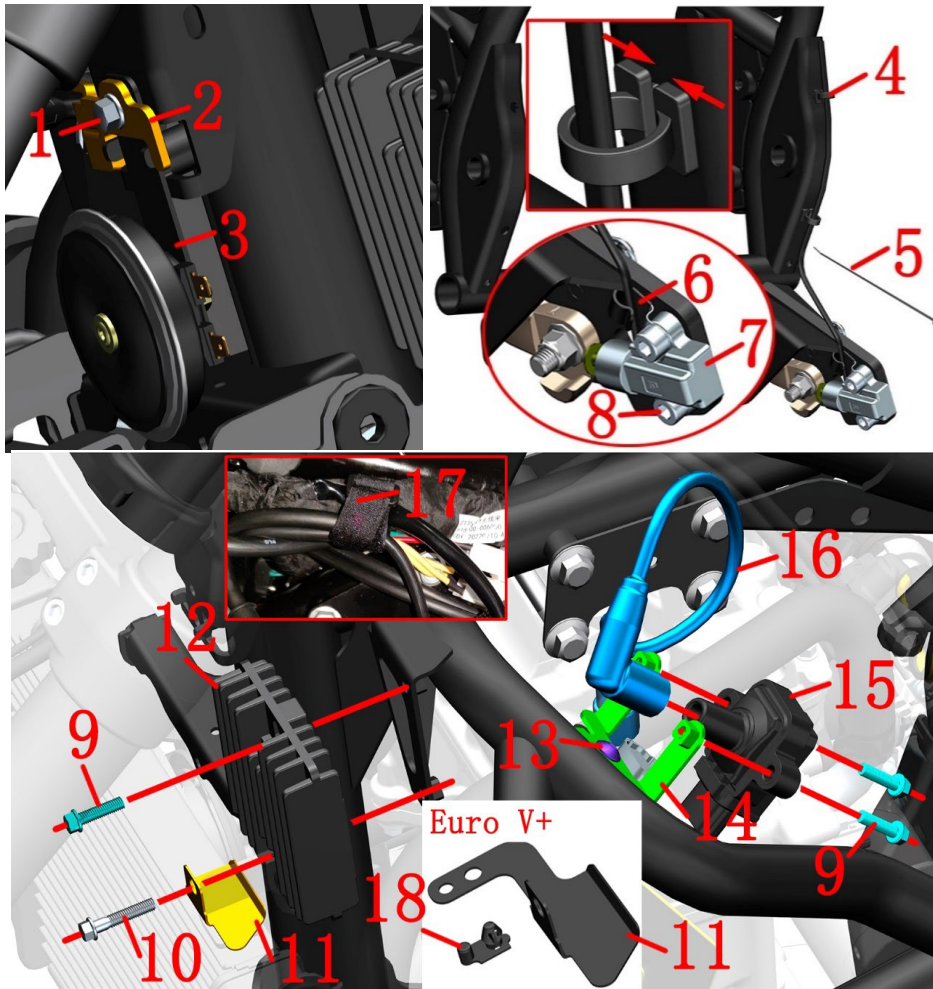
- Do not pull the cable hard when removing the sub-mud switch.
- The replacement of the spark plug and the matters needing attention are described in the instruction manual.

## ●Ignition coil

Pull out the high-voltage wire (16) then end of the spark plug, pull out the end of the ignition coil body and remove it. Remove the bolt (9) with 8# sleeve and remove the ignition coil body (9). Then using 4# hexagon socket remove the bolt (13) and remove the high-pressure package support (14).

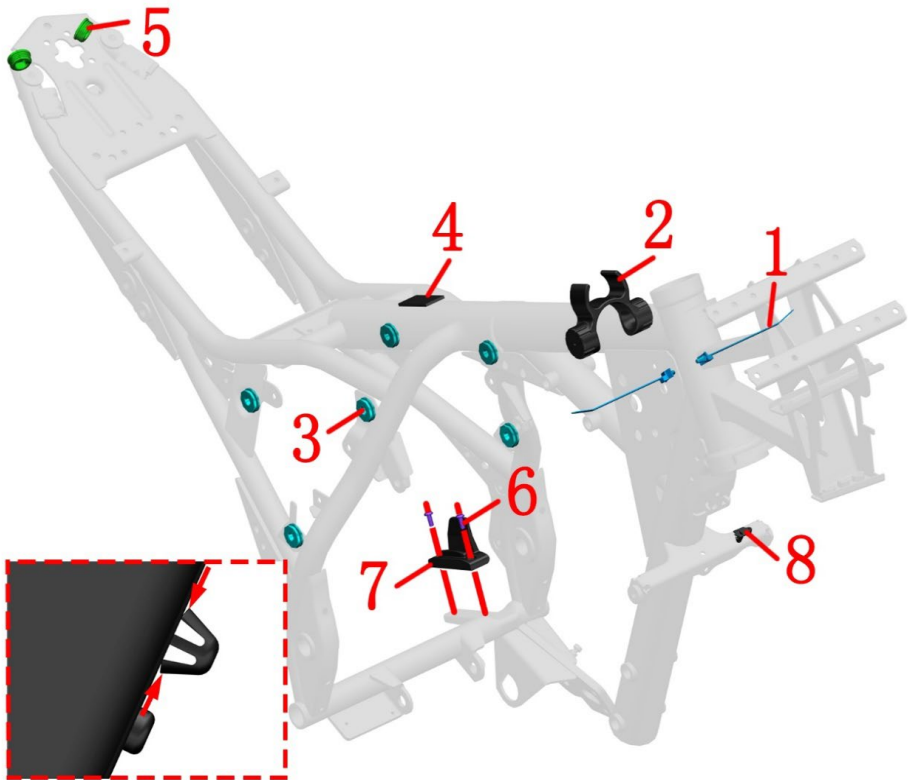
| Fig.3 FRAME&ELECTRONIC PARTS COMPONENT | | Frame plastic parts | | CHK<br>ADJ | |

- Inner fuel tank fix glue cushion  
Use both hands to hold the two ends cylinder parts of the inner fuel tank limited glue cushion (2) and should push it out.
- Side cover cushion  
Remove the side cover cushion (3) with your hand directly.
- Battery cushion  
Put off the battery cushion (4) directly by hand.
- Frame waterproof rubber plug  
Remove the frame waterproof rubber plug (5) with your hand directly.
- Wear block  
Use a 3# hexagon socket to remove the 2 bolts (6) and then remove the wear block (7).
- Cable plastic staple  
Use a pair of pliers to clamp in the direction of the arrow with a little force and then push the cable plastic staple (8) out of the frame.

- It must be dismantled them first, such as the cushion, fuel tank cover, inner fuel tank, sider cover, tail dress and so on.
- All parts should be correctly assembled.
- The plug strap (1) is a non-detachable structure and it is not recommended to cut it directly. It is difficult to remove the broken portion of the buckle that is forcibly removed from the frame triangular reinforcing plate.

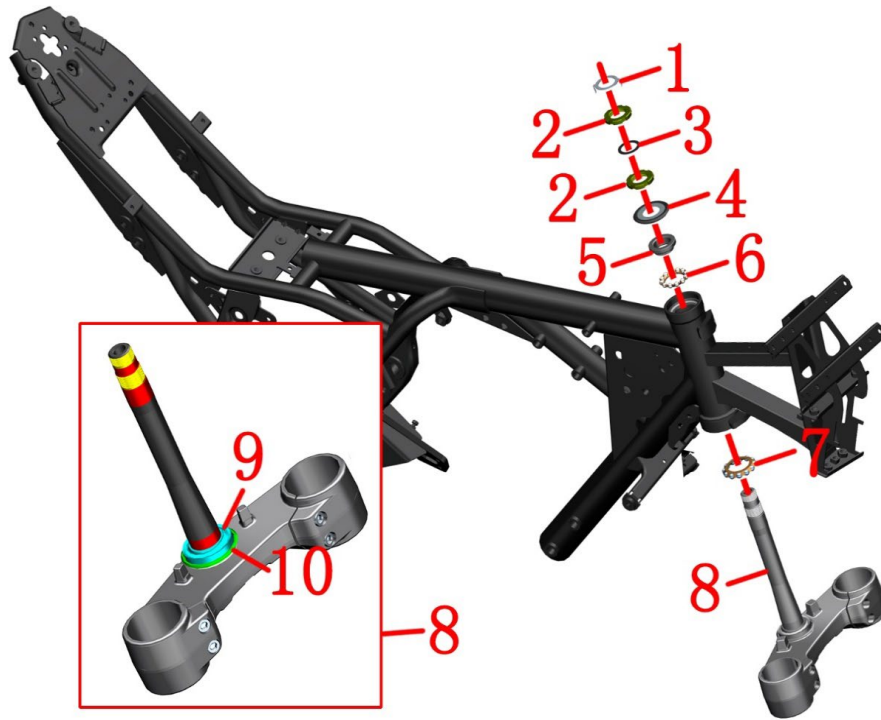
| Fig.4 FRAME&ELECTRONIC PARTS COMPONENT | | Steering rack component | | CHK | CAUTION |

- Please pay attention to fix the awaiting repair motorcycles during disassembly, prevent dumping by accident.
- Please check whether the steel beads of the conjoined body have abnormal phenomena such as partial abrasion and rust. If YES, please change, if not, please be sure to grease the old grease and repaint the lubricating grease on it.

- It must be to check whether the steel ball is available during reassembly.
- It must be reasonable to adjust the steering, too loose will cause the locomotive to brake slightly, and the locomotive will shake slightly, too tight can lead to inflexibility, resulting in safety hazards.

- If you have the ability and the right tool, you can change the shaft ring (9) and the dustproof cover (10). During the replacement process, pay attention to the protection of the lower connected plate. After replacement, it must be to check the parallelism of the column and the damping hole, the vertical degree of the vertical column and the lower connected plate.

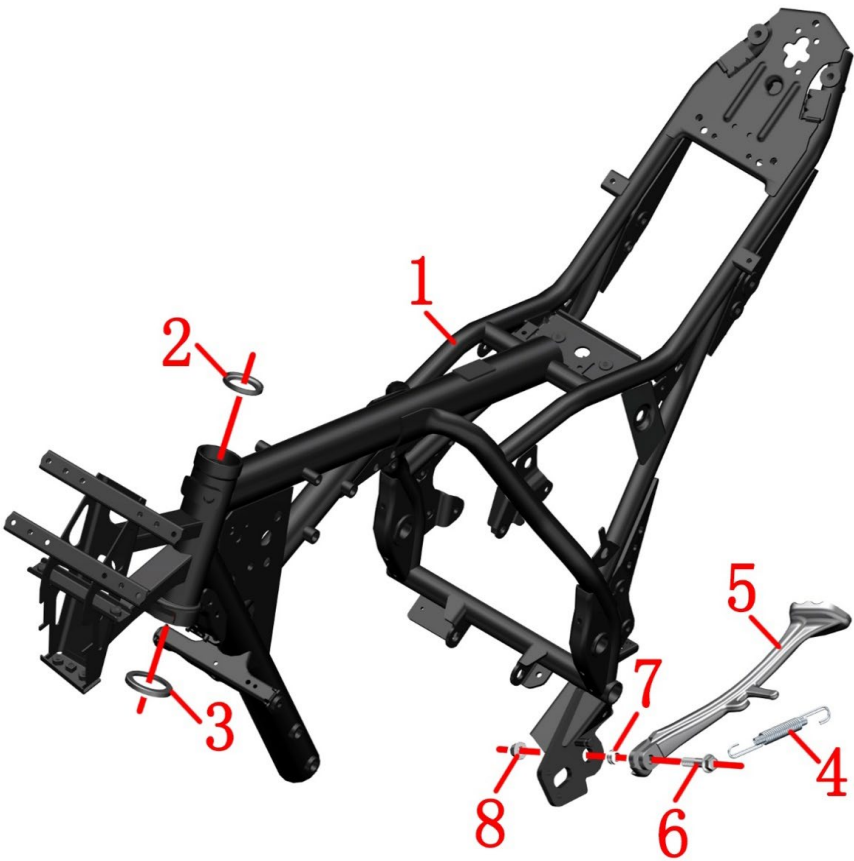
| Fig.5 FRAME&ELECTRONIC PARTS COMPONENT | | Frame, Side support | CHK | |

- Checking the cushion loop  
Checking whether the seat ring (2) and (3) is frayed, If yes, it needs to be replaced. Fix the seat ring well and paint the lubricating grease on it with appropriate tool.
- Sider support  
The thick steel wire shall be rolled into a circle and put into the spring (4) hook. Pay attention to ensure that the steel wire cannot be loosened or scattered during the pulling process. And guard against the personal injury caused by spring contraction, remove the nuts (8) and bolts (6) with the 14# sleeve. Remove the side support (5) and bush (7), paint the lubricating grease on the bush(7) when re-assembling ,then put it into the frame (1).

- Remove the wind deflector component, handle bar component, steering column component first.
- Paint the lubricating grease on the cushion ring to decrease the rotary resistance of front forklift.

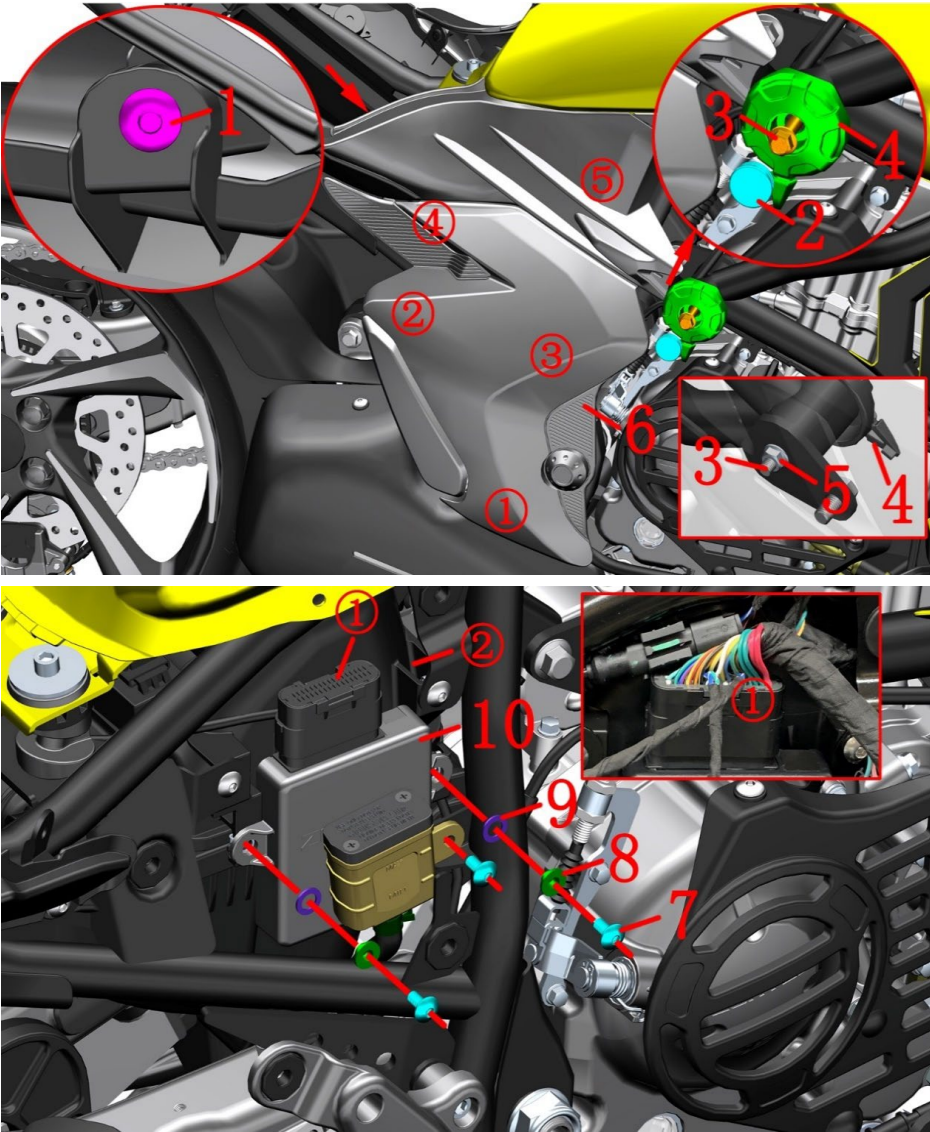
| Fig.6 FRAME&ELECTRONIC PARTS COMPONENT | | PKE component | CHK | |

Remove the seat cushion first, and then remove the expansion nails (1) at the connection between the right side cover (6) and the rear cover. Remove the waterproof rubber plug (2), after holding the nut (5) with 13# plug wrench then using a 12# sleeve to loosen the bolt (3) by 5 threads, without completely removing it. Pull out the decorative ball (4) and rotate it clockwise to stagger the groove on the right side cover. Pull out the right side cover in the order of ①-②-③-④-⑤. Turn the right side cover component over to the back, find the plug of the induction antenna, pull it off and remove the right side cover component.

●Non-professionals are strictly prohibited to disassemble the PKE system components, otherwise it may cause permanent damage.

●The button battery model used in the band version: CR1225.

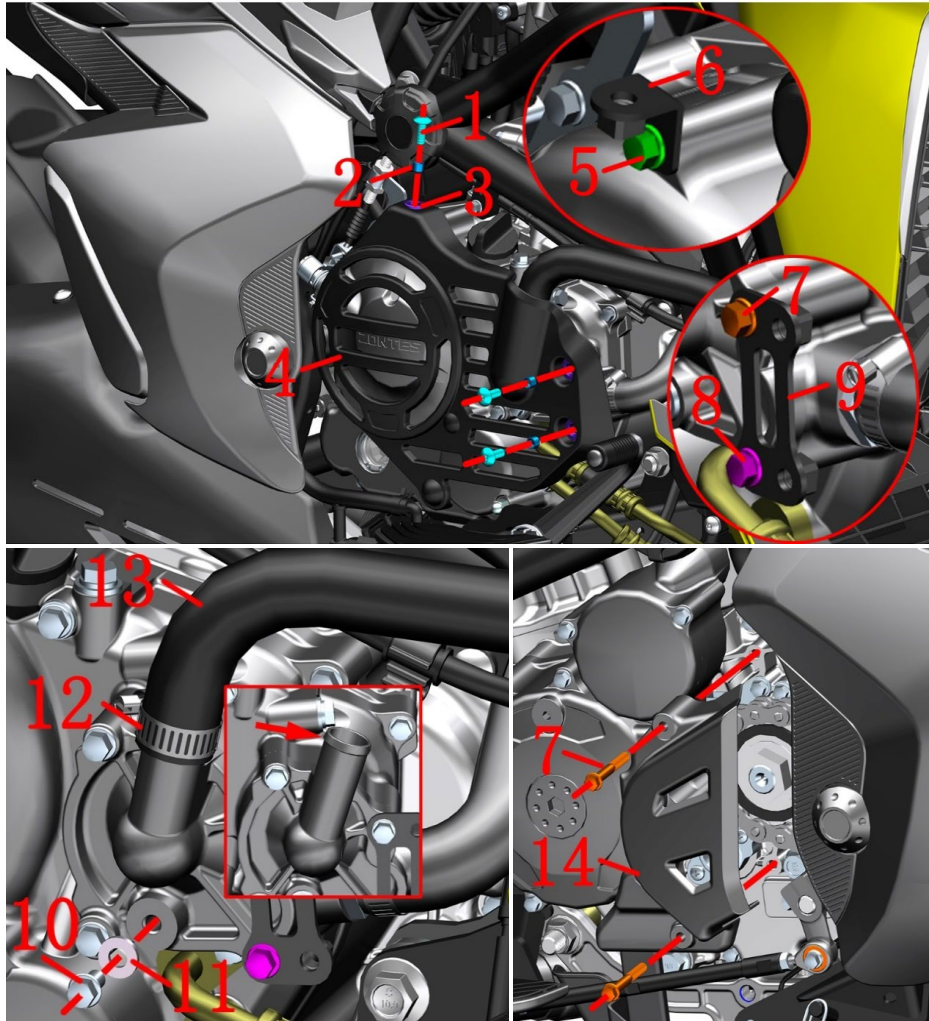
| Fig.1 FRAME&ENGINE | | Engine decorative cover components | CHK | |

After removing the bracket, screw the bolts that holds the bracket back to the engine to prevent leakage.

After wearing waterproof gloves with both hands, remove the bolt (10) with an 8# sleeve, and remove the combined sealing ring (11).

Loosen the two clamps (12) with a flat-blade screwdriver and remove the boss indicated by the arrow.

● The 3 M6 bolts of the engine trim cover bracket must be coated with thread fastening glue before reassembly, with a torque of 10N.m.

● The coolant should be drained before disassembly.

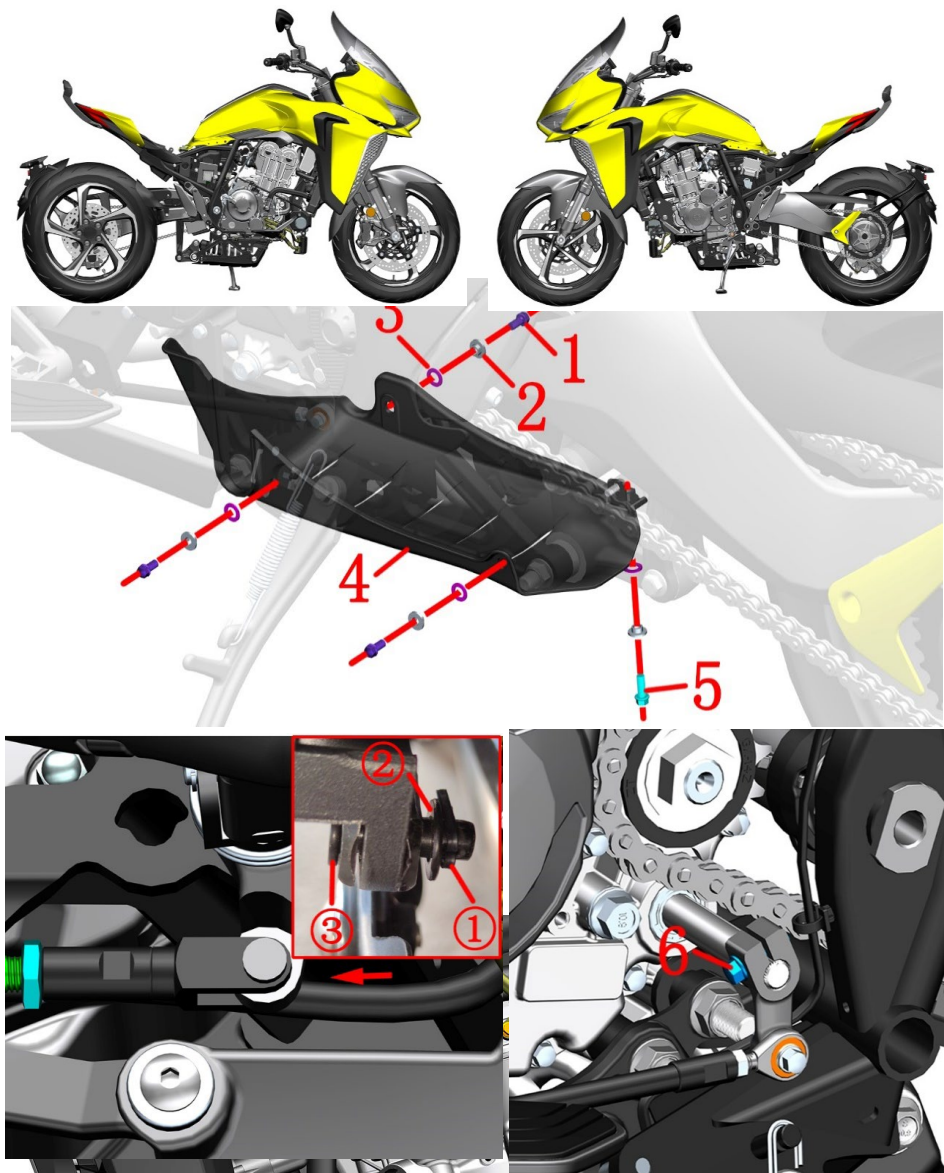
| Fig.2 FRAME&ENGINE | | FRAME&ENGINE 1 | CHK | |

- Use the appropriate tools to support the vehicle to prevent accidents caused by the dumping of the vehicle during the disassembly process; single operation is strictly prohibited.

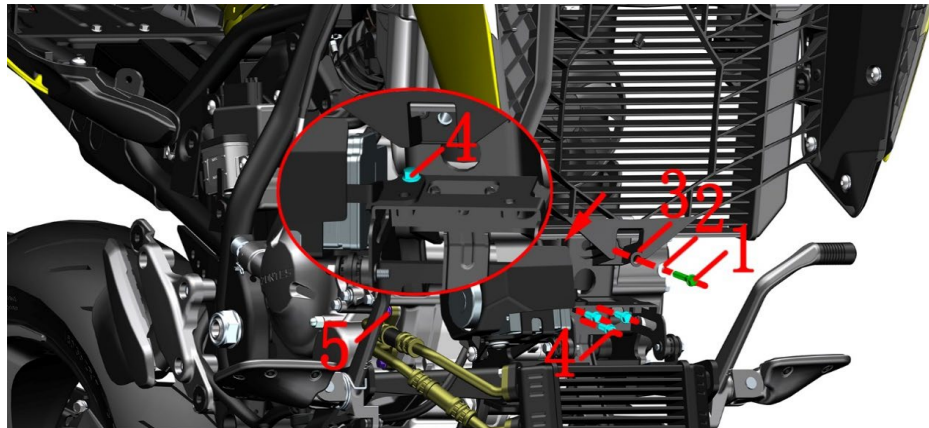
| Fig.3 FRAME&ENGINE | | FRAME&ENGINE 2 | | CHK | CAUTION |

It is recommended to cover the front pedal support with waterproof and oil-resistant plastic cloth, and then remove the two bolts(5) on the right side with 8# sleeve and pull out the two oil pipes.

It is recommended to use a 8# ring wrench with a 72 tooth ratchet wheel corner to remove the bolts(5) of the intake manifold. Or loosen the clamp at the air outlet of the air filter and the clamp between the throttle valve body and the intake manifold; And unplug the high-pressure oil pipe, fuel injector and external pressure sensor.

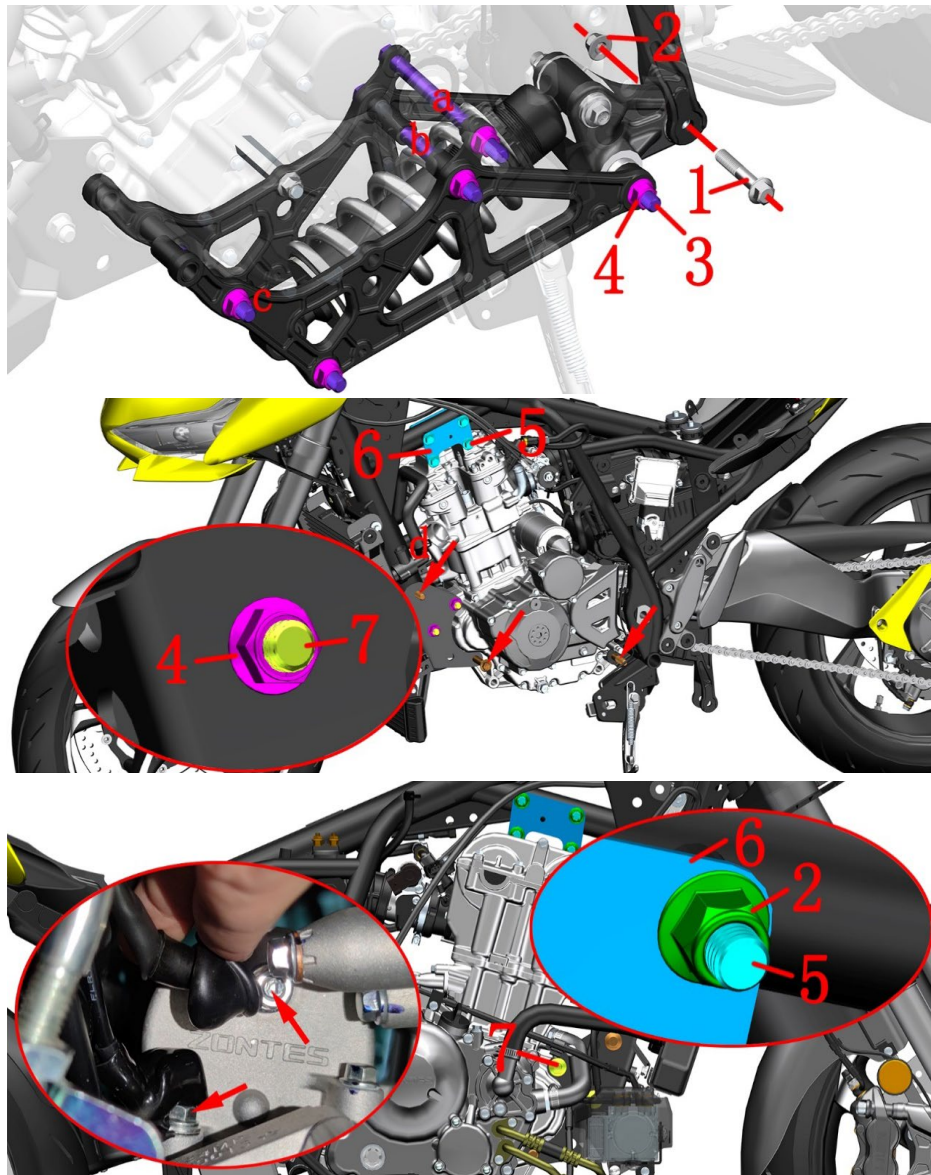
| Fig.4 FRAME&ENGINE | | FRAME&ENGINE 3 | CHK | |

Make sure that the vehicle is supported firmly, and the rear flat fork assembly of the rear wheel cannot be supported because the rear shock absorber assembly needs to be removed later. Use a 14# sleeve to fix the head of the bolt (3) on the right side, and use a 17# sleeve to remove the nuts (4) at three places a, b, and c on the left side. Do not remove the bolt (3) yet. Note that the other 2 places only need to loosen the nut (4) for about 5 turns, which is convenient for subsequent removal of the rear shock absorber assembly.

Open the protective cap indicated by the arrow in Figure 3 on the right side, remove the upper nut with a 10# sleeve, and then pull out the cable, and screw the nut back to the motor to avoid loss. Or remove the nut on the red positive end of the starter relay on the upper right side of the air filter, and then remove the positive wire of the motor. This method is difficult and requires re-routing the positive wire, so it is not recommended.

Refer to the method of adjusting the clutch wire to remove the engine end of the clutch wire

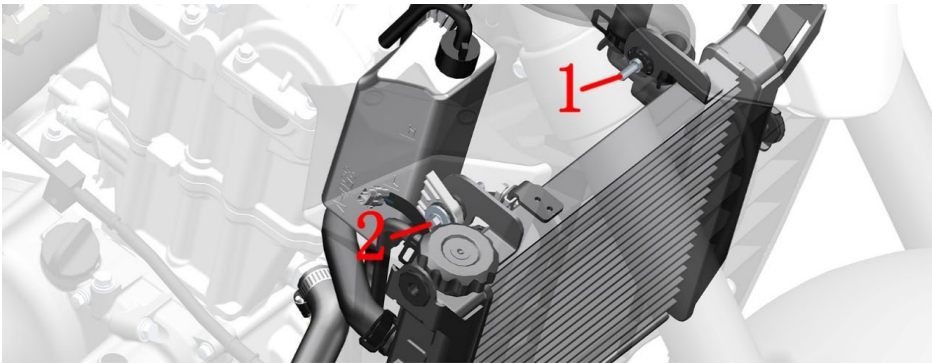
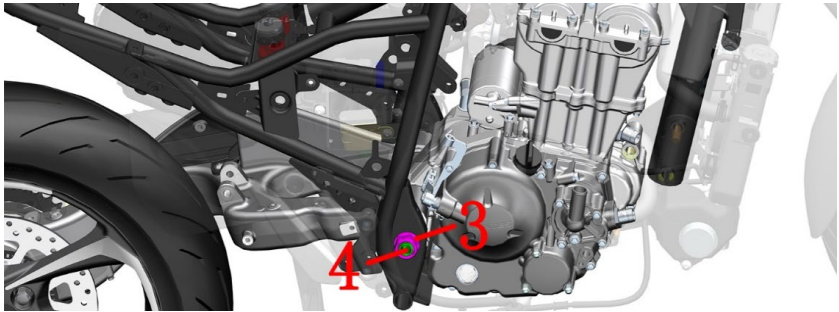
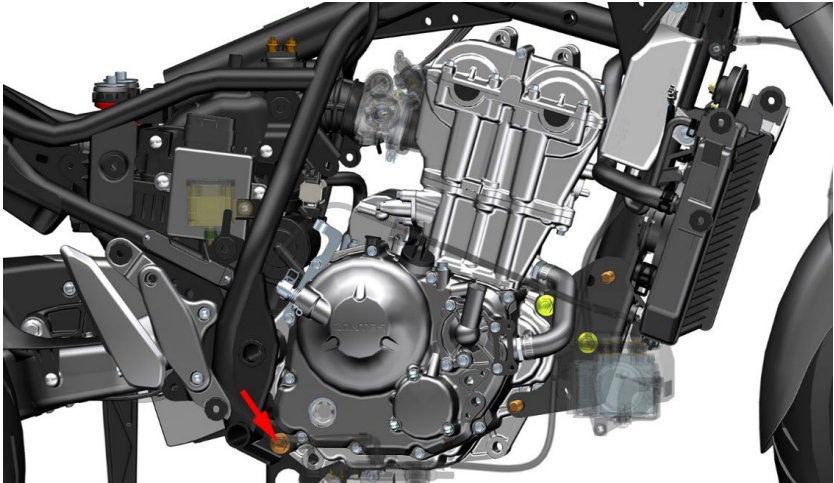
| Fig.5 FRAME&ENGINE | | FRAME&ENGINE 4 | | CHK | |

Loosen the bolts (1) on the upper direction of the main water tank with an 8# sleeve on the left side, and loosen the bolts (2) on the right side. Grasp the bottom of the water tank assembly and turn it upward at a certain angle to facilitate subsequent unloading of the engine.

Loosen the chain first and remove it from the small sprocket according to the method of adjusting the chain. Tie the chain to the rear fork.

Unplug the desorption tube and exhaust tube on the left side. After loosening the clamp (9), pull out the air outlet pipe from the throttle valve body.

Unplug the temperature sensor indicated by the arrow in Figure 5.

- Remove the side cover, seat cushion, fuel tank, etc. in advance.
- Do not pull the cable hard when unplugging the connector.
- Always keep the disc brake oil cup cover facing up.

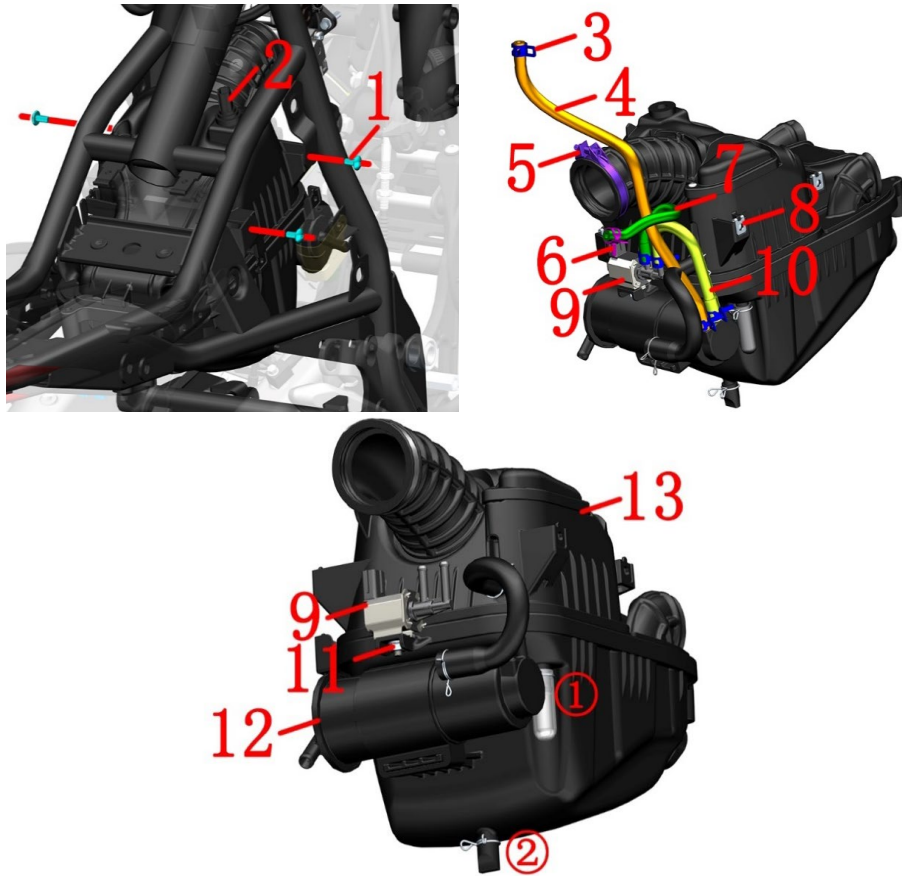
plug, which should be  $35 \pm 2 \Omega$ , otherwise the solenoid valve fault can be judged.

● Check whether the temperature sensor is damaged

- Remove the side cover, seat cushion, fuel tank, etc. in advance.
- Regularly check whether the filter element of the carbon tank and air filter is not ventilated, otherwise it may cause the oil supply to affect the driving experience.
- It should be no crimp, entanglement and other phenomena.

In case of poor engine performance; Poor idle speed; If the air-fuel ratio is incorrect, check the carbon canister solenoid valve.

Use a multimeter to measure the resistance between the two inserts of the carbon canister solenoid valve

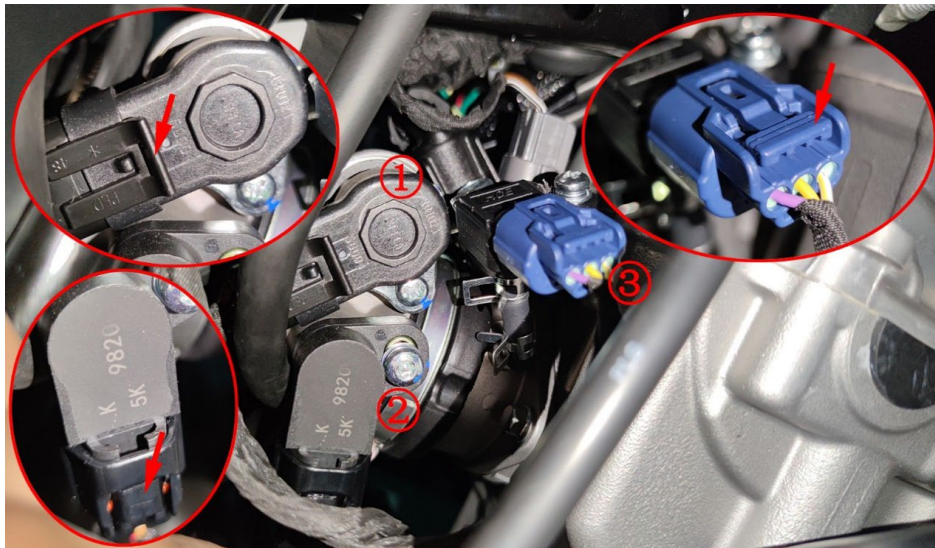
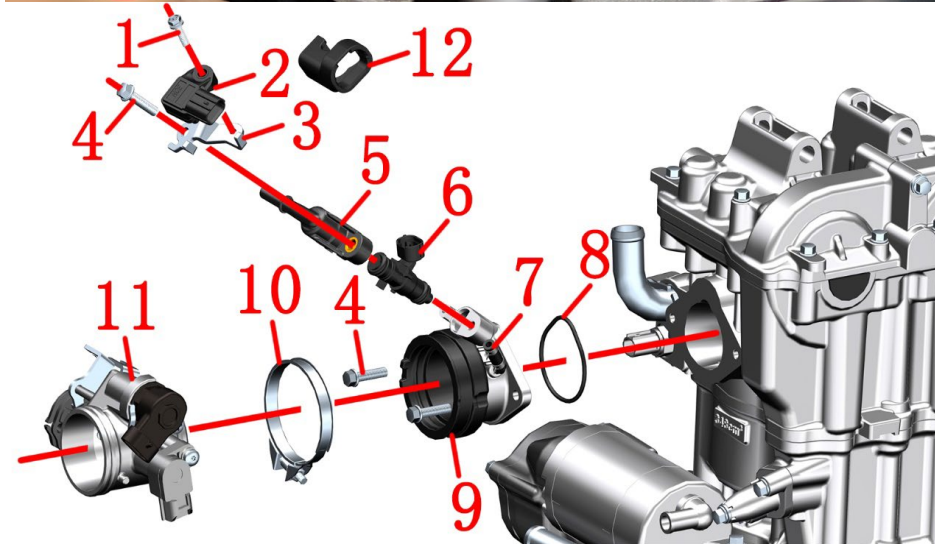
● Check whether the throttle position sensor ② is damaged

Connect the diagnostic instrument to the whole vehicle, press the flameout switch (without ignition), turn the throttle handle from the initial position to fully open, and check whether the throttle position signal changes from 0 to 100.

Loosen the clamp on the intake manifold end of the hose (7) and pull it out.

After loosening the clamp (10), separate the throttle valve body assembly (11) and the intake manifold assembly (9), and remove the clamp (10).

● Check whether the external intake pressure sensor is damaged

Loosen the connector and check whether the pin is skewed or broken. The vehicle is connected to the diagnostic instrument without ignition. Check the engine parameters to see whether the pressure parameters are consistent with the local atmospheric pressure.

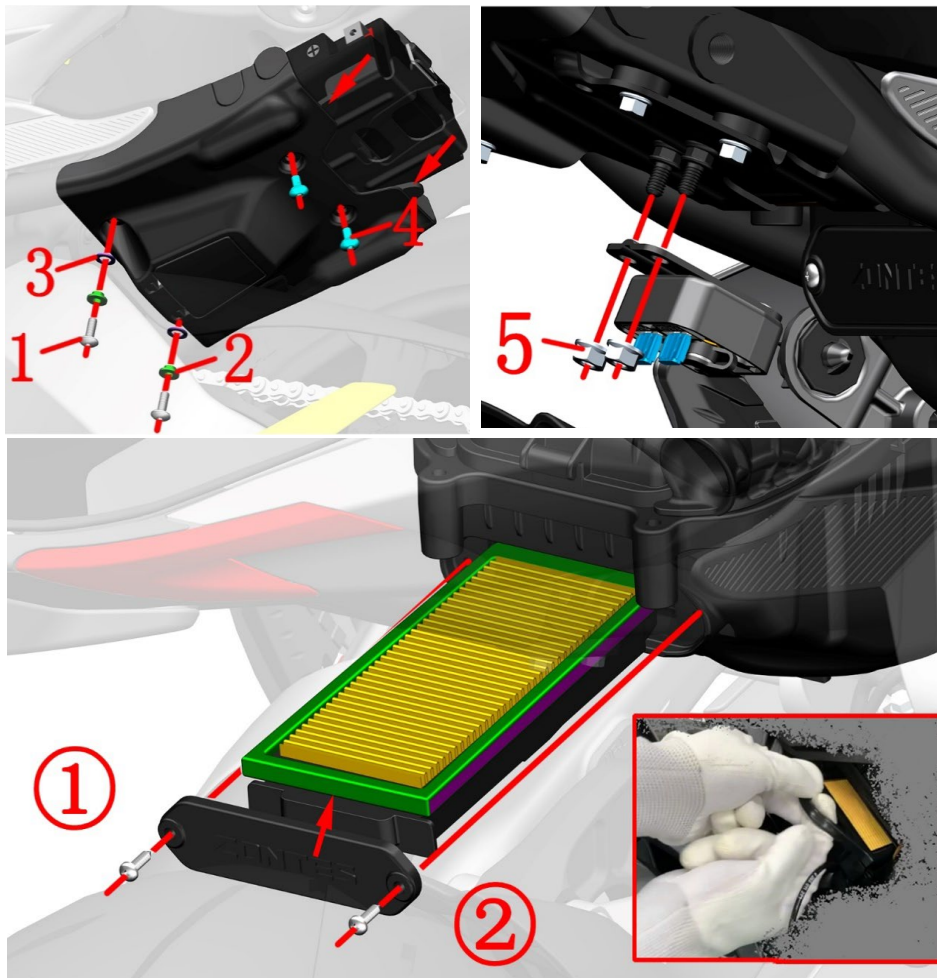
| Fig.4 INDUCTION SYSTEM COMPONENT | | Replace the air filter element | | CHK | |

● The sealing ring must be assembled in place. Leakage or assembly may not cause dust to enter the engine. In severe cases, the internal parts of the engine may be damaged.

● Note that the torque should not be too large when locking the Phillips bolt to prevent damage to the parts.

● When flushing the vehicle, be careful not to allow water to enter the air filter. If a small amount enters, remove the oil pipe and release it. Make sure that there is no water inside the air filter to start the vehicle.

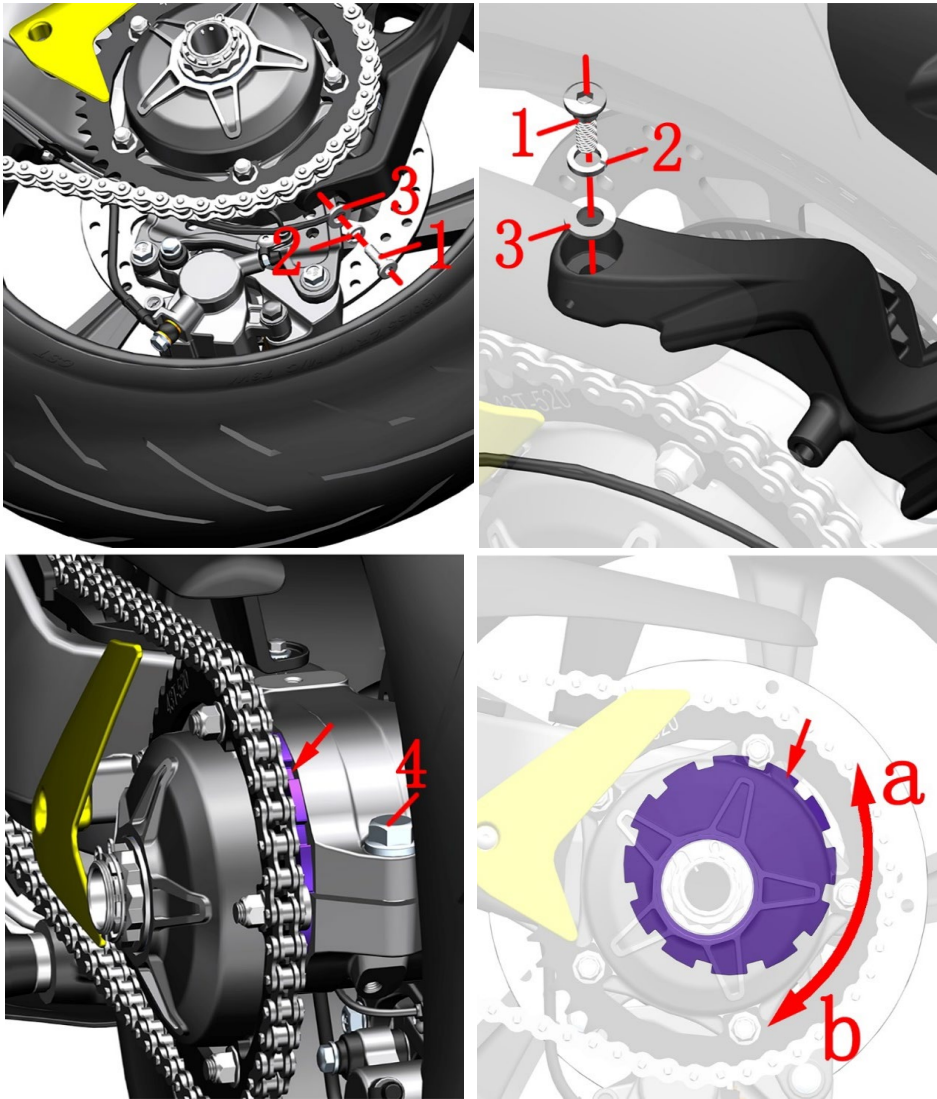
| Fig.1 Rear wheel, swinging arm assembly | | Adjustment chain | | CHK | |

Use a 21# sleeve to loosen the bolt (4).

Use a special hook wrench to turn the eccentric chain adjuster at the arrow indication. The counterclockwise direction is to tighten the chain, and the clockwise b direction is loose.

The chain sag is 18~25mm. If it is too large, it will cause the chain to be accidental or damage the engine. If it is too small, it will aggravate the wear of the chain and sprocket.

- The upper bolt can only be removed after holding the rear mud plate assembly; Do not pull the cable
- The torque of the bolt (4) is 100N.m.
- The chain must be checked regularly for excessive wear; the chain should be cleaned and properly lubricated regularly.

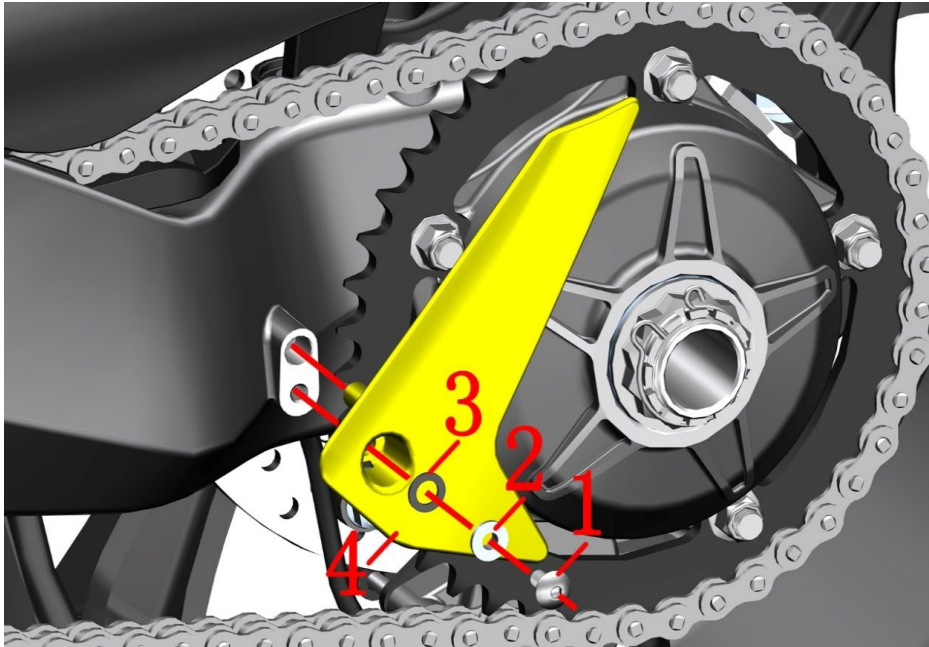
| Fig.2 Rear wheel, swinging arm assembly | | Sprocket baffle | CHK | |

● When reassembling, pay attention to the limit boss on the sprocket baffle to be inserted into the limit hole of the rear fork.

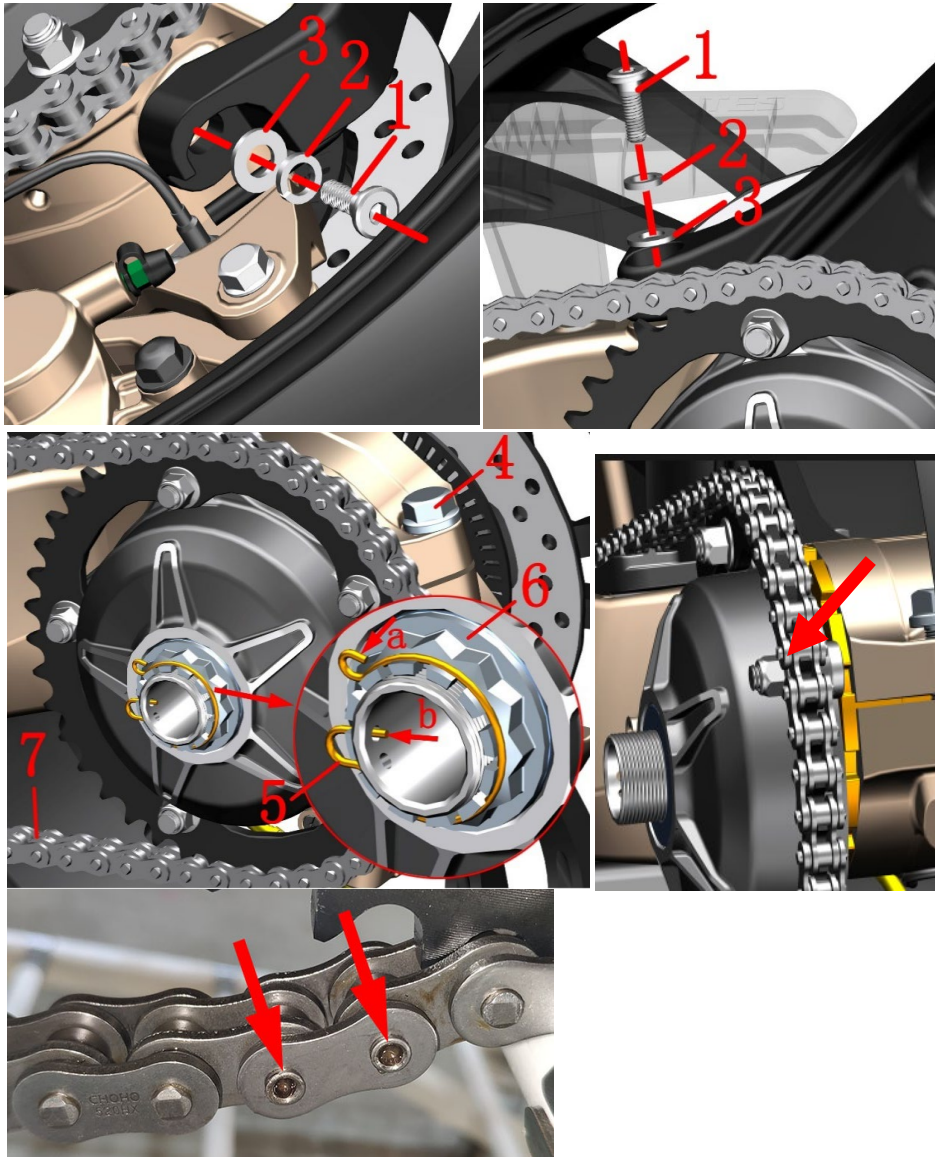
| Fig.3 Rear wheel, swinging arm assembly | | | Sprocket assembly 1 | CHK | CAUTION |

●The upper bolt sits only after the rear mud plate assembly needs to be dragged down; you can't pull the cable.

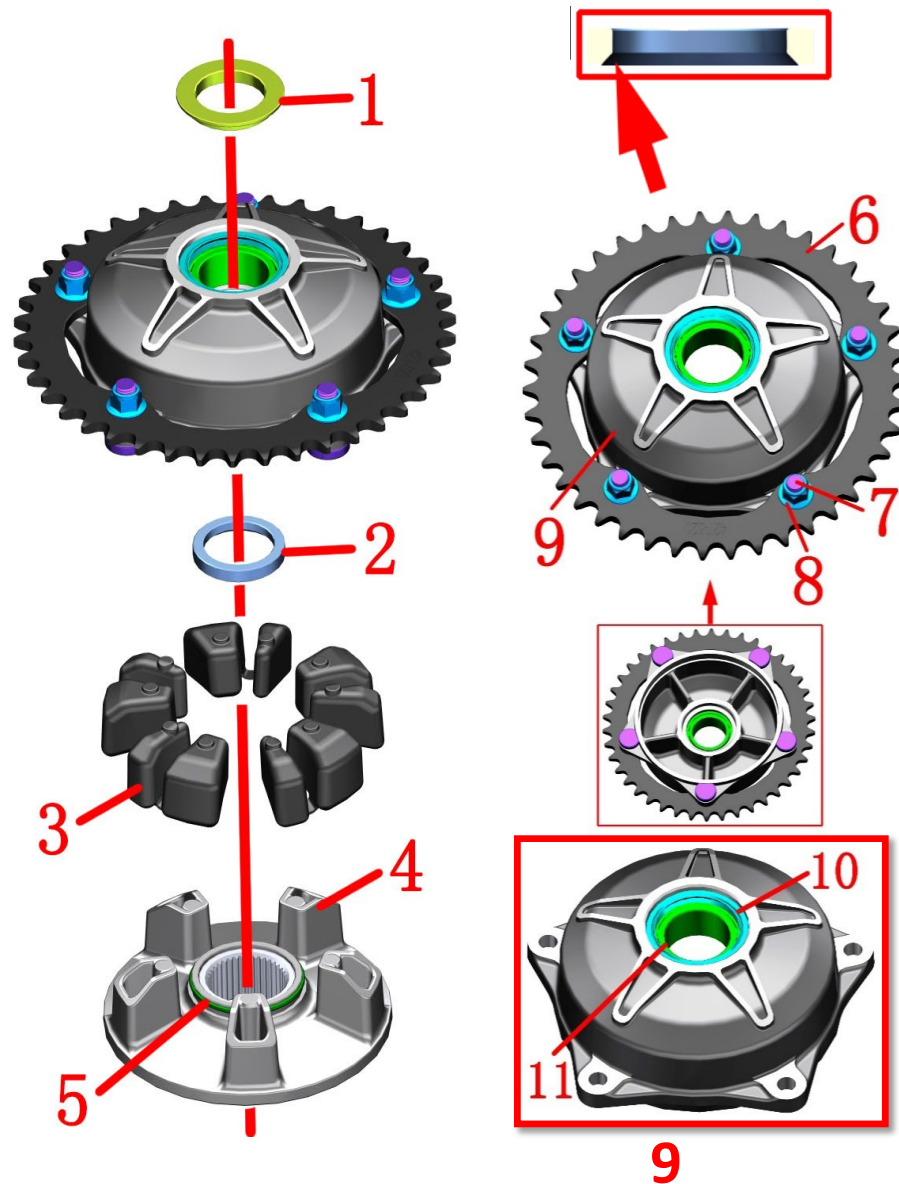
| Fig.4 Rear wheel, swinging arm component | | Sprocket assembly 2 | CHK | |

● The notch position of the bolt (7) is facing inward.

● The sprocket seat housing assembly(9) already contains an oil seal and bearings. The distance from the upper end surface of the bearing to the upper end surface of the outer casing is 7.9 to 8.0 mm.

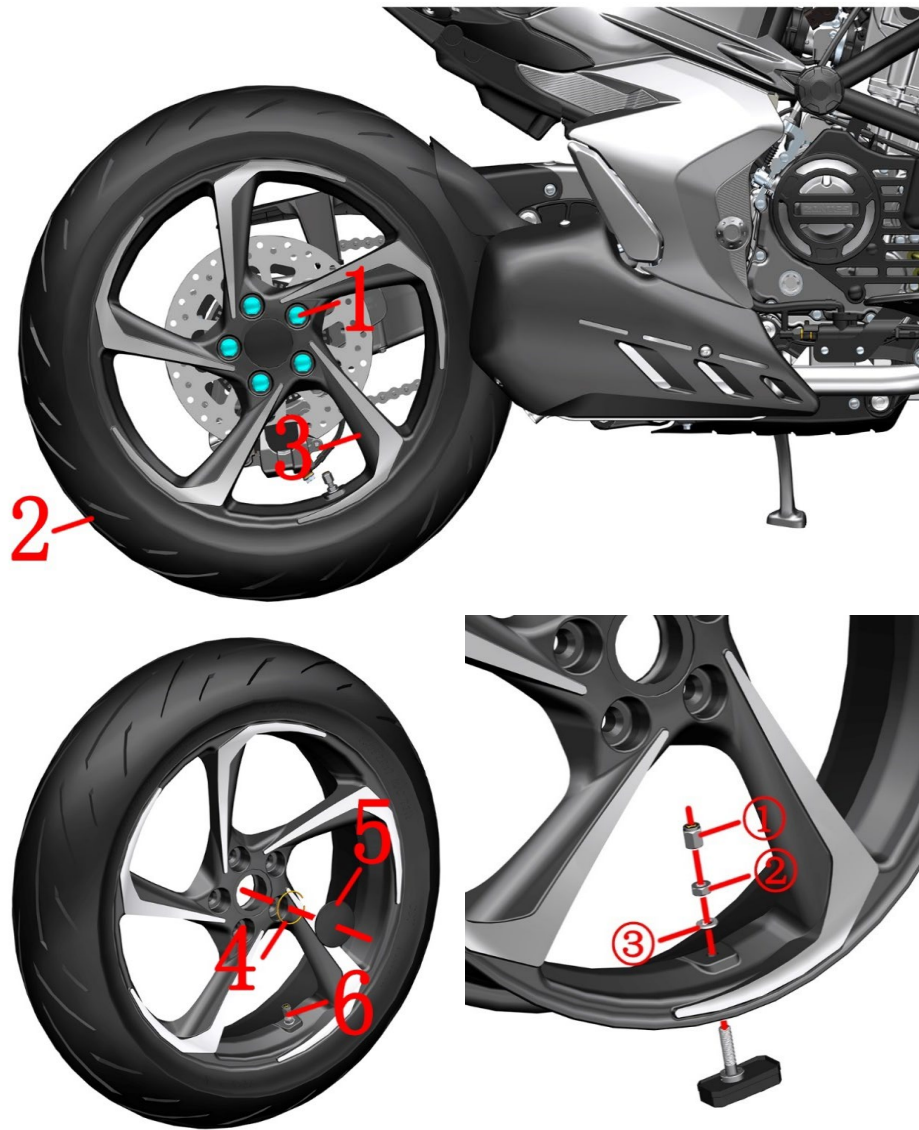
| Fig.5 Rear wheel, swinging arm component | | Rear wheel component | | CHK | |

● It should not be used because the tire self replenishment may block the air hole of the tire pressure monitoring sensor, resulting in inflation difficulty or tire pressure monitoring failure.

● Not enough tire pressure can cause abnormal wear and tare. Too high pressure in summer might have possibility of tire bursting.

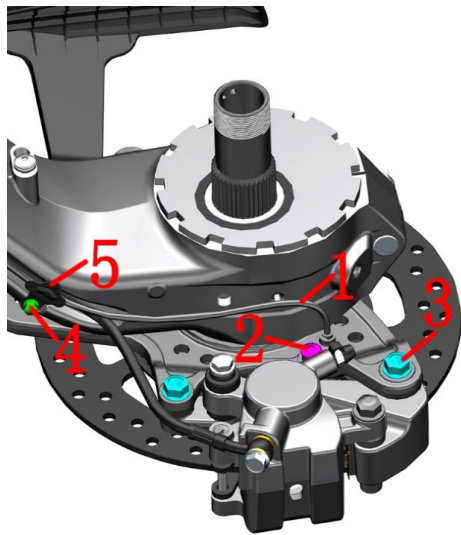
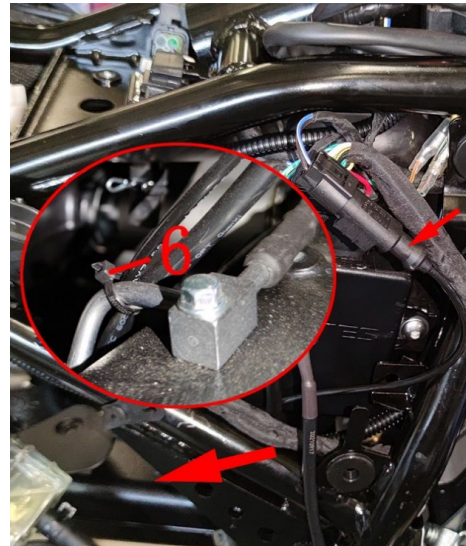
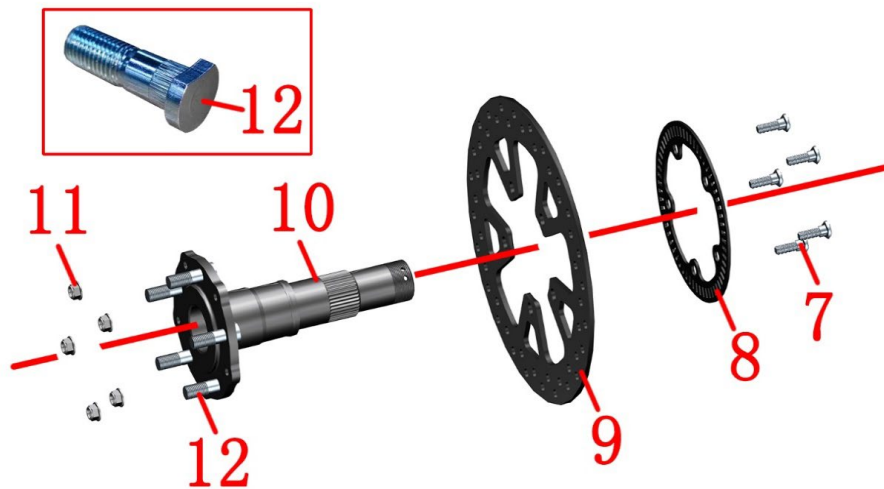
| Fig.6 Rear wheel, swinging arm component | | | Rear axle assembly | | CHK<br>ADJ | REMARKS |

● The replacement of the bolts (12) separately must be secure and reliable.

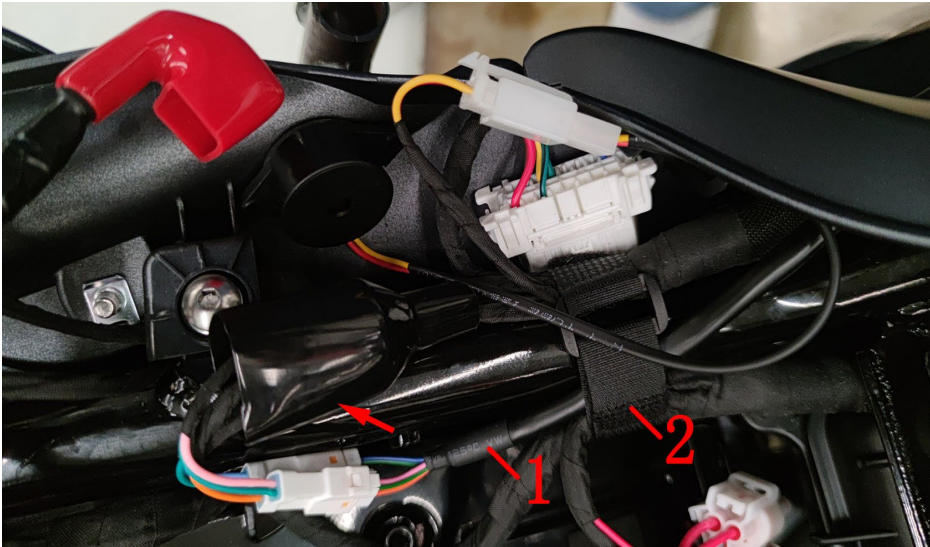
| Fig.7 Rear wheel, swinging arm assembly | | Rear auxiliary mud plate component 1 | CHK | |

- Rear auxiliary mud board assembly  
Find the 3 plugs at the transfer plug and unplug the shown three plugs.  
Untie the strap(2).  
Cut off the cable tie (3) on the upper right side of the rear flat fork.  
Remove the 4 tubing brackets according to the steps on the previous page.  
Carefully pull the auxiliary mudboard adapter cable out of the motorcycle from the vicinity of the battery and remove it to the rear auxiliary mudboard assembly, then roll up the adapter cable and tie it with a rope.
