# ZT350-VX (EURO V&EURO +)

Service manual

2025/04/08

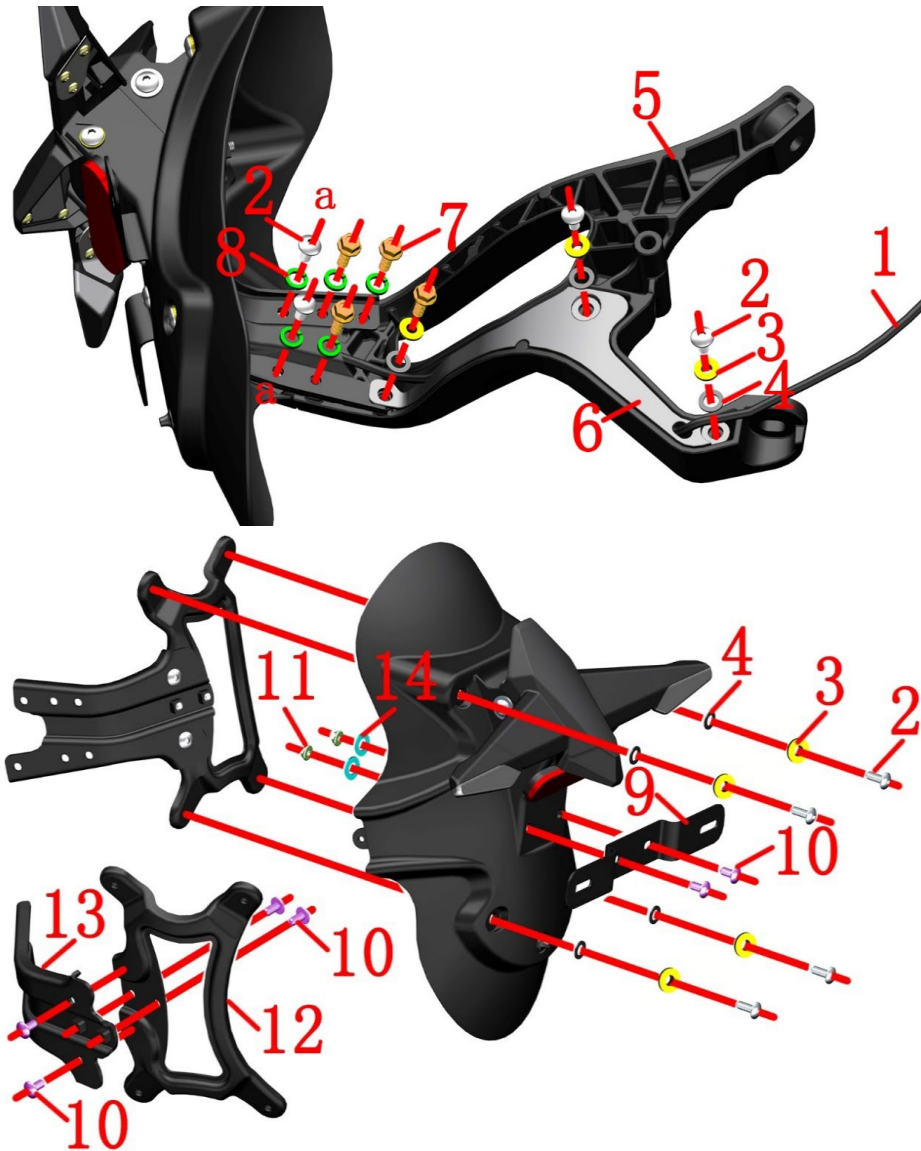
| Fig.8 Rear wheel, swinging arm assembly | | Rear auxiliary mud plate component 2 | | CHK | CAUTION |

- Do not pull the cable hard when removing the vice fender connecting cable.
- When reassembling, first check if there is any pressure on the wire to prevent short circuit when tightening the bolt.

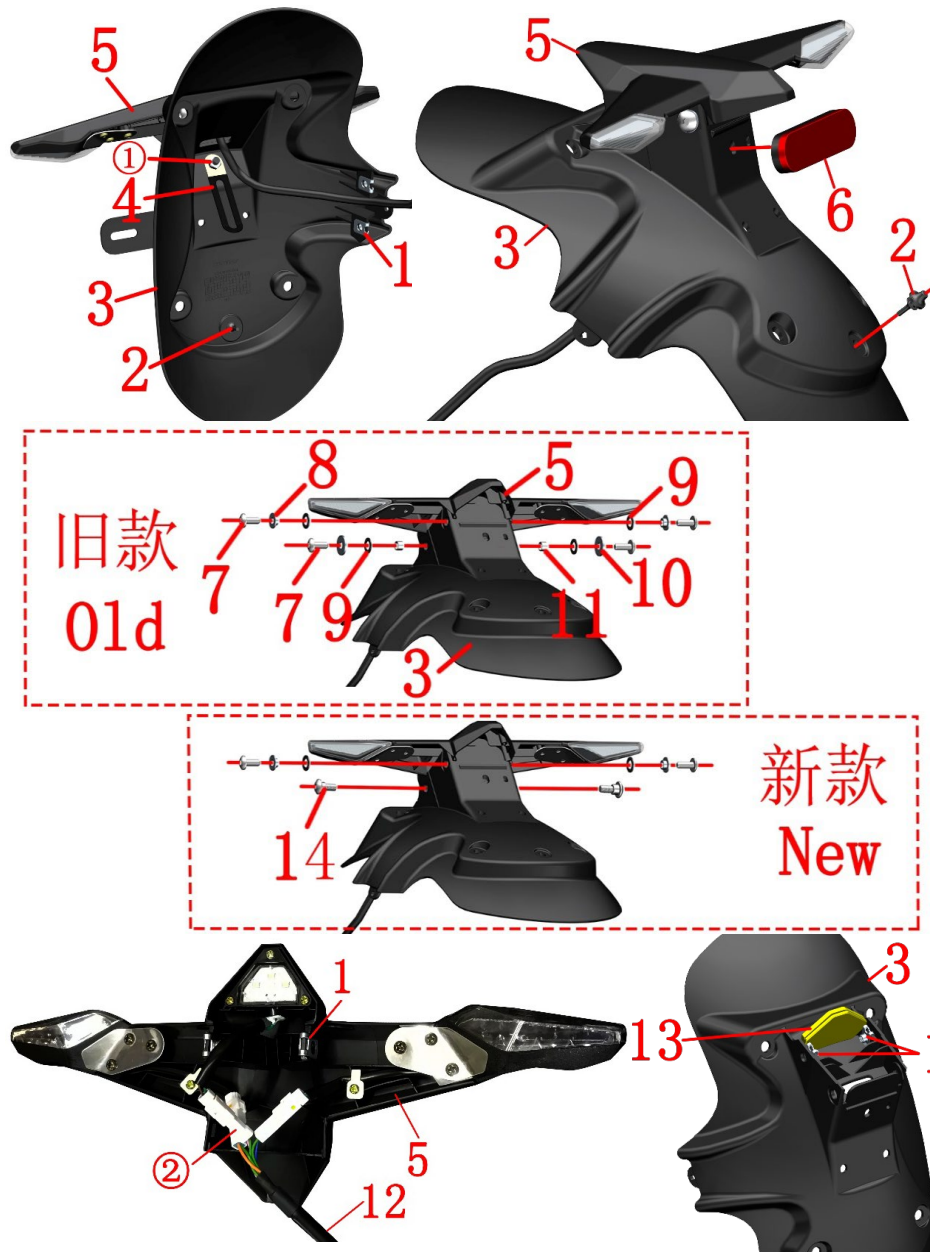
| Fig.9 REAR WHEEL COMPONENT | | Rear sub-mud assembly 3 | | CHK | CAUTION |

Short circuit caused by bolts. Pay attention to the lamp connector, do not insert the wrong, turn left Green + orange; right turn signal is green + blue; license plate light is green + pink.

● The old model uses M6×16 bolt + GB96.1 φ 6 + flanging bushing buffer glue + muffler anti-ironing board bushing 2 pieces of structure. Buy 2 pieces " 1251100-375000 Hexagon socket head screw M6×16+ 8.5×5 SUS302 " instead to reduce assembly steps.

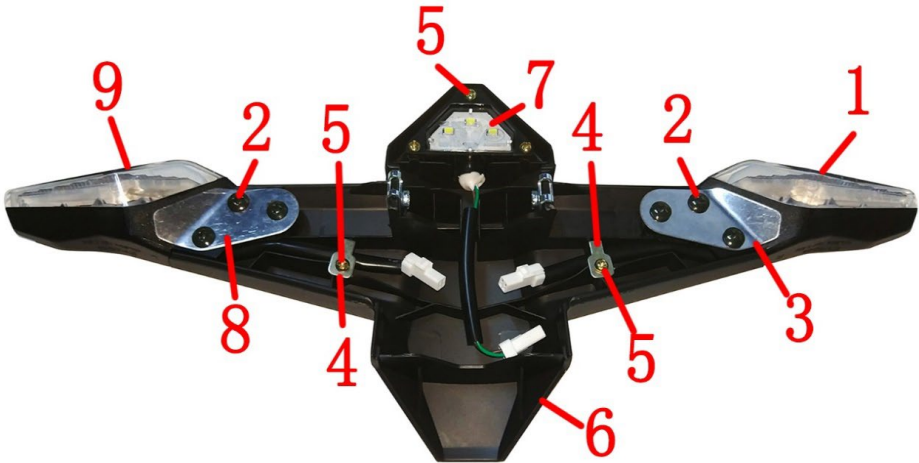
| Fig.10 Rear wheel, swinging arm assembly | | Rear turning light parts for after sales service | | CHK | |

- Avoid fasterning the bolt on the cable while reassembling in case of shrt circuit.

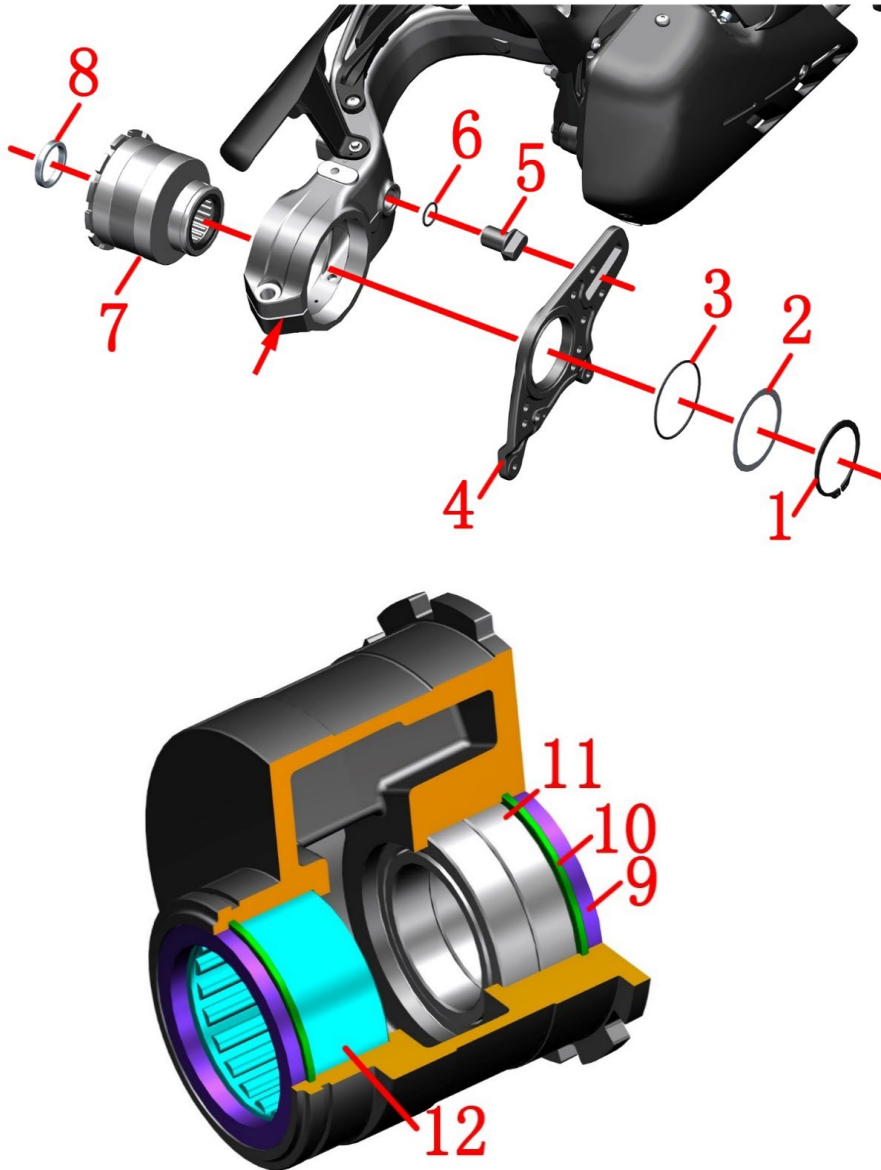
| Fig.11 Rear wheel, swinging arm component | | Chain adjuster assembly | | CHK | CAUTION |

● It is recommended to inspect, maintain and clean the bearings every 6,000 km.

● If the disassembled chain adjuster assembly is inspected before the reassembly, carefully check whether the oil seal is damaged; the bearing needs to be pressed into place.

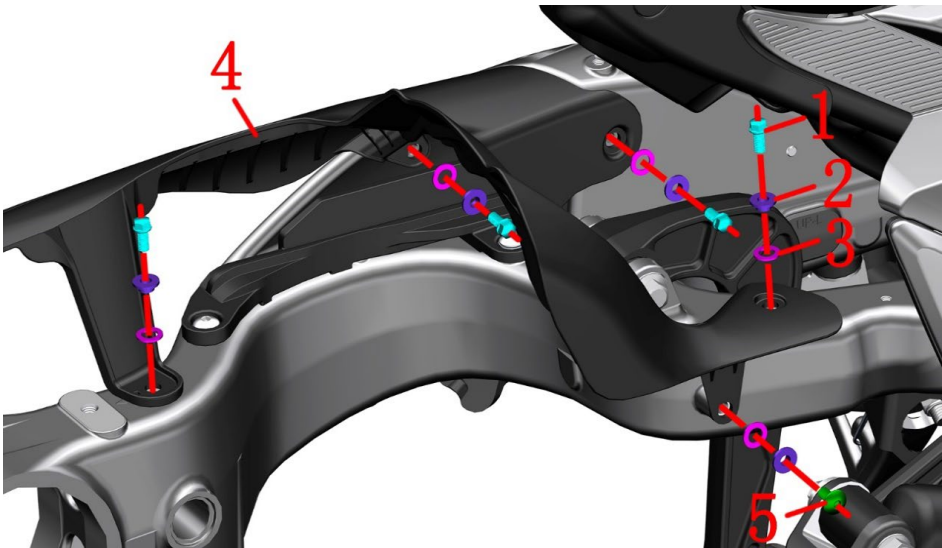
| Fig.12 Rear wheel, swinging arm component | | Rear mud board | CHK | |

- When heating and tearing the applique, be careful not to align the same part for a long time to prevent damage to the inner mud board.
- The muffler assembly and lower shroud assembly must be removed in advance.

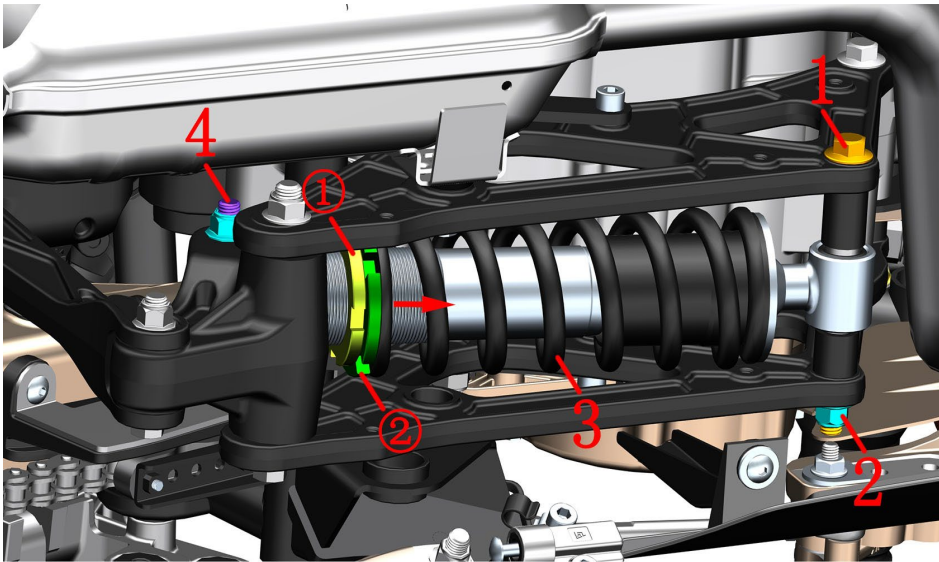
| Fig.13 Rear wheel, swinging arm component | | Rear shock absorber | CHK | |

- The rear shock-absorbing connecting rod plate must be disassembled in advance.
- Use suitable tool to support the motorcycle. Avoid accidents caused by falling down. Single person operate it is prohibited.

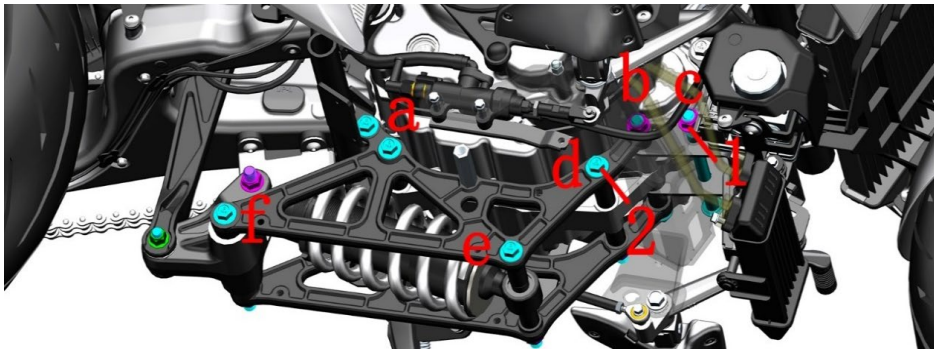
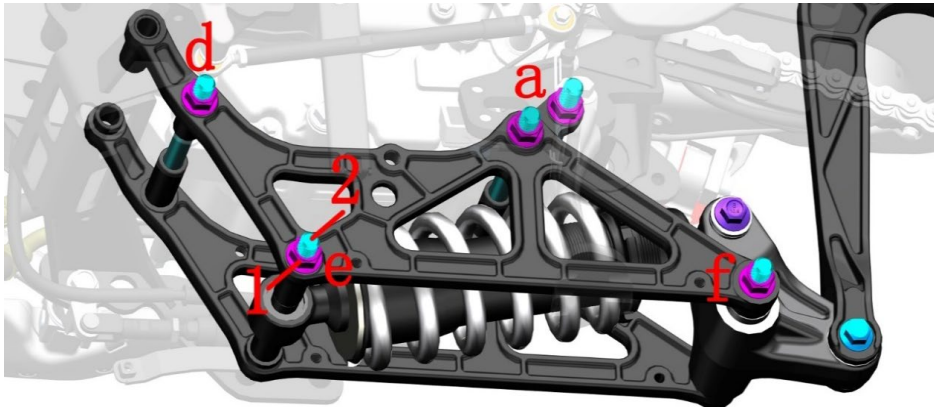
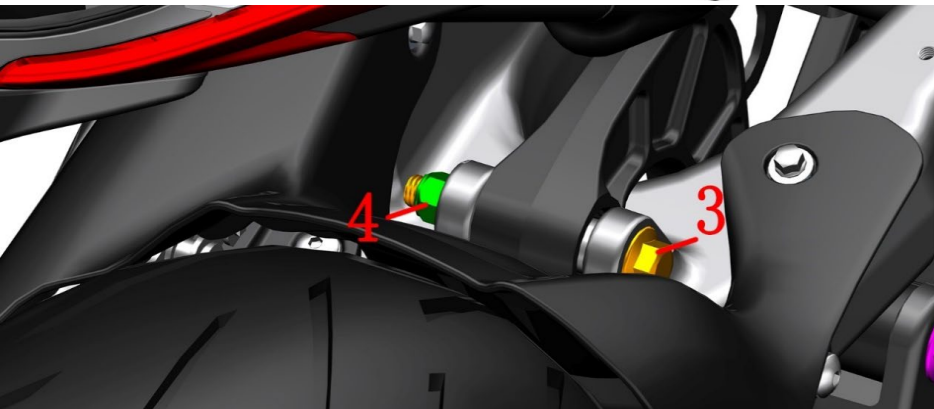
| Fig.14 Rear wheel, swinging arm component | | | CHK | |

● Removing the rear shock absorber assembly will cause the rear flat fork assembly to be unable to support the entire vehicle, so do not support it on the rear flat fork.

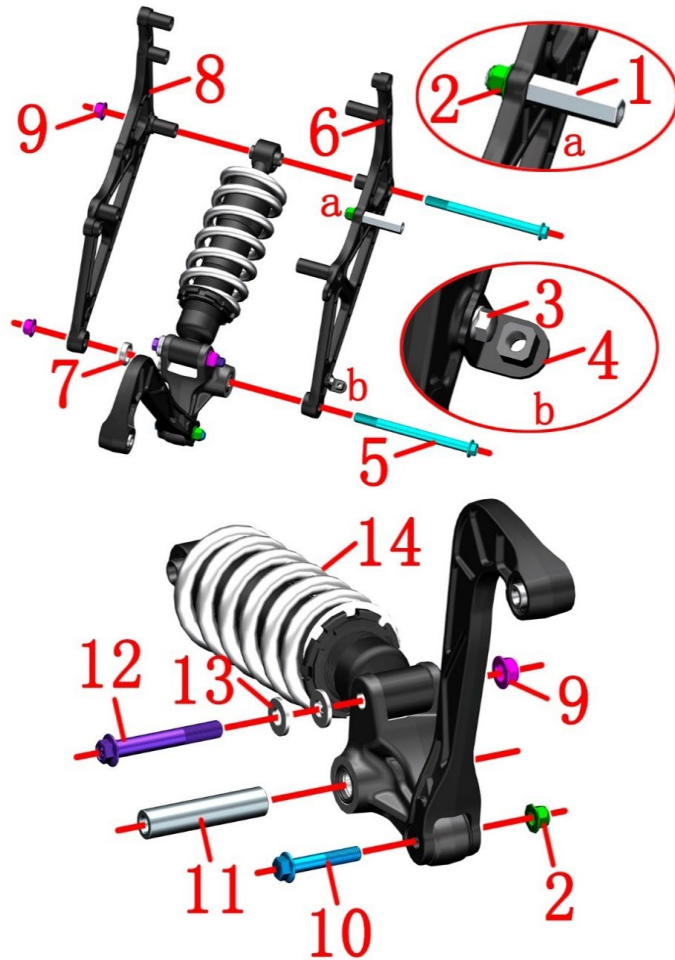
● When assembling the bracket (4), do not tighten the bolts (3) first, you need to put the rear shock absorber back into the vehicle and use the rear shock absorber link baffle to locate the bracket position and then tighten it.

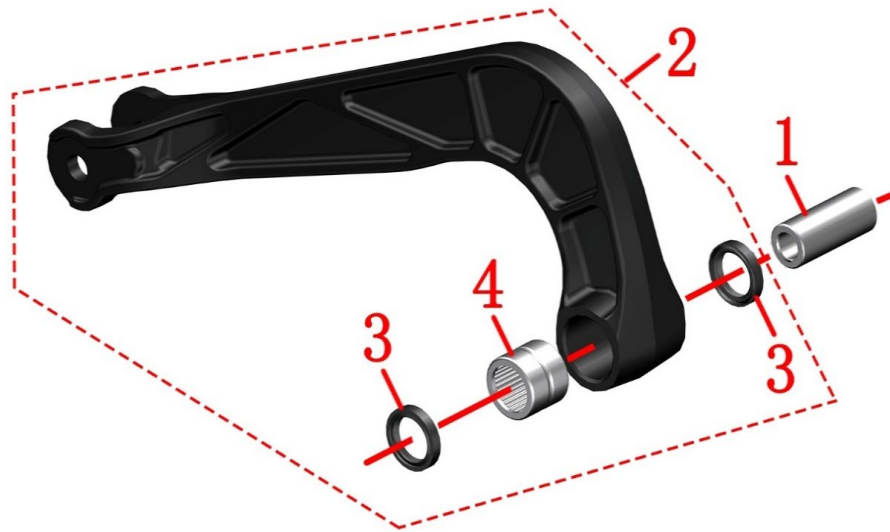
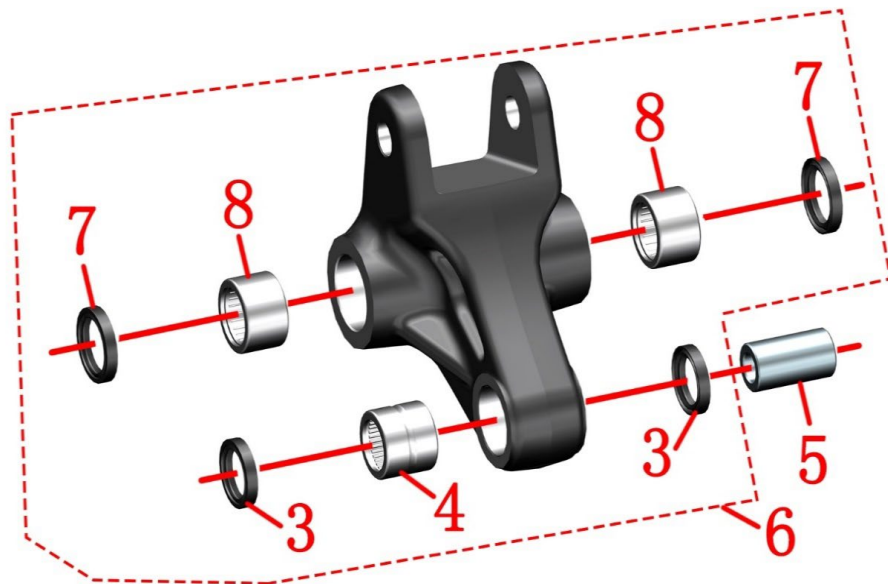
| Fig.16 Rear wheel, swinging arm component | | Rear shock absorption 3 | CHK | |

Remove the bushing (11), fix the head of the bolt (12) with a 14# sleeve, and then remove the nut (9) with a 17# sleeve. Take out the bolts (12) and remove the 2 pieces of spacers(13), the rear shock absorber (14) and the rear shock absorber link assembly.

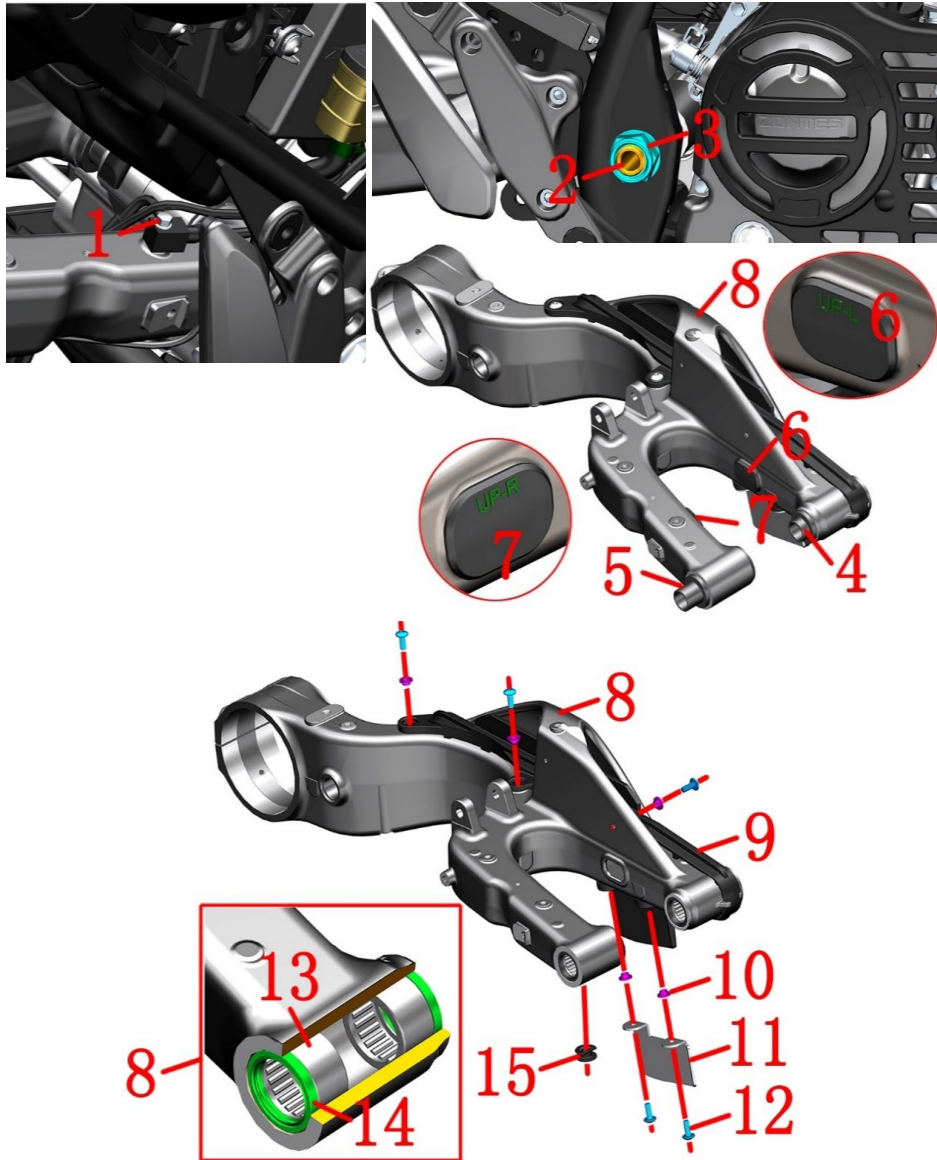
| Fig.17 Rear wheel, swinging arm component | | Rear fork component | | CHK | CAUTION |

Remove the five bolts (12) and the flange bushing (10) with the 6# hexagon socket tool and remove the fixing bracket (11)and the wear-resistant block (9) from the rear fork assembly(8).

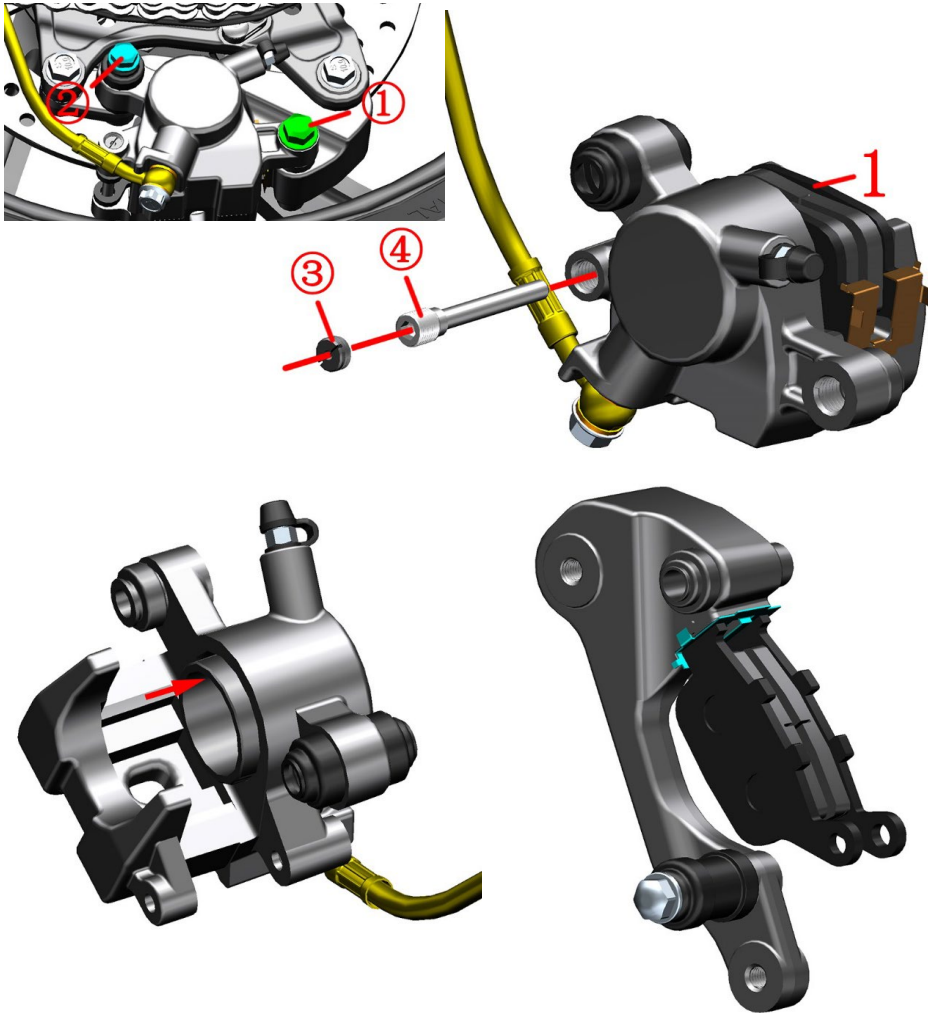
| Fig.18 Rear wheel, swinging arm assembly | | Change rear brake arresters | | CHK | |

Loosen the upper slide shaft① with a 14 mm sleeve.

Loosen the lower slide shaft② with a 12mm wrench.

● After changing the arrester, adjust the height of braking pedal according to "Foot pedal, gear shift rod assembly" if necessary.

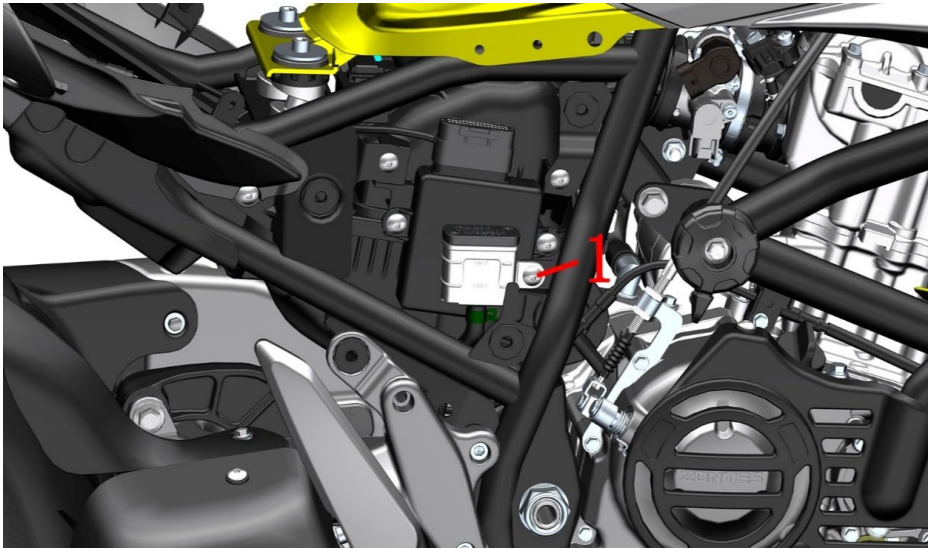
| Fig.19 Rear wheel, swinging arm assembly | | Rear brake main pump adds brake fluid | CHK | |

- Add disc brake liquid  
Remove the seat cushion and the right side cover first; remove the bolt (1) with 4# inner hexagon.  
Pull out the oil cup④; Should always remain above the oil tube interface, parallel to the ground. Avoid braking failure caused by air getting into the oil circulation. Disassemble bolt① with cross screwdriver.  
Take off oil cup cap②, sealing gasket③.  
Keep the top of oil cup④ parallel to the ground. Add DOT4 braking liquid. Ensure the liquid level is between "MAX" and "MIN".  
While reassemble, pay attention install sealing gasket③ in correct position and direction.  
Step gently on the pedal constantly. Do not ride the motorcycle until the braking force is recovered.

- Support the motorcycle well on flat ground before checking.
- Check regularly if the braking liquid surface is between "MAX" and "MIN".
- If liquid surface is below "MIN", check the arrester status and confirm if the braking system is leaking.

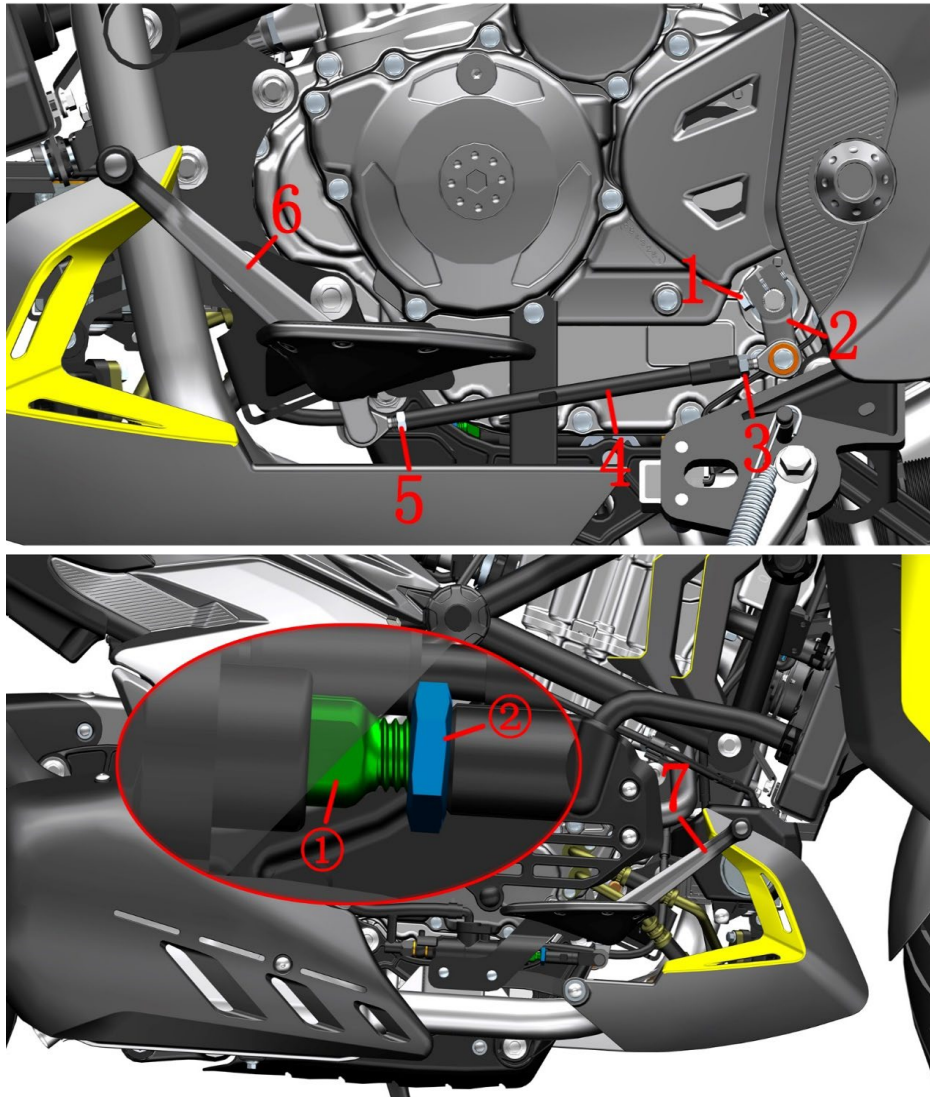
| Fig.1 FOOT PEDAL COMPONENT | | Adjust the hight of foot pedal | | CHK | CAUTION |

Use an 10# open-end wrench to loosen the nut (3), and nut (5) respectively. Use 8# open spanner to adjust the gear shift rod (4) adjustment bolt until the height becomes suitable. Then tighten the nuts. If the above-mentioned method can not adjust the gear shift rod to a satisfying position, take off bolt (1) and adjust gear shift rod spline of rocker arm (2) with a straight screwdriver by shoving a little bit the groove in the middle while dragging it out. Reassemble after the height is suitable. Pay attention to the aligning of the groove in the middle.

Use an 10# open-end wrench to loosen the nut (2). Spin the adjustment rod bolt (1) and adjust the brake pedal (7) to 85mm up to the top pedal (8). Fix the adjustment rod bolt (1) and tighten Nut (2).

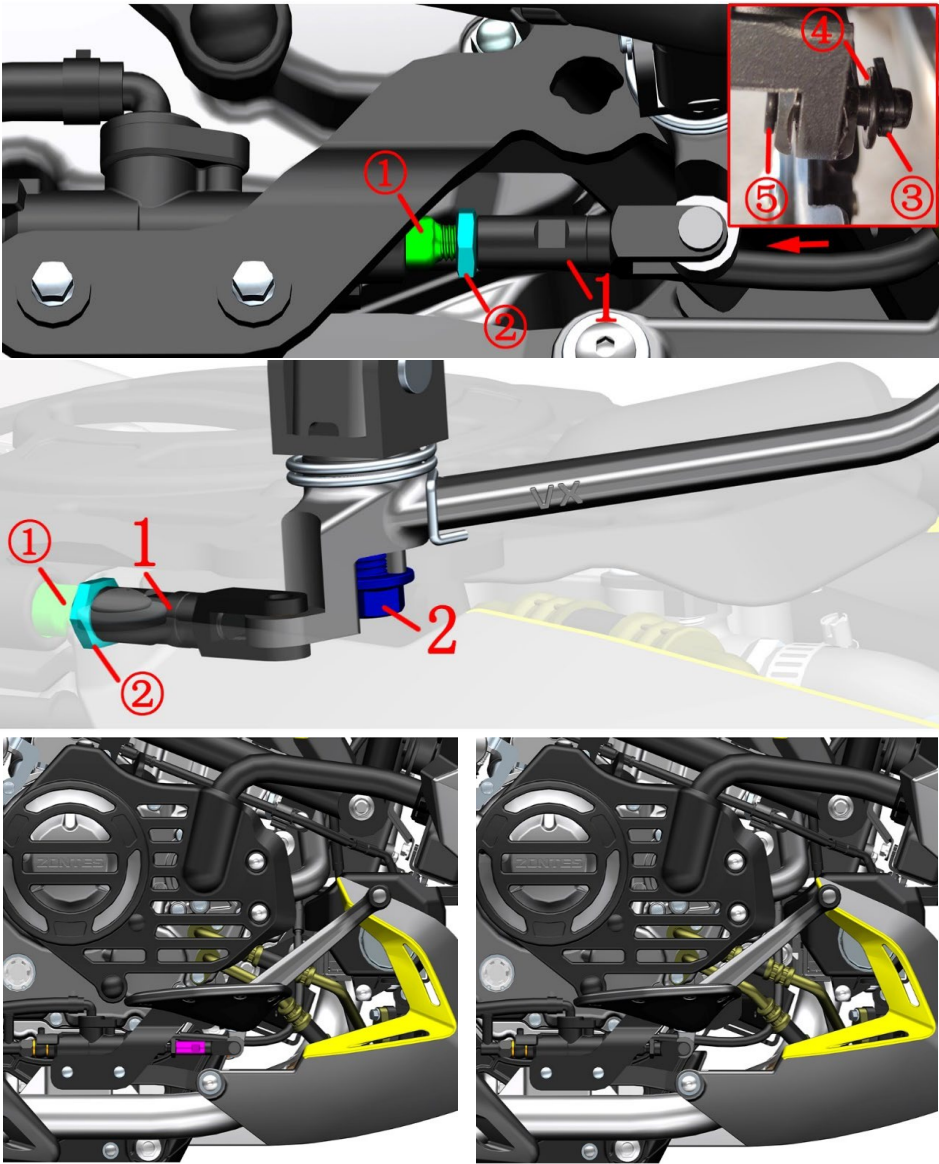
| Fig.2 FOOT PEDAL COMPONENT | | Front right pedal mounting position adjustment | | CHK | |

- Front right foot position adjustment
- Fix the screw ① with 10# open-ended wrench, loosen the nut ② with 14# open-ended wrench, and loosen the extension rod (1) with 10# open-ended wrench.
- Break the split pin ③ straight and remove it. Remove the gasket ④ and remove the pin shaft ⑤. Remove the extension rod (1).
- After grasping the front right foot pedal firmly, remove the bolt (2) from the back of the front foot pedal support with 14# ring wrench.
- Install the foot pedal assembly back into a hole position, and assemble the U-joint on the adjusting screw ① without assembling the extension rod (1). Assemble according to the disassembly sequence. Adjust to the proper position according to the method of adjusting the brake pedal angle.

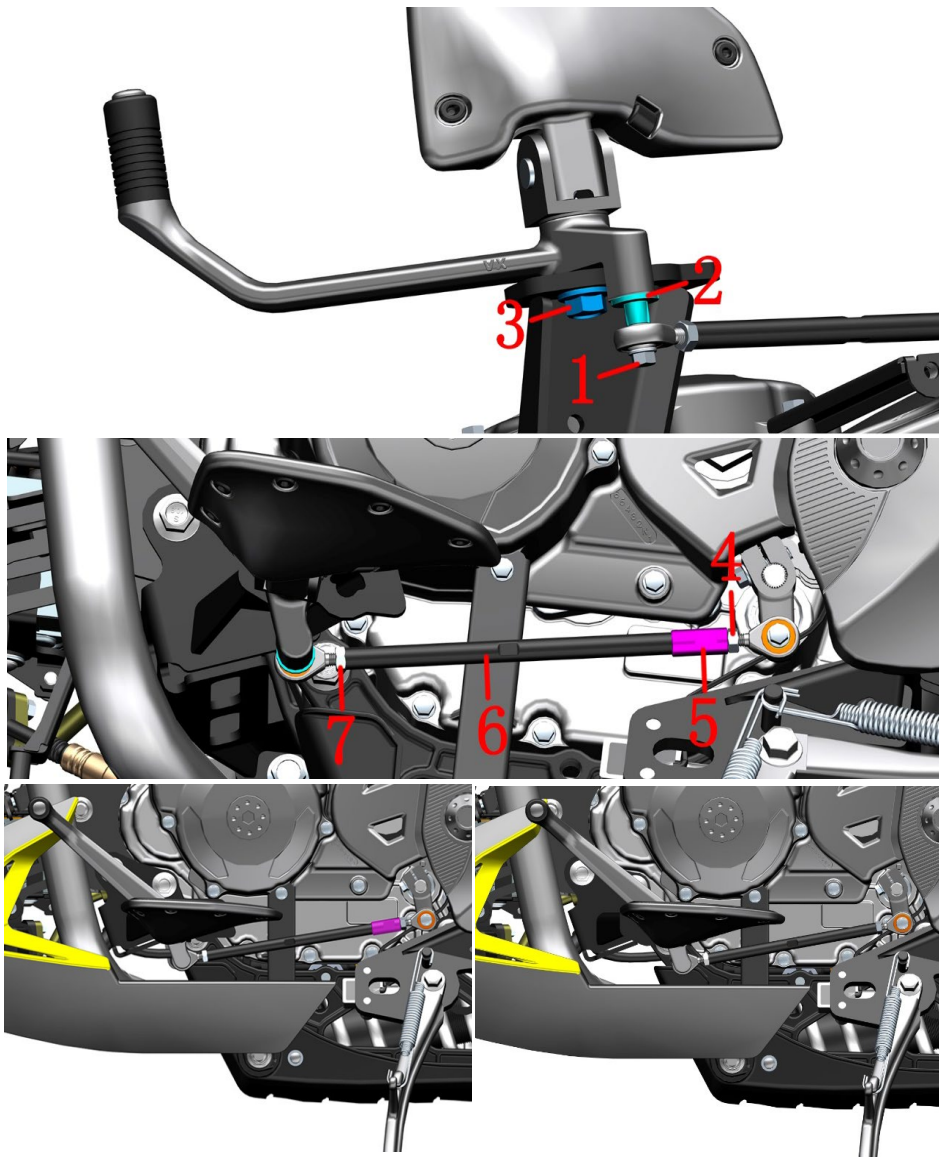
| Fig.3 FOOT PEDAL COMPONENT | | Front left pedal mounting position adjustment | | CHK | CAUTION |

Use a 10# open-end wrench to loosen the nut (4), bushing (5), screw (6) and nut (7).

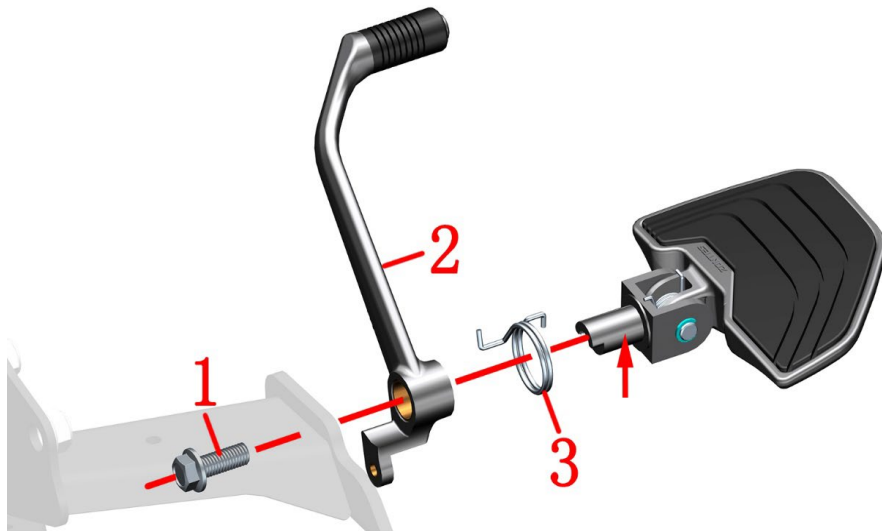
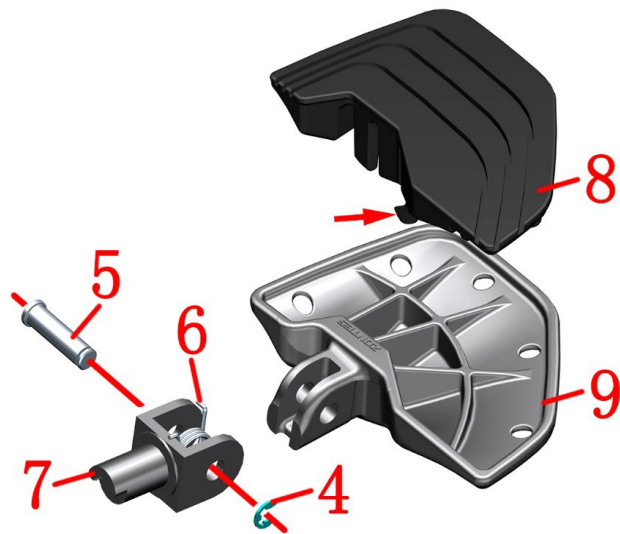
| Fig.4 FOOT PEDAL<br>COMPONENT | | Front right footrest component | CHK | |

- The boss of the support shall be aligned with the mounting hole on the pedal support before assembly.
- Pay attention to the installation direction of pedal torsion spring and brake pedal torsion spring.

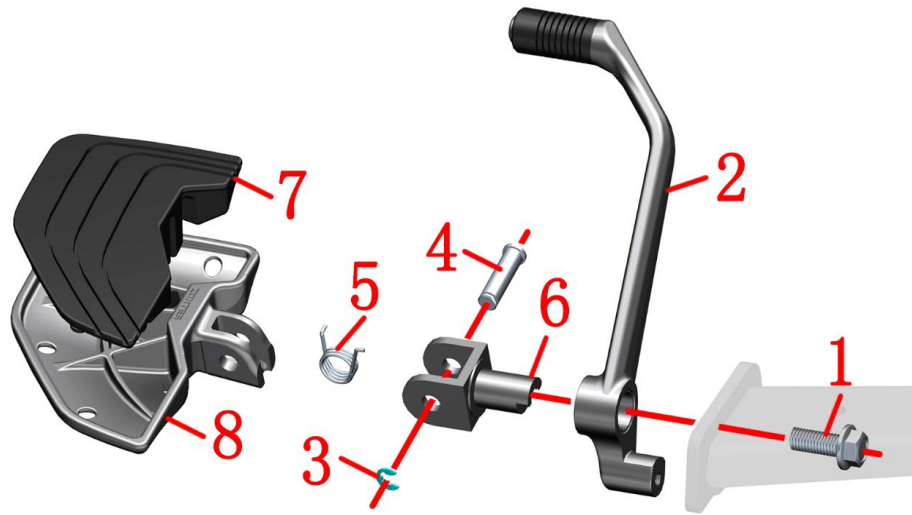
| Fig.5 FOOT PEDAL COMPONENT | | Front left footrest component | | CHK | CAUTION |

- The boss of the support shall be aligned with the mounting hole on the pedal support before assembly
- The foot pedal torsion spring pay attention to the installation direction.

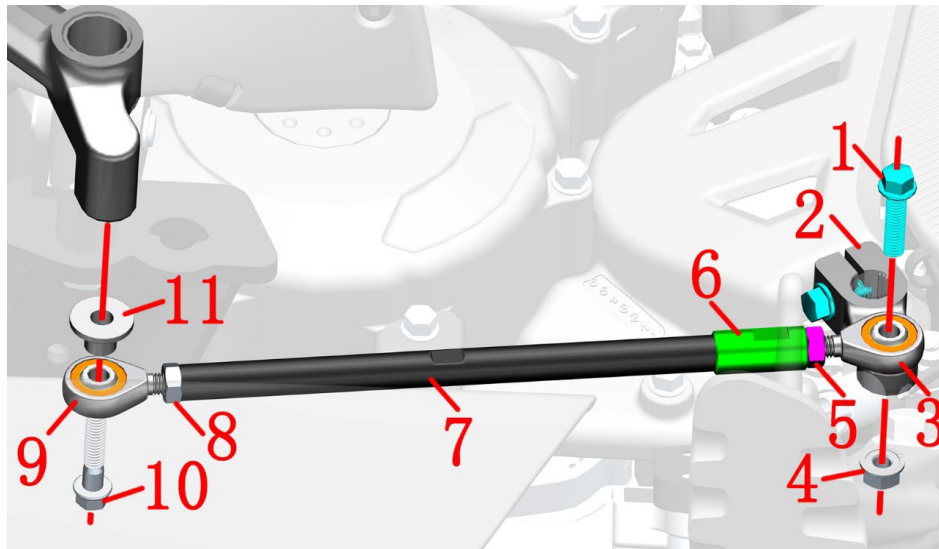
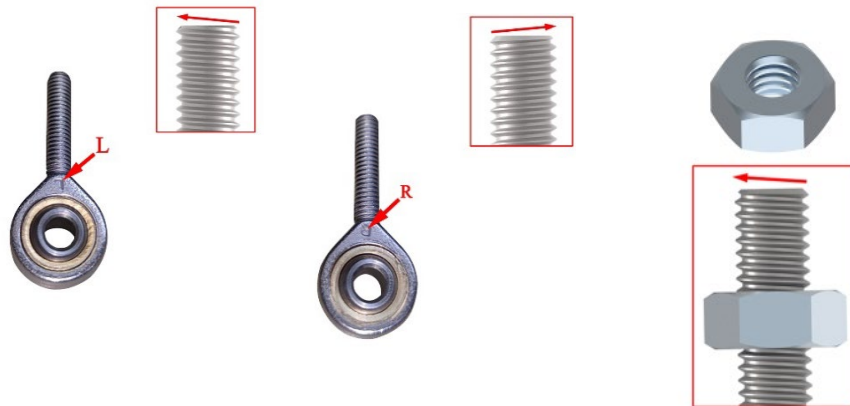
| Fig.6 FOOT PEDAL COMPONENT | | Shift lever assembly | | CHK | CAUTION |

Loosen nut(5) and nut(8) respectively with 10# open-ended wrench, rotate the groove position on adjusting screw(7) with 8# open-ended wrench, and loosen bushing (6) with 10# open-ended wrench. Use 10# sleeve to remove bolt(10) and bushing(11). Remove the bearing(9), nut(5), nut(8), bushing(6) and adjusting screw(7). Remove the bolt(1) at the engine shift shaft with an 8# ring wrench, and then pull out the spline rocker arm assembly with a slotted screwdriver. After fixing the bolt(1) with 8# sleeve, remove the nut(4) with 10# sleeve and remove the spline rocker arm(2) and bearing(2).

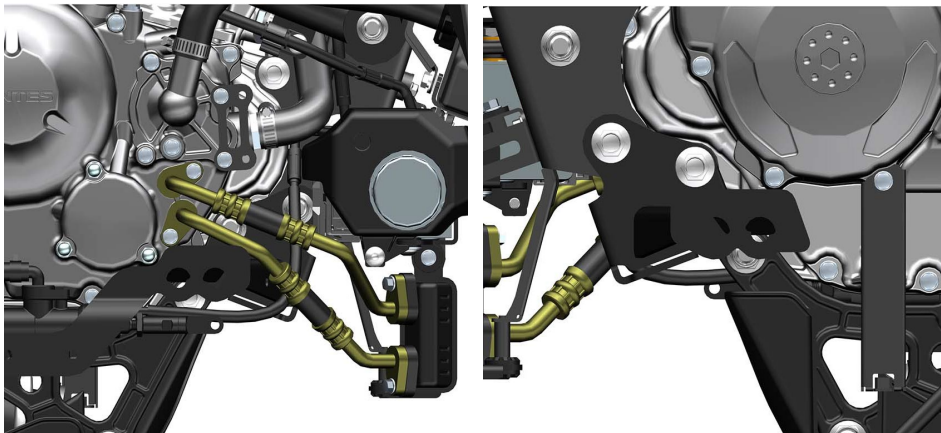
| Fig.7 FOOT PEDAL COMPONENT | | Front footrest bracket | CHK<br>ADJ | CAUTION |

First, remove it by referring to the steps for removing the fairling and the right bracket of the fairling. Follow the steps to remove the muffler assembly to remove. Refer to the previous steps to remove the left and right pedal assemblies to remove. Remove it as shown in Figures 1 and 2.

Use an 8# sleeve to remove the bolts(1) above the right hydraulic control unit bracket. Tilt the vehicle to the left and fix it firmly, then use an 8# sleeve to remove the 2 bolts(3). Note that a small amount of oil will leak from the oil pipe at this time, and pull out the two oil pipes. Note that when there is an O-ring at the oil pipe, be sure to check whether it is damaged. It is recommended to replace a new 9.8×2.4 O-ring. After fixing the head of the bolt(2) with a 14# sleeve, remove the two nuts(4) with a 17# sleeve, hold the front pedal bracket(5) firmly, pull out the bolt(2) and remove the pedal bracket. Screw the 2 bolts(3) back to the engine to straighten the vehicle.

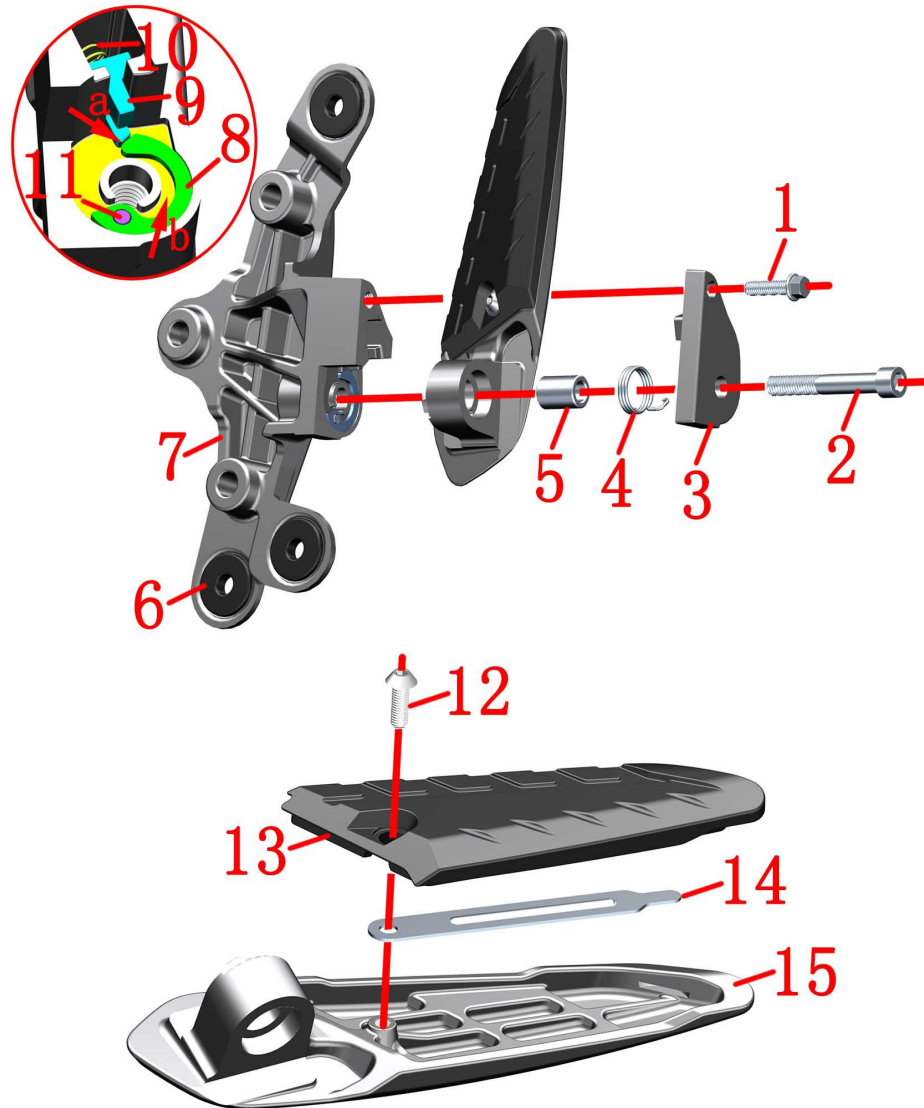
| Fig.9 FOOT PEDAL COMPONENT | | Rear right pedal bracket components(Old model) | | CHK | CAUTION |

●When reassembling, apply a proper amount of grease to the blue surface indicated by arrow "b". Note that the slider top sheet needs to hold the slider.

●Reassembly is to tighten the bolt (1) first, then pre-tighten the bolt (2). The bolt (2) head should be coated with a proper amount of thread fastening glue. After tightening the bolt (2), it is necessary to confirm whether the pedal rotation is flexible or not.

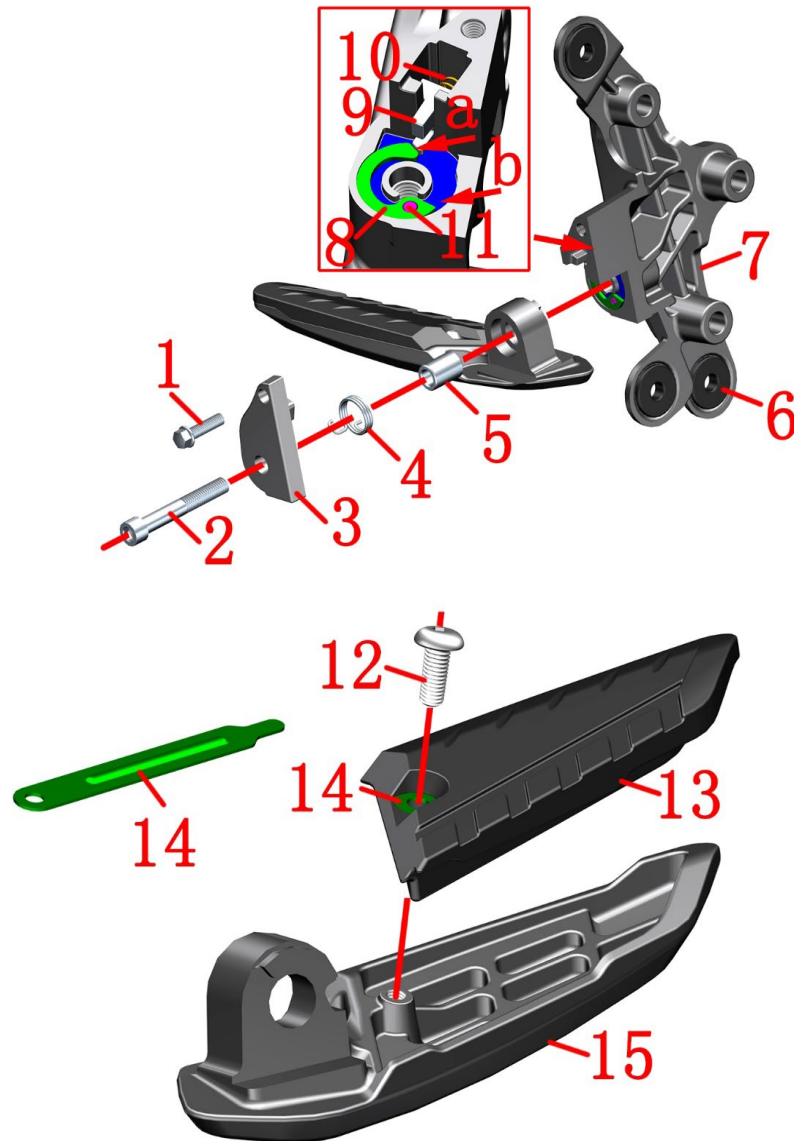
| Fig.10 FOOT PEDAL COMPONENT | | Rear left pedal bracket components(Old model) | | CHK | |

●When reassembling, apply a proper amount of grease to the yellow surface indicated by arrow b. Note that the slider top sheet needs to be held against the slider as indicated by arrow a.

●Reassembly is to tighten the bolt (1) first, then pre-tighten the bolt (2). The bolt (2) head should be coated with a proper amount of thread fastening glue. After tightening the bolt (2), it is necessary to confirm whether the pedal rotation is flexible or not.

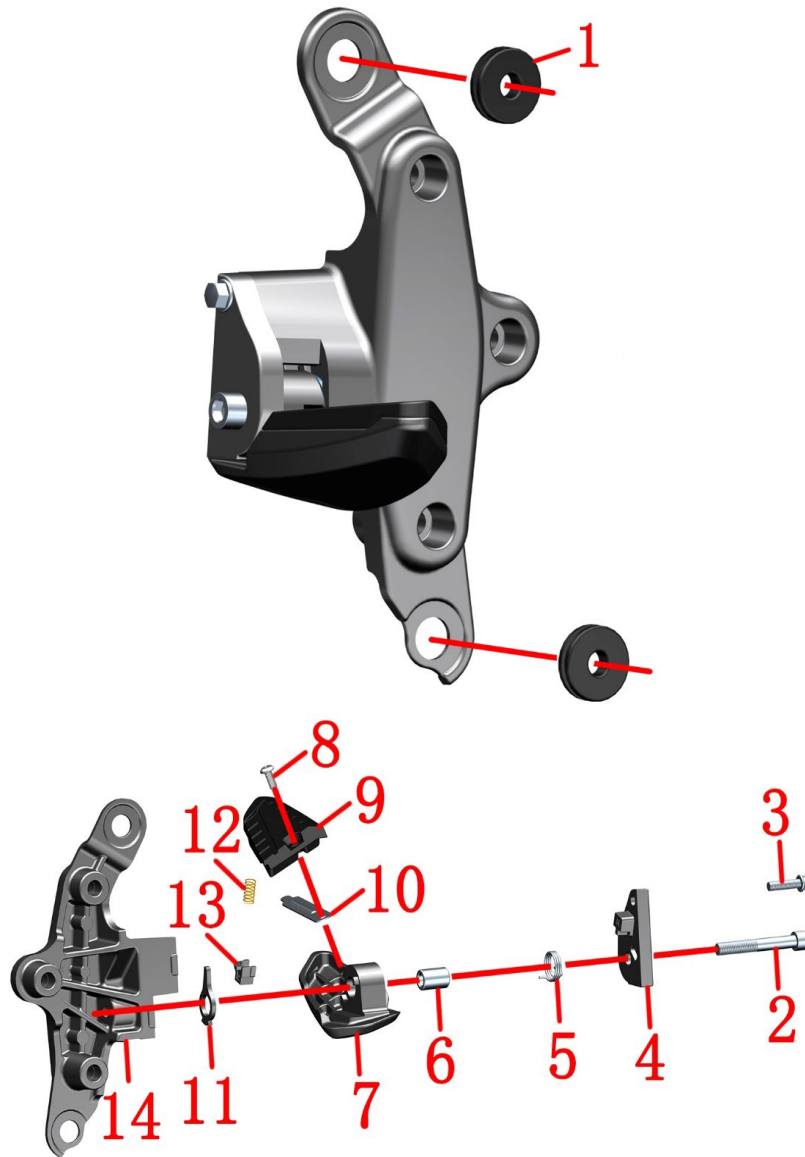
| Fig.11 FOOT PEDAL COMPONENT | | Rear right pedal bracket components (New model) | | CHK | CAUTION |

●When reassembling, apply a proper amount of grease to the food pad(11). Note that the slider top sheet needs to hold the slider.

●Reassembly is to tighten the bolt (3) first, then pre-tighten the bolt (2). The bolt (2) head should be coated with a proper amount of thread fastening glue. After tightening the bolt (2), it is necessary to confirm whether the pedal rotation is flexible or not.

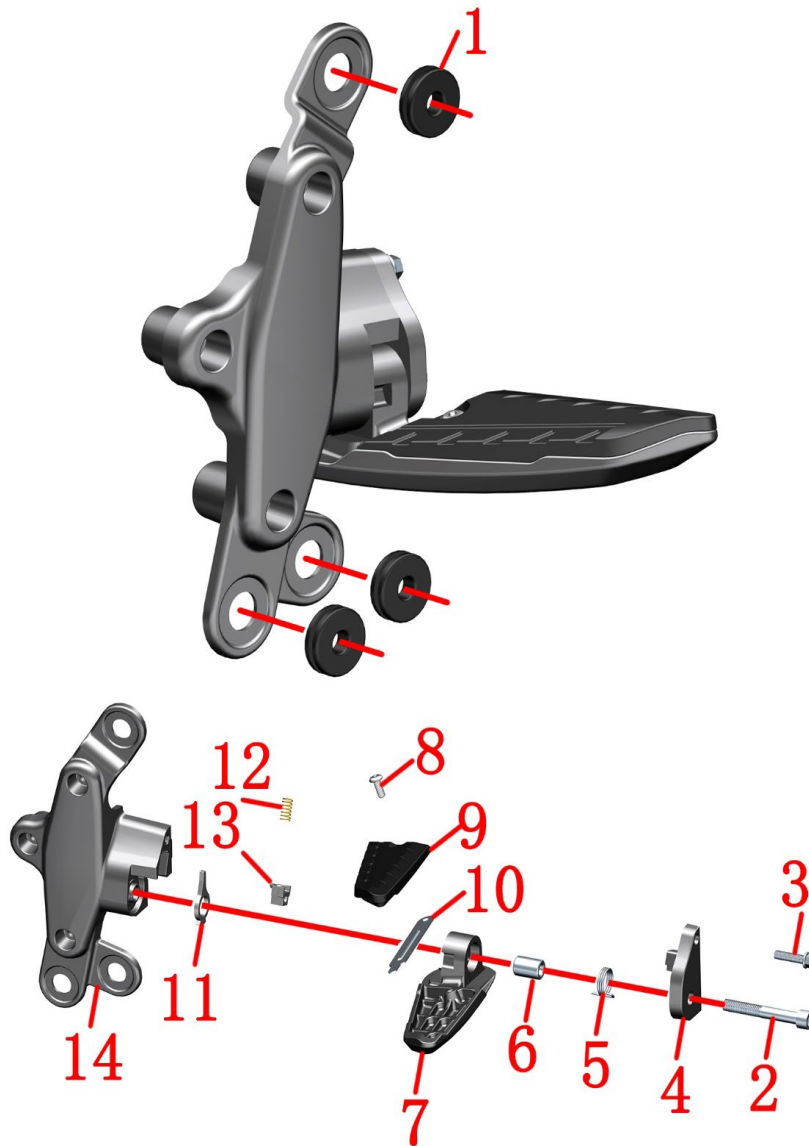
| Fig.12 FOOT PEDAL COMPONENT | | Rear left pedal bracket components (New model) | | CHK | CAUTION |

●When reassembling, apply a proper amount of grease to the food pad<sup>(11)</sup>. Note that the slider top sheet needs to hold the slider.

●Reassembly is to tighten the bolt <sup>(3)</sup> first, then pre-tighten the bolt <sup>(2)</sup>. The bolt <sup>(2)</sup> head should be coated with a proper amount of thread fastening glue. After tightening the bolt <sup>(2)</sup>, it is necessary to confirm whether the pedal rotation is flexible or not.
