# ZT350-VX (EURO V&EURO +)

Service manual

2025/04/08

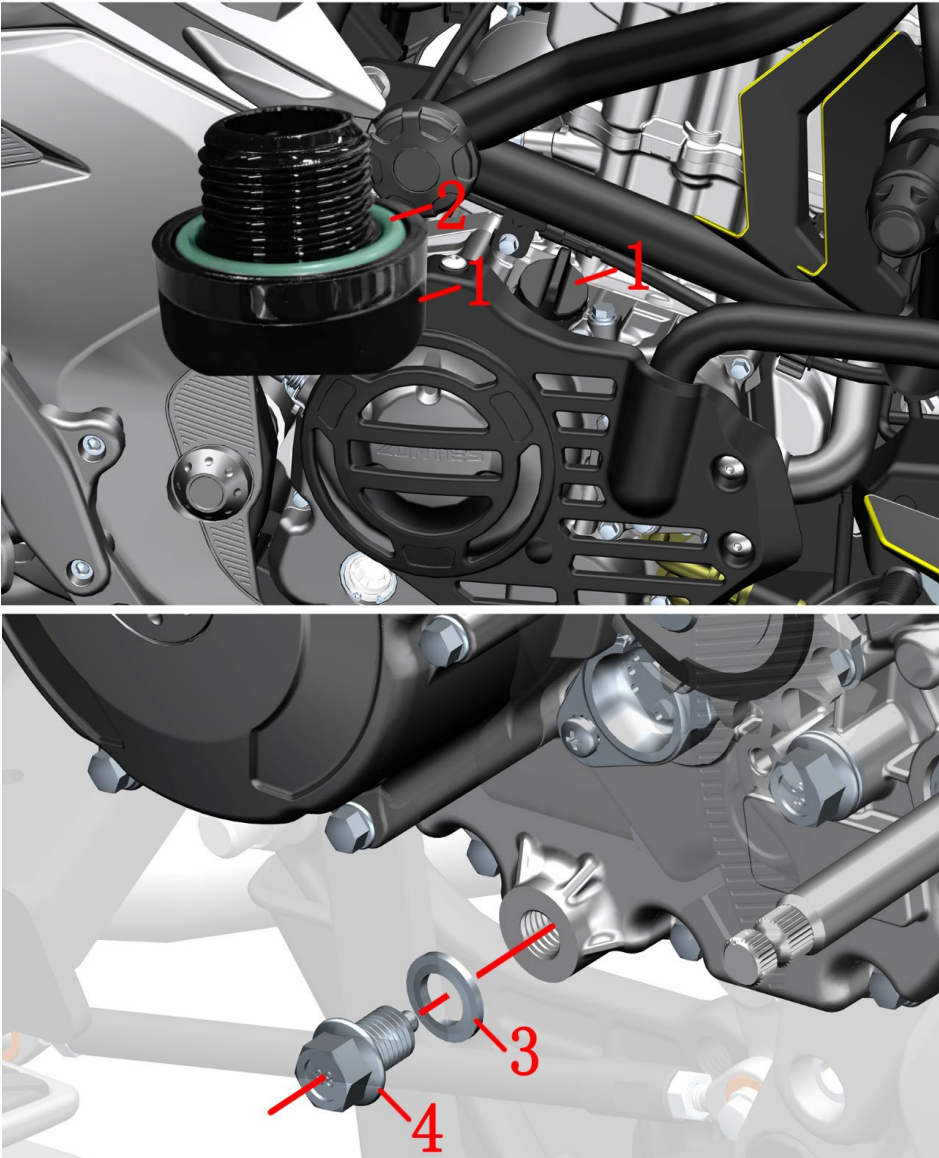
| Fig.1 COOLING SYSTEM COMPONENT | | Change engine oil | CHK | |

Wipe off the dirty oil with clean nonwovens. Be sure that the surface of oil draining bolt and sealing gasket are not scratched and has no impurity before reassembling. Torque on bolt is 24±4N.m. Too strong will damage the thread. Too weak will cause leakage of oil.

Add from opening on right crankcase of engine 1.6L(1.7L if oil filter is changed) new engine oil of SAE 10W-50/10W-40 with API SM degree or higher. Then tighten the oil filler plug(1), pay attention to check the O-ring(2) is damaged or aging, and do not leak.

Idle for 5 minutes and then shut down for 3 minutes. Observe the oil level through the oil window. If the liquid level is lower than the minimum oil level mark, add new oil to the maximum oil level mark. Check again for leakage according to the above method.

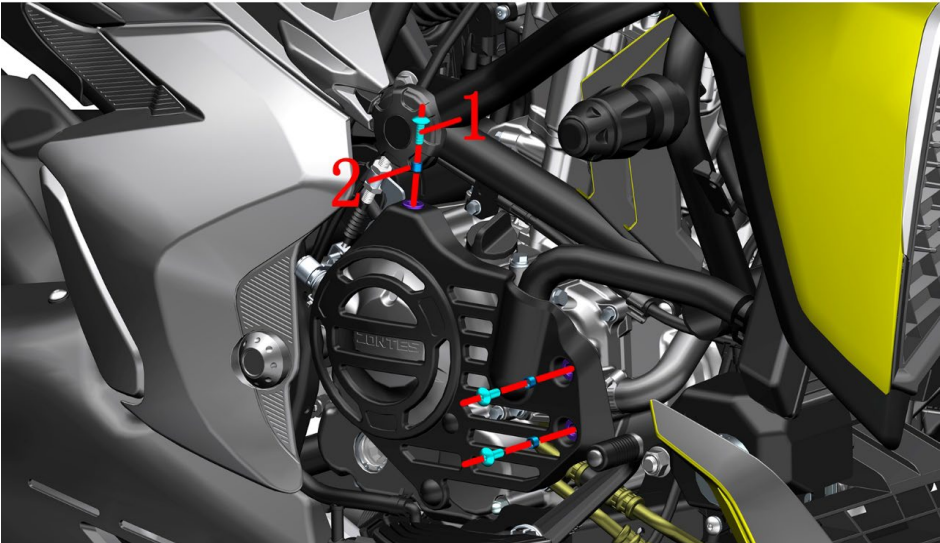
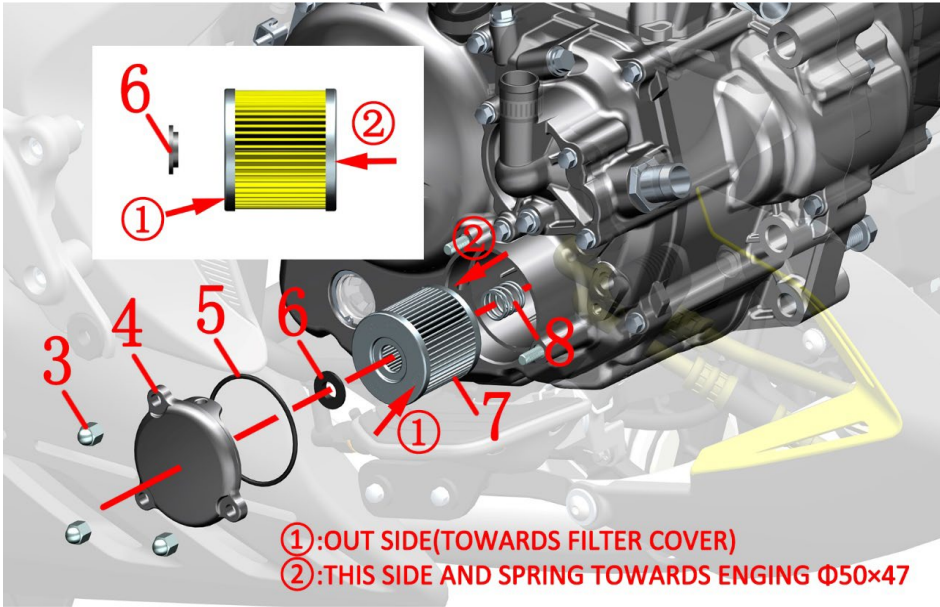
| Fig.2 COOLING SYSTEM COMPONENT | | Change engine oil filter | | CHK | CAUTION |

- Ensure every component is well assembled.
- To change engine oil filter and seal ring(5) at the same time is suggested.
- Engine oil filter can not be turned over when assembling.
- Note that the seal ring (6) is facing the fine filter with the “OUT SIDE (TOWARDS FILTER COVER)” side. It is forbidden to install reverse or leak.
- 【1】 The ZT180 refined filter seal component already included oil filter、 55×2.5 O-ring (5) and ZT180MN Engine oil refined filter seal ring(6) .

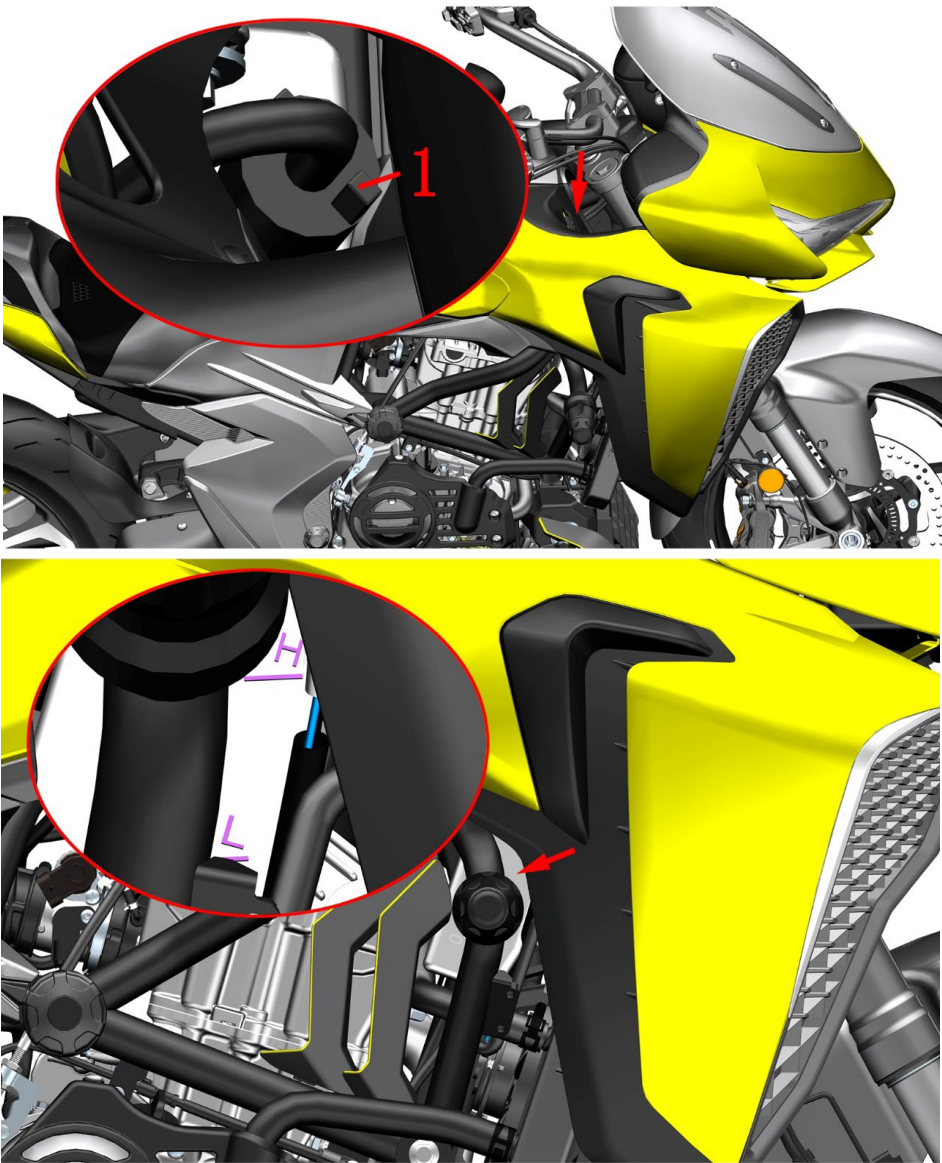
| Fig.3 COOLING SYSTEM COMPONENT | | Add coolant | CHK | |

- Total volume of cooling liquid is 1580ml.
- Cooling liquid might damage the coating of motorcycle. Be careful while adding. If it is spilt in small quantity, please clean it immediately with soft cloth.

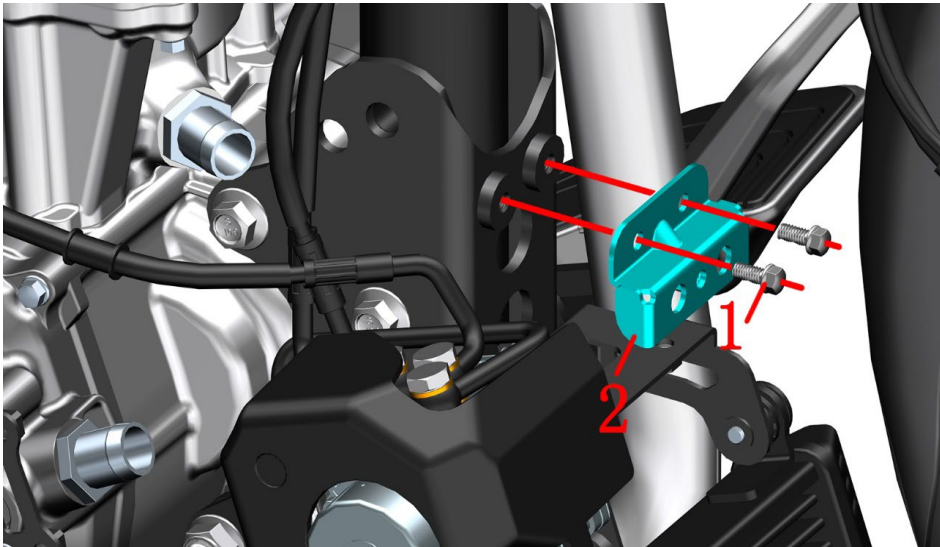
| Fig.8 COOLING SYSTEM COMPONENT | | Main water tank assembly 2 | | CHK | |

Compressed air with lower air pressure can be blown from the back to the water tank from a long distance to clean up foreign objects on the surface. Or use a low-pressure water gun to spray the radiating fins from a long distance to clean up foreign objects on the surface.

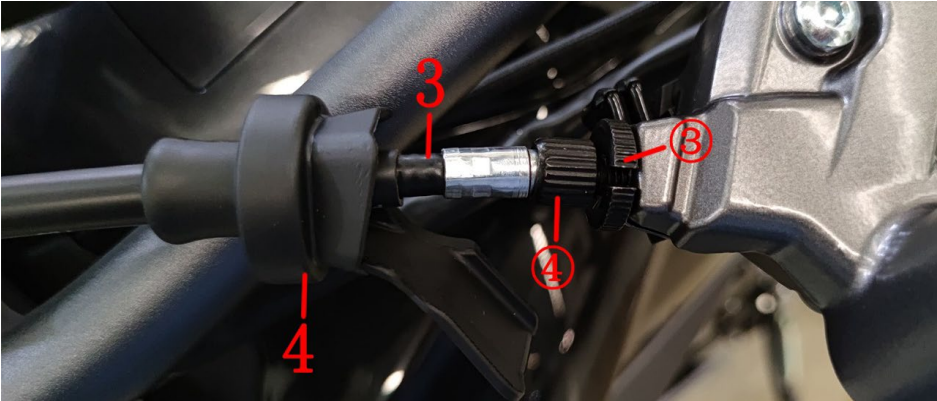
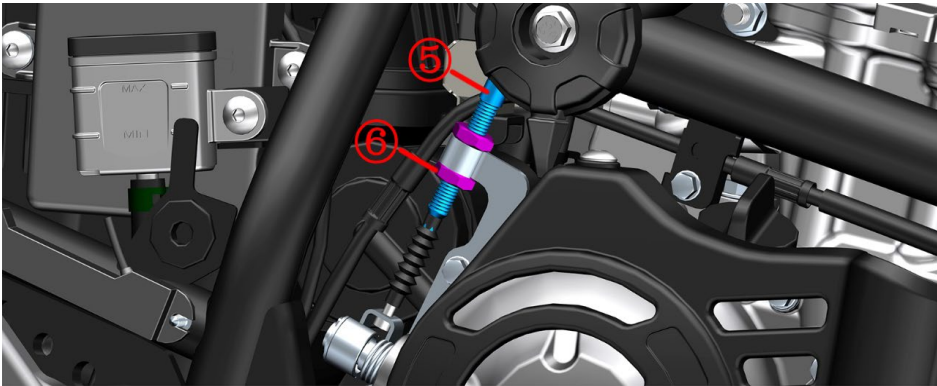
| Fig.1 FRONT FORK COMPONENT | | Throttle/clutch cable clearance adjustment | | CHK | |

- The motorcycle support should be fixed during disassembly to prevent accidents caused by incline.
- Throttle line adjustment should be noted as follows:
  - After adjustment, ensure that the throttle can be reset automatically. It is forbidden to increase the idle speed of the engine due to adjustment of the cable.
  - The engine idle speed rise cannot occur in the direction of rotation.
  - Checking the engine idle speed should be performed under the condition of a heat engine and should be at 1500 to 1700 rpm.
- The clutch adjustment should be noted as follows: Excessive free travel can cause wear and malfunction of the clutch and gearshift mechanism. After adjustment, be sure to stagger the nut, adjusting screw, and slot on the rocker arm to a certain position to prevent the cable from coming out of the slot.

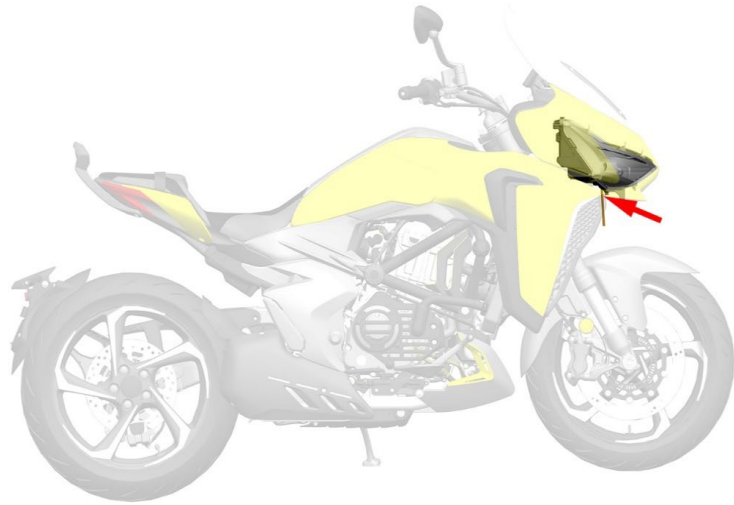
| Fig.2 FRONT FORK COMPONENT | Light height adjustment | CHK | |

It is forbidden to adjust the light height during riding. It is advisable to adjust the road with a smooth road surface and a straight line distance of about 150 meters without affecting traffic safety at night.

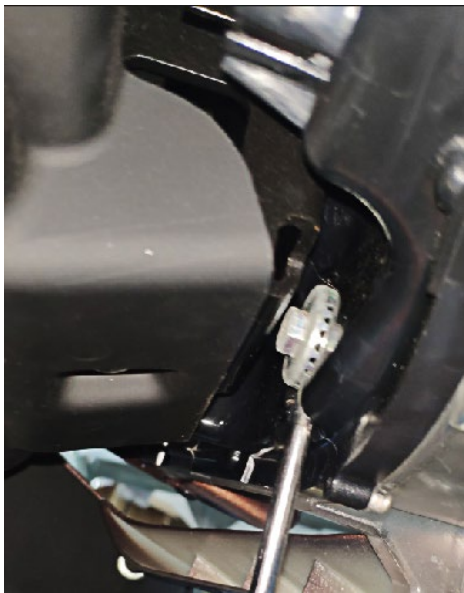
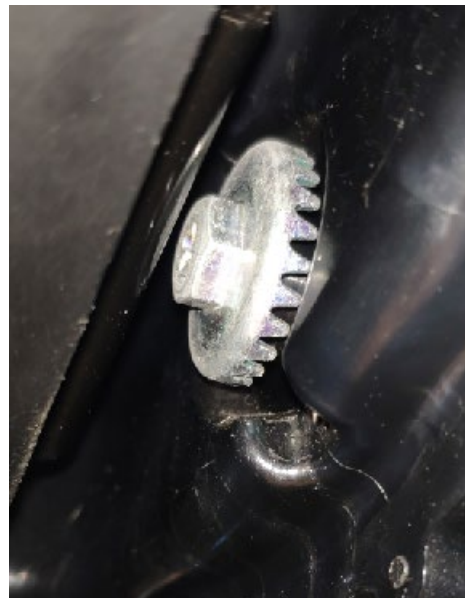
The driver sits in the bike and straightens the bike. The other person inserts the PH2 type Phillips screwdriver (diameter 6mm) into the hole at the bottom of the vehicle head, aligns it with the tooth profile of the adjusting bolt, turns clockwise for lowering, and counterclockwise for higher beam height.

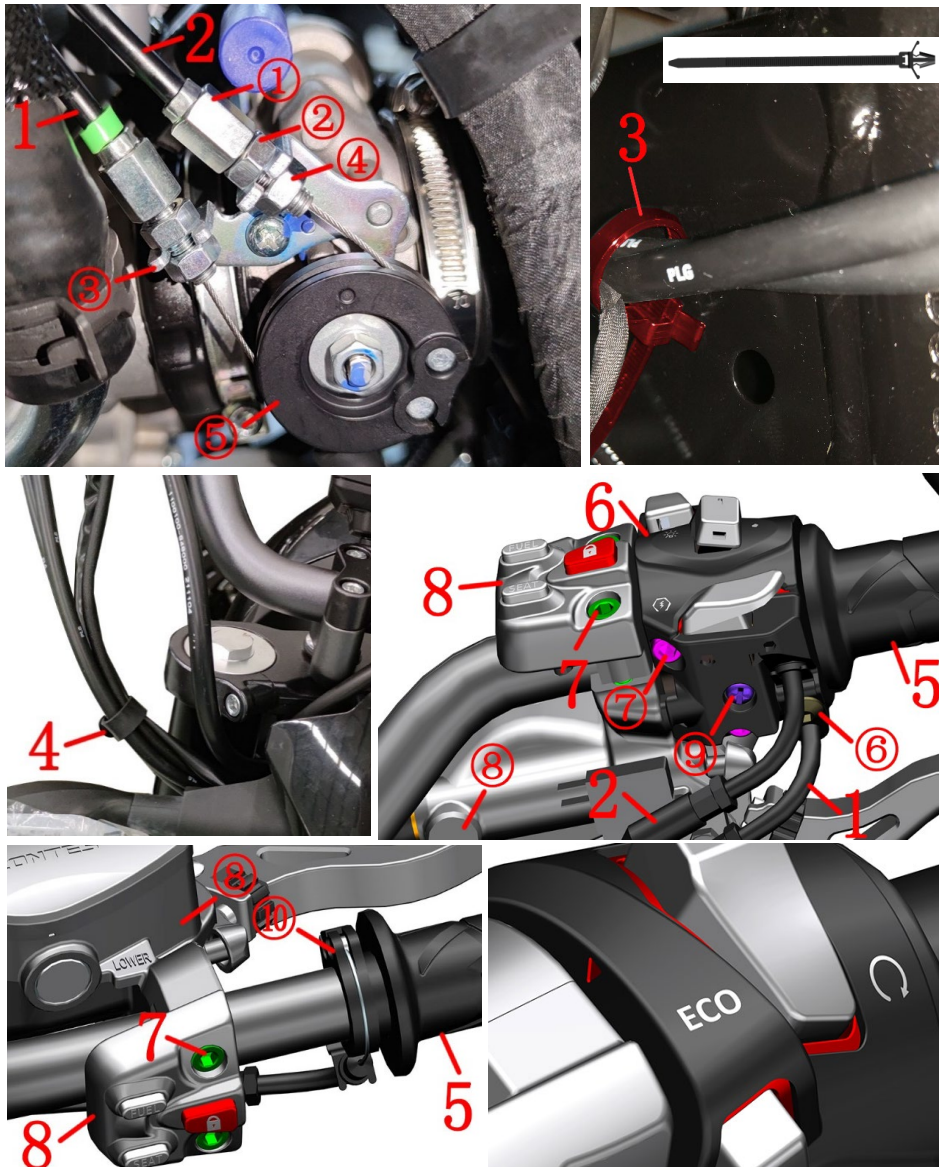
| Fig.4 FRONT FORK COMPONENT | | Replace the throttle line | | CHK | |

Use 10# an open-ended wrench to screw the nut ② of the accelerator oil line (1) up to the bottom, and screw the nut ④ down out of the adjusting pipe ①; Remove the cylindrical joint of the oil filling line from the rotary table ⑤; Referring to the previous steps, first completely loosen the nuts ② and ④ of the oil return line (2), remove the cylindrical joint from the rotary table, and then move the adjusting pipe of the oil return line (2) upward, over the bracket ③ on the throttle valve, and then pull it out.

Adjust the throttle cable clearance according to the method of adjusting the clearance; The idle speed should not change and reset flexibly when turning the steering handle left and right after adjustment.

Lock nuts ② and ④.

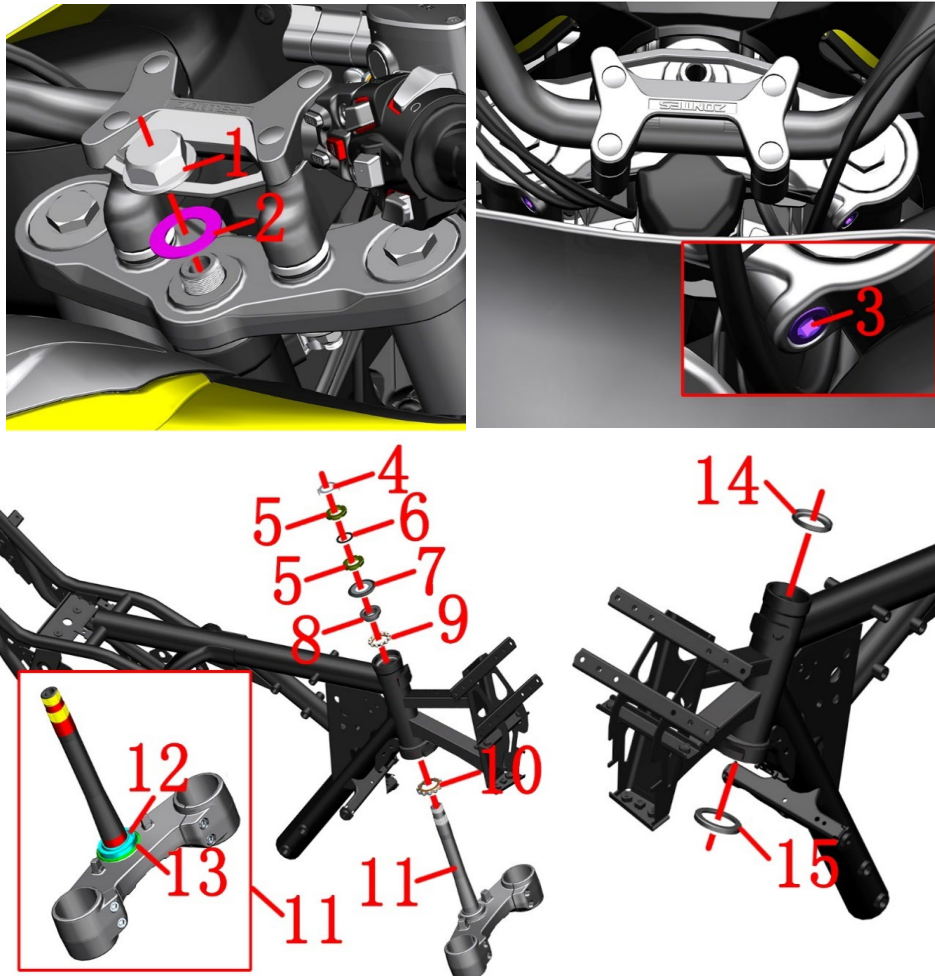
| Fig.5 FRONT FORK COMPONENT | | Steering adjustment | CHK | |

Remove the adjusting nut (5), remove the upper dust cover (7), shaft ring (8), cinjoined steel ball (9), cinjoined steel ball (10), lower coupling plate assembly (11). Remove the directional column & front shock absorber & front wheel assembly, and check the shaft ring and the connecting steel ball for abnormal wear or rust. At the same time, check whether the seat rings (14) and (15) in the front riser of the frame are abnormally worn or rusted. The newly replaced conjoined steel ball should be evenly greased, pay attention to the amount of grease.

Check if the pressure of the front tire is the recommended air pressure at room temperature: 280 kPa. If it is lower than the recommended air pressure, the front tire pressure should be inflated to 350 kPa first, and then deflated to 280kPa. If it is otherwise set the front wheel and turn to inspect the tire tread, if it is worn or deformed, the front tire needs to be replaced. If no, continue to operate.

Set up the front wheel and shake the lower part of the fork by hand to check if the steering shaft is loose or if the left and right rotations are not flexible.

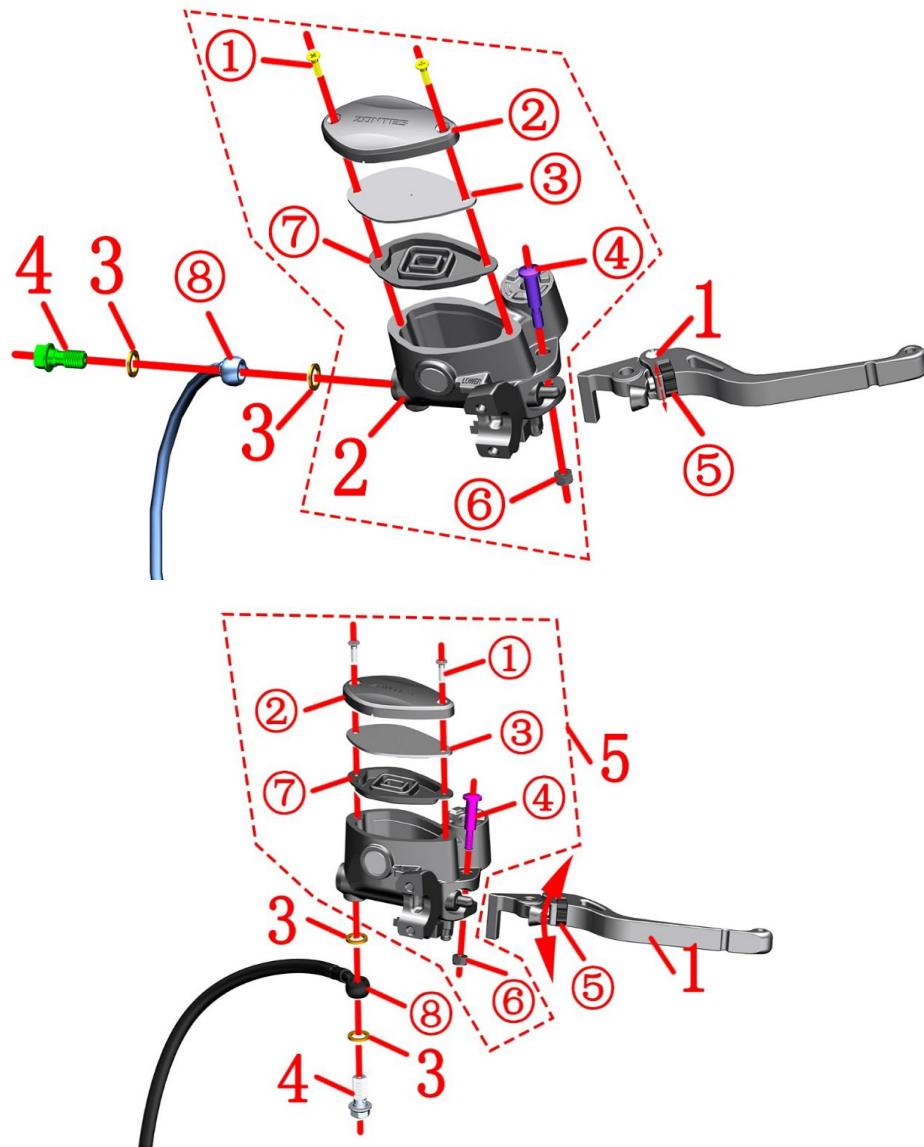
| Fig.6 FRONT FORK COMPONENT | | Add brake fluid, rocker adjustment | | CHK | CAUTION |

Fix the front disc brake main pump, remove the bolt (4) and copper pad (3) with a 12# sleeve, and do not disassemble if it does not need to be replaced. Always replace the tubing connector (8) at a high level to prevent air from entering the tubing and cause brake failure. Also clean oil should be removed to prevent dripping onto parts such as covers or mufflers. After replacement, be sure to hold the handle (1) continuously and tap the main pump (2) of the disc brake at the same time to eliminate a small amount of gas entering the brake oil circuit and confirm that the braking returns to normal.

If the handle needs to be replaced, fix the bolt (4) with 5# inner hexagon socket tool, and then remove the nut (6) with 10# sleeve or double offset ring spanner; Remove the bolt (4) and then remove the handle (1).

Before driving the motorcycle, check whether the brake fluid level is above the "LOWER" marking. If not, check the brake disc or brake disc for wear and whether there is any oil leakage or oil leakage in the brake system. Abnormal needs to add brake fluid.

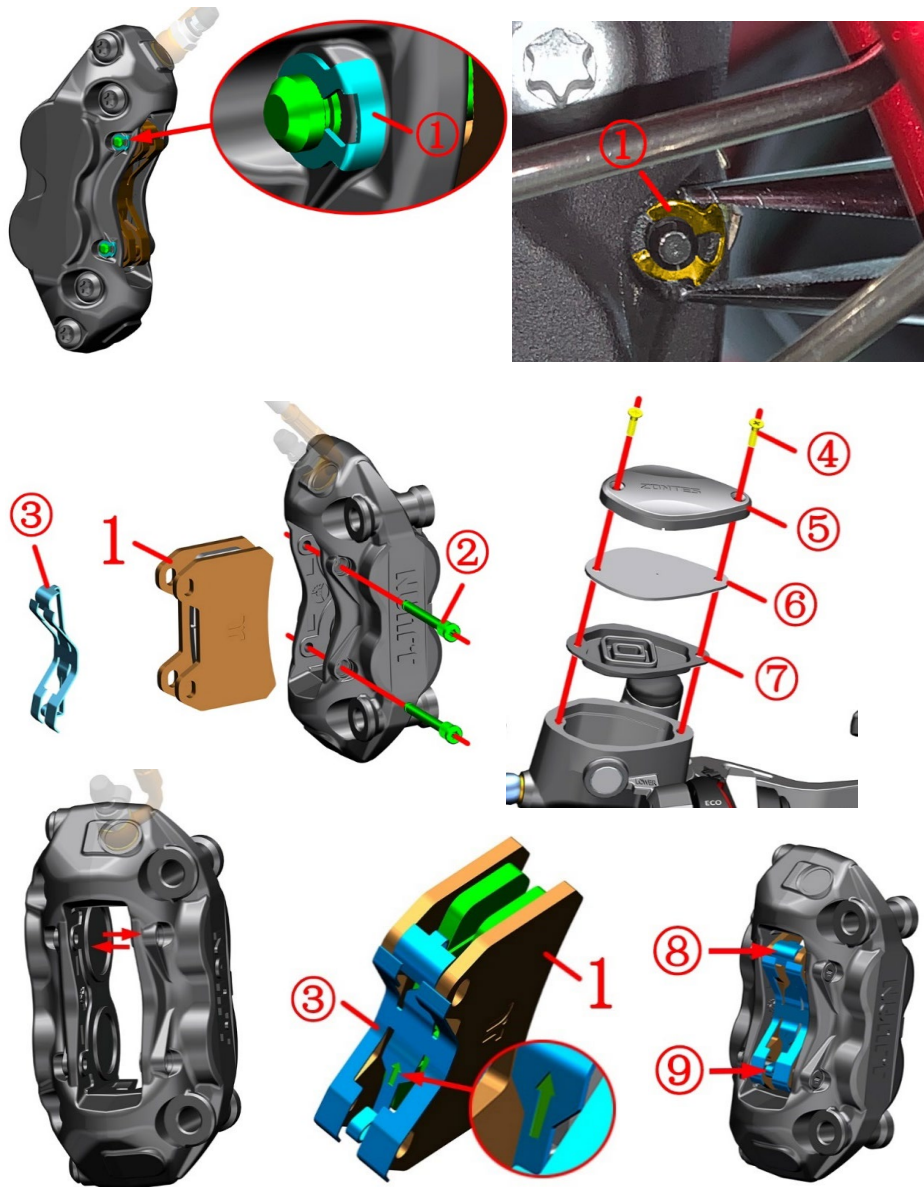
| Fig.7 FRONT FORK COMPONENT | | Replace the front brake pads | CHK | |

## ● Replace the front brake pad

● It is recommended to replace brake pads in pairs with qualified maintenance units.

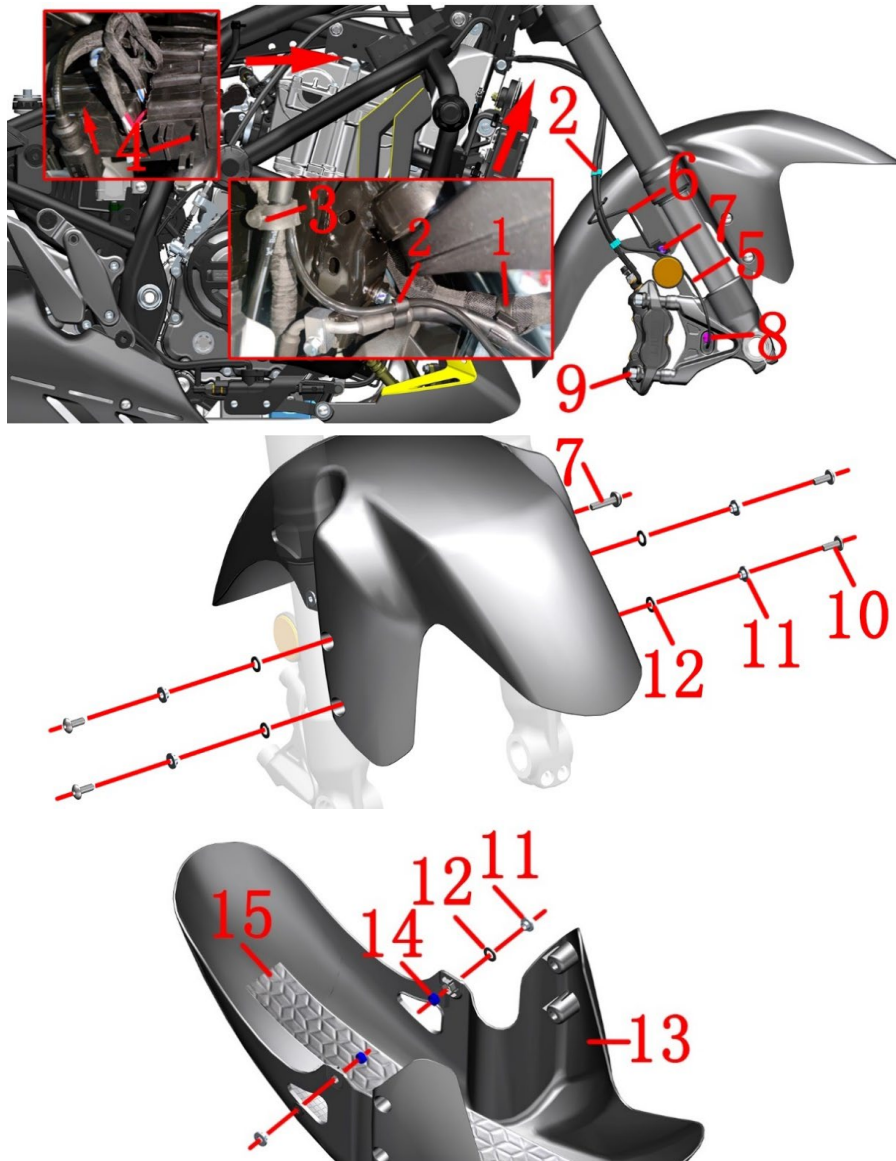
| Fig.9 FRONT FORK COMPONENT | | Front mudguard & wheel speed sensor component | CHK | CAUTION |

Use a 8# hexagon socket to remove the bolts(9); let the caliper sag naturally, and it is strictly forbidden to invert the caliper. It is forbidden to invert the caliper to prevent the air from entering and causing the brake to fail.

Remove the 4 bolts (10) with the 4# hexagon socket by hand and remove the bushing (11) and cushion rubber (12). Using 6# hexagon socket remove the bolt(7) on the left side. Take off the bushing (11) and cushion rubber (12) and the nuts(14). If the shockproof plate(15) needs to be replaced, heat it with a hot-air gun and remove it after the double-sided adhesive is softened.

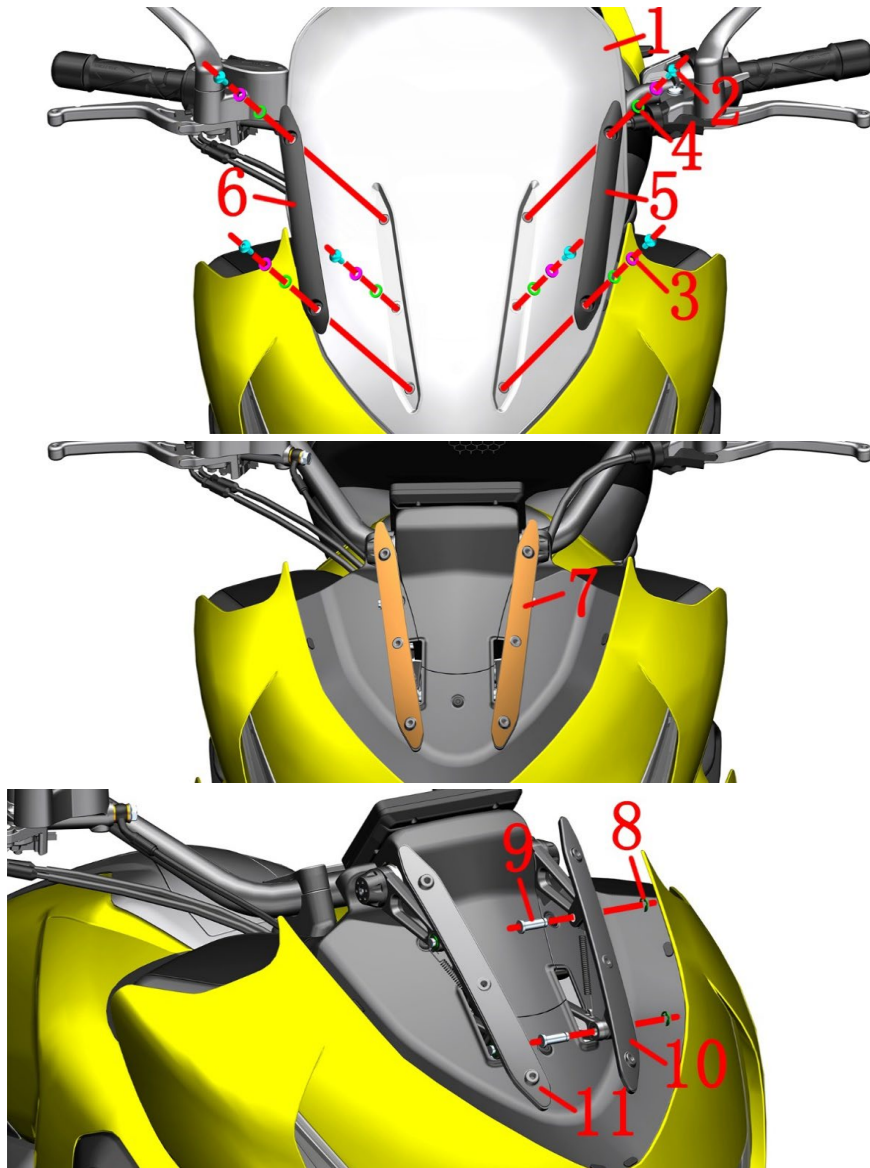
| Fig.10 FRONT FORK COMPONENT | | Windshield components 1 | CHK | |

- The windshield should be protected from scratches during disassembly.
- The circlip is small, please keep it well during disassembly and prevent it from falling into the vehicle.
- You can search "ZT310-VX Headlight Replacement Video" in the assembly video to watch the detailed video tutorial. The disassembly is the same, only the appearance of individual parts is different.

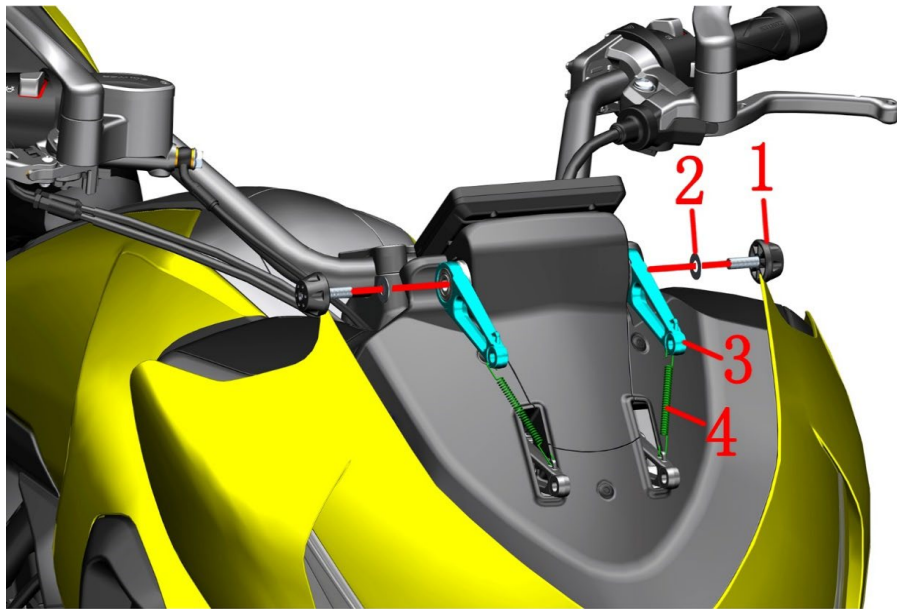
| Fig.11 FRONT FORK COMPONENT | | Windshield components 2 | | CHK | CAUTION |

● Pay attention to safety when removing the spring. The extension spring sold on the official website (4) does not contain a heat-shrinkable tube. You need to purchase a  $\phi 8$  heat-shrinkable tube by yourself.

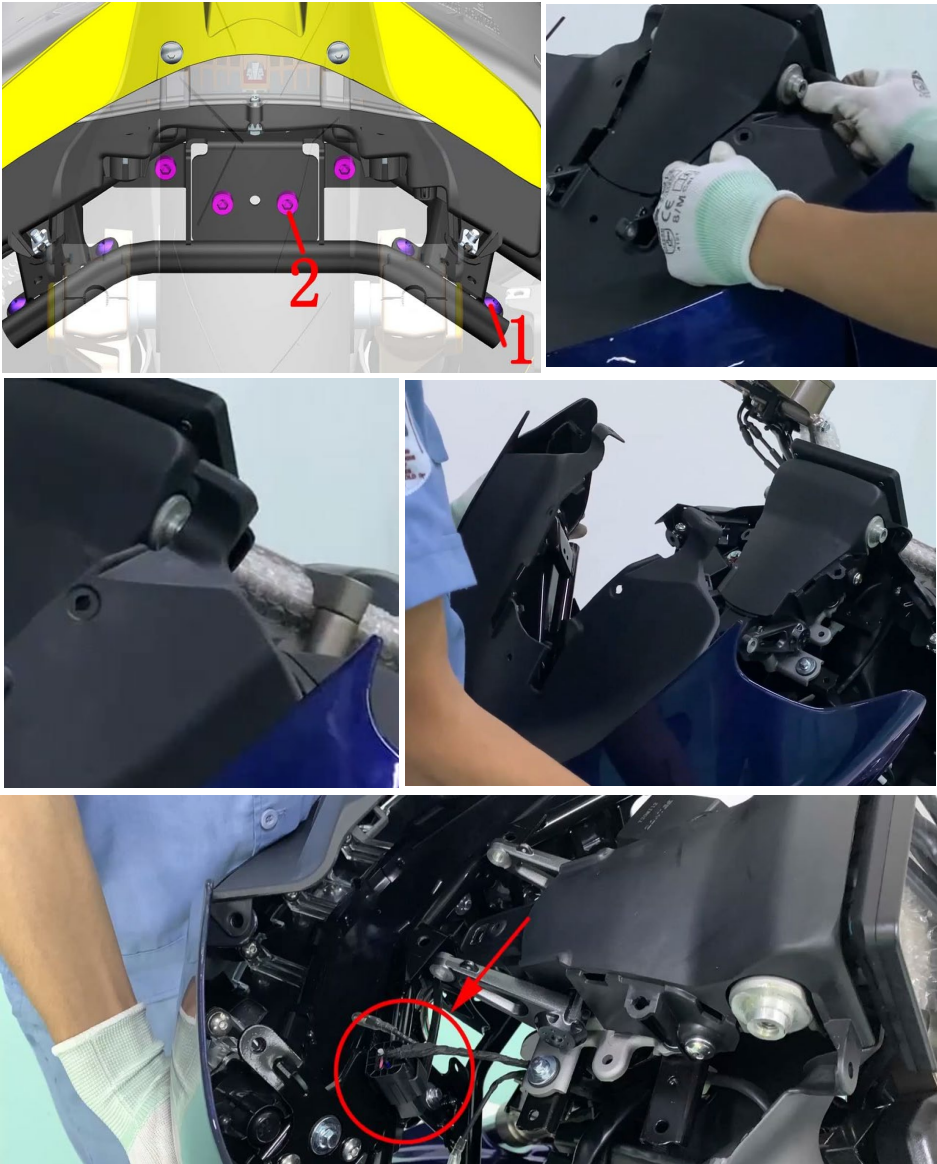
| Fig.14 FRONT FORK COMPONENT | | Headlight assembly 3 | CHK | |

- You can search "ZT310-VX Headlight Replacement Video" in the assembly video to watch the detailed video tutorial.The disassembly is the same,only the apperance of individual parts is different.
- The parts should be protected during the disassembly process to prevent damage to the paint surface.
- When removing the buckle, pay attention to the strength to prevent damage to the buckle.

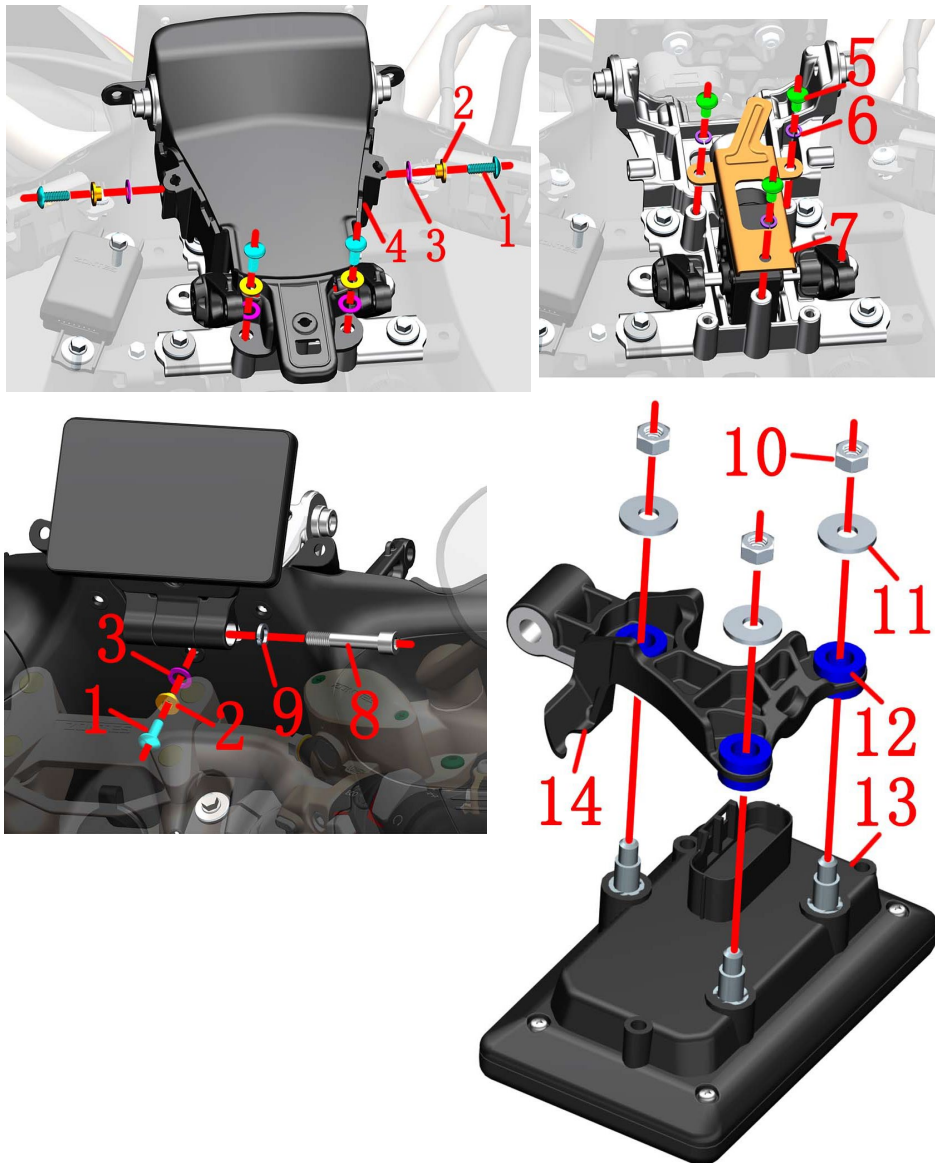
| Fig.18 FRONT FORK COMPONENT | | Windshield motor components | | CHK<br>ADJ<br>CAUTION |

●Protect protective measures to prevent scratching the instrument lens.

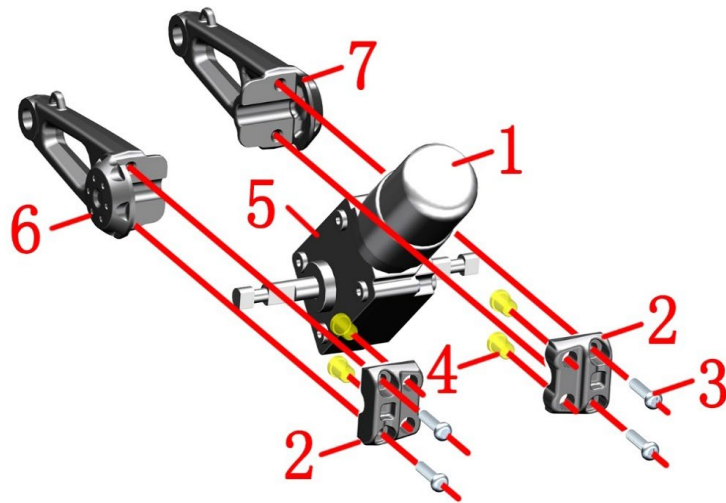
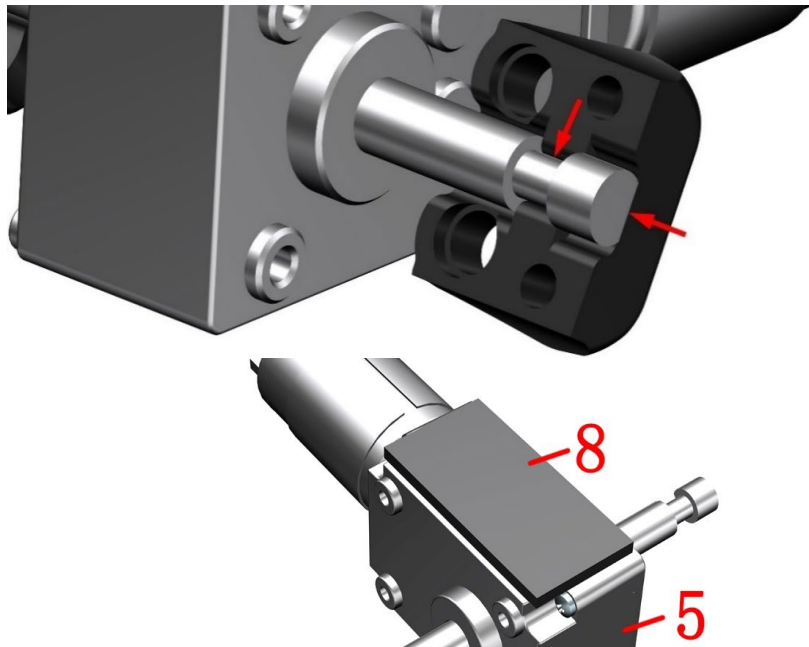
| Fig.19FRONT FORK COMPONENT | | Windshield motor sub-assembly | | CHK | |

- Do not pull the cable directly when pulling the plug.
- Pay attention to the limit plane and limit groove of the motor and rocker clamp when reassembling.
- If you buy a windshield motor,you need to buy a Battery rubber gasket(8), pasted on the side of the windshield motor pressure plate.

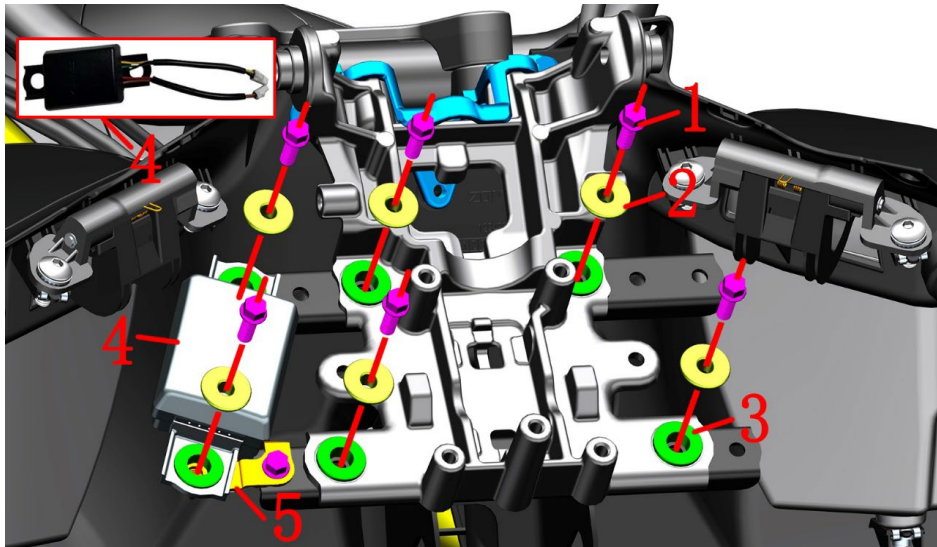
| Fig.20FRONT FORK COMPONENT | | Remove windshield base | CHK | |

● Do not pull the cable directly when pulling the plug.

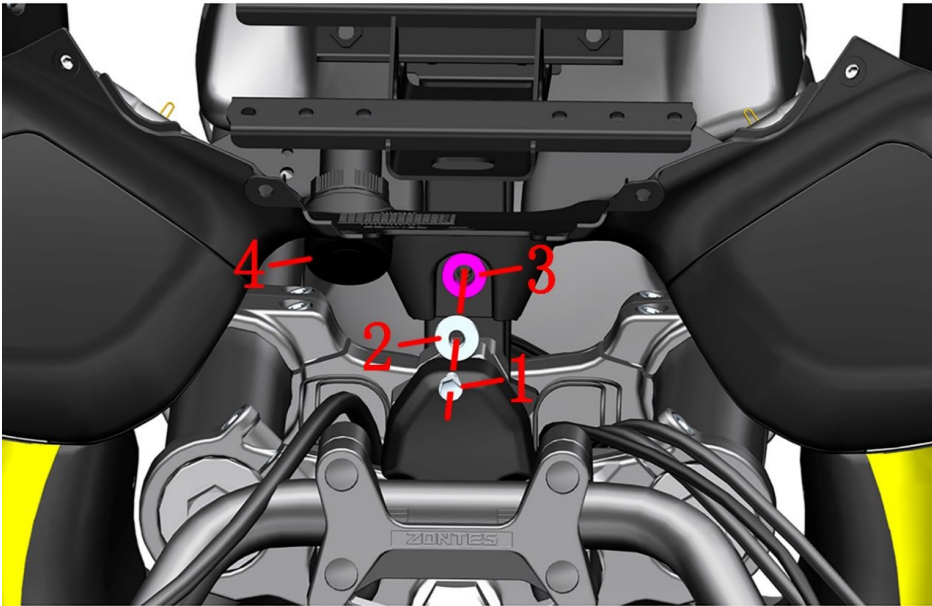
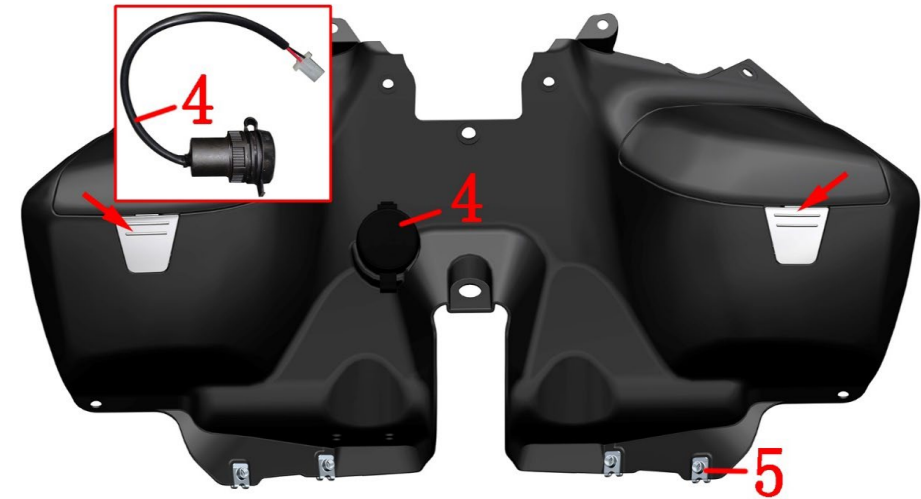
| Fig.21FRONT FORK COMPONENT | | Storage box, rear surrounding components 1 | | CHK | |

- Do not pull the cable directly when pulling the plug.

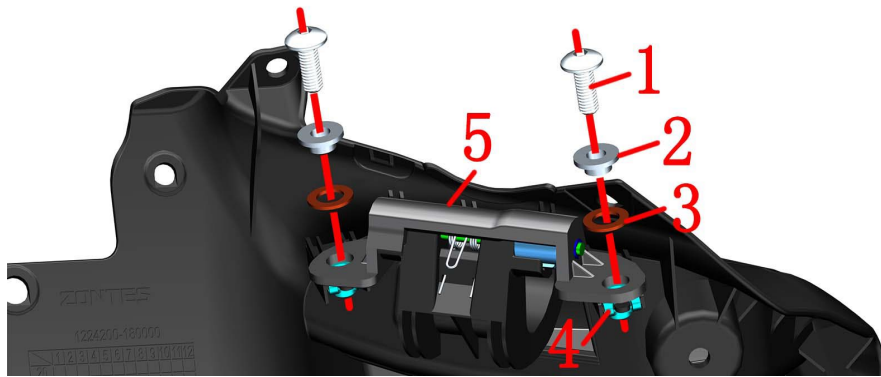
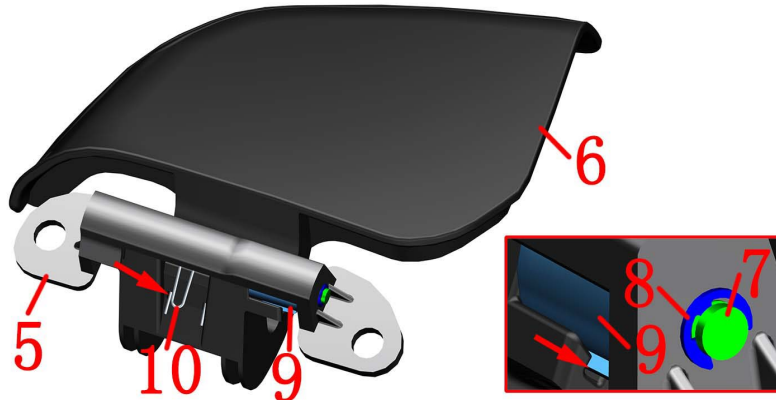
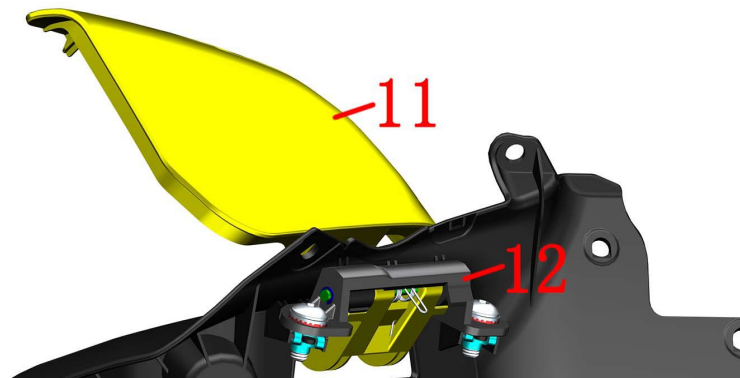
| Fig.22FRONT FORK COMPONENT | | Storage box, rear surrounding components 2 | CHK | CAUTION |

● When reinstalling, make sure that the spring (9) is inserted into the upper hole of the storage box cover; the anti-rotation slot of the damper (8) should be aligned with the storage box cover.

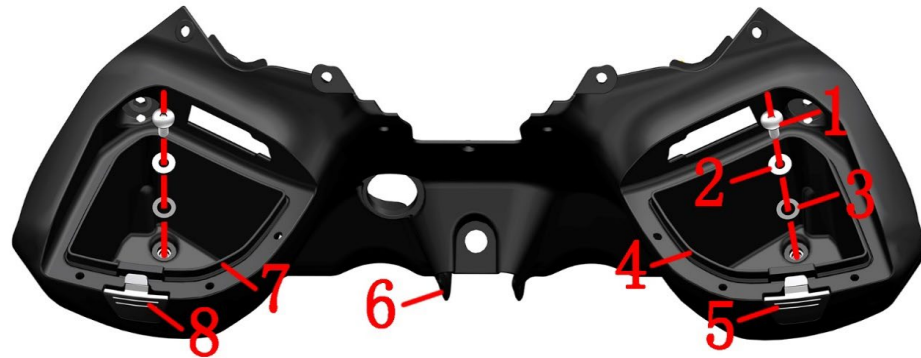
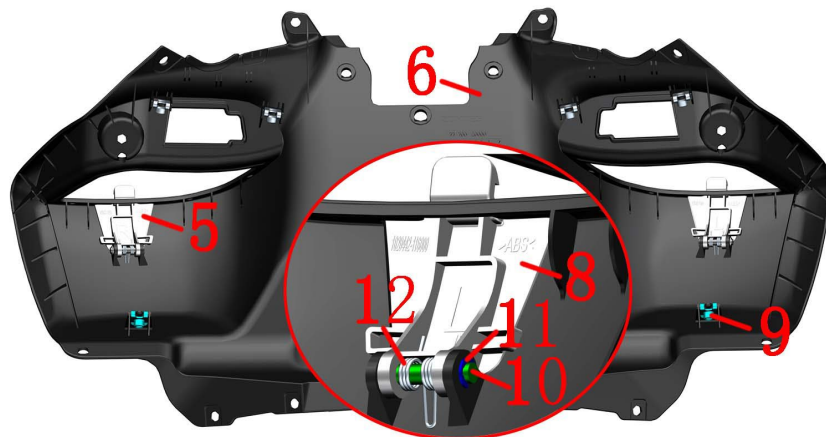
| Fig.23 FRONT FORK COMPONENT | | Storage box, rear surrounding components 3 | | CHK<br>ADJ<br>CAUTION |

Use 4# inner hexagon to remove bolt (1), remove bushing (2) and cushion rubber (3); remove right storage box (4). Remove the left storage box (8) in the same way.

After removing the circlip (11), rotate the pin (10), spring (12) and left switch (8). Use the same method to remove the right switch (5).

● When reassembling, make sure that the spring (12) should be inserted into the hole of the storage box switch.

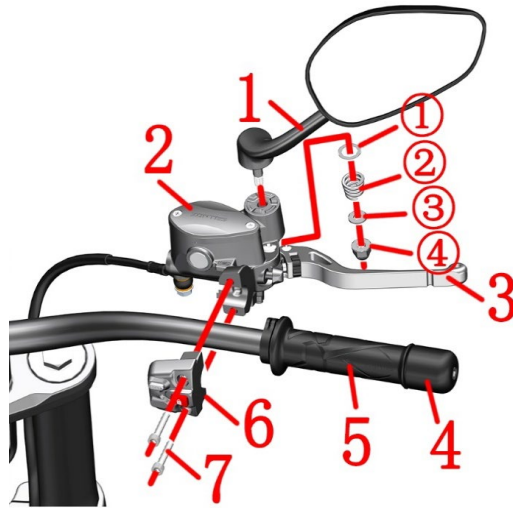
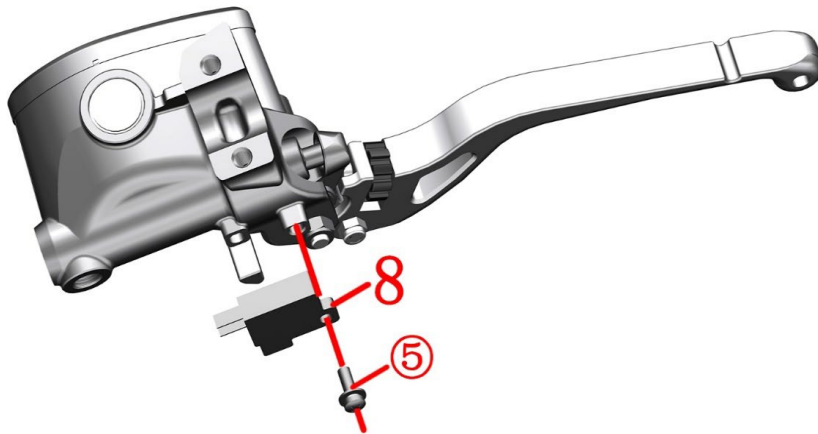
| Fig.24 FRONT FORK COMPONENT | | Right handlebar component | CHK | |

- The motorcycle should be fixed after horizontal support.
- Periodically check that the fluid level of the brake fluid is between 3/4 of the observation window.
- Do not flush the cup directly with high pressure water.
- When assembling the balance block, align the protruding parts at both ends of the shrapnel with the fixing holes on the handle and then insert the direction into the holes.
- The small spacer of the rear view mirror anti-rotation limit slot needs to be aligned with the slot on the mirror bar bolt.
- The right handlebar refers to the switch to replace the throttle line.
- The joint between the front disc brake main pump and the half cover should be aligned with the right hand to match the triangle on the switch.
- The old model will be discontinued; the old switch can be replaced directly with the new one.
