# ZT350-VX (EURO V&EURO +)

Service manual

2025/04/08

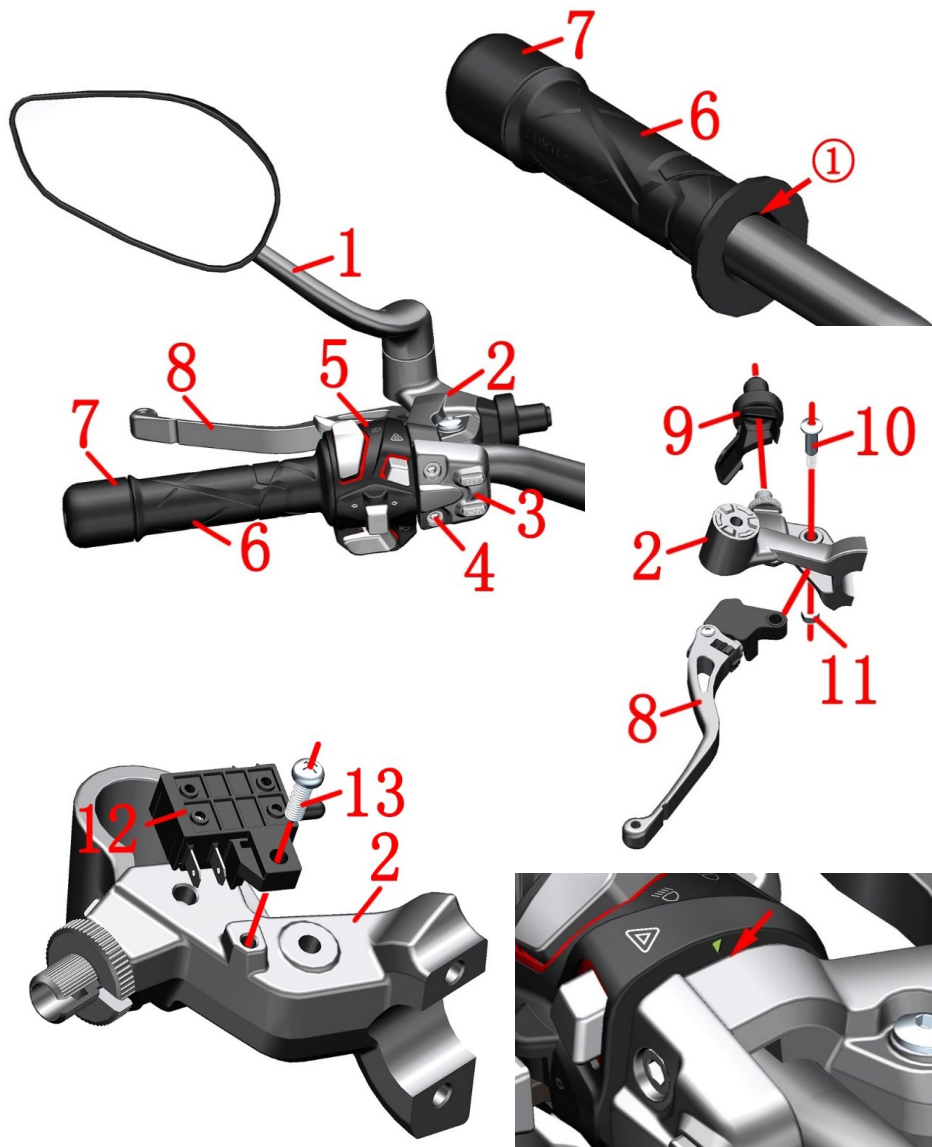
| Fig.25 FRONT FORK COMPONENT | | Left hand component | | CHK | CAUTION |

● Press during reassembly: the left hand grip rubber sleeve - balance block - switch - left hand rocker arm - left rear view mirror. Note the triangle symbol on the rocker arm assembly and the half cover seam alignment switch.

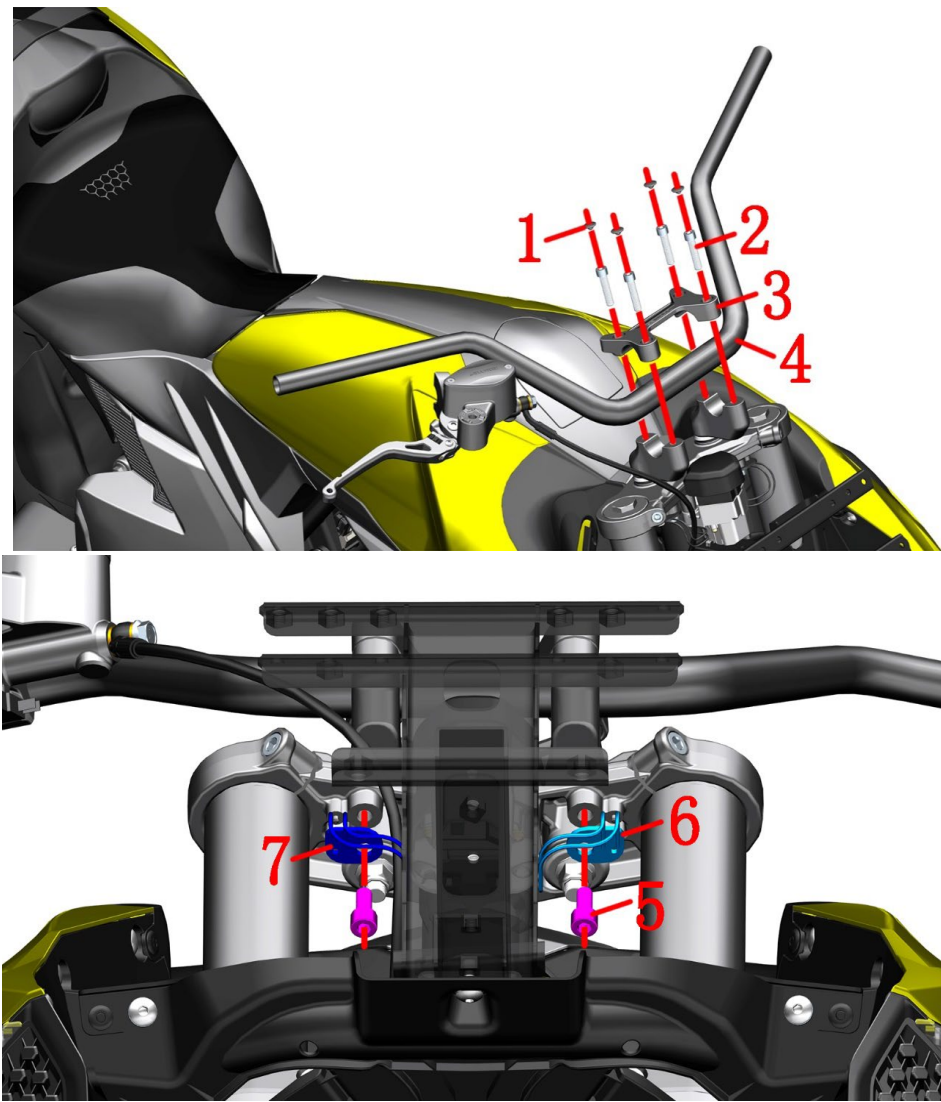
| Fig.26 FRONT FORK COMPONENT | | Direction handle&TFT Instrument | CHK | |

- When assembling the clamping block, please tighten the two bolts at the front first, and then tighten the bolts at the rear (close to the fuel tank side). Wrong sequence or diagonal locking may break the briquette.
- The parts should be protected during the disassembly process to prevent damage to the paint surface.

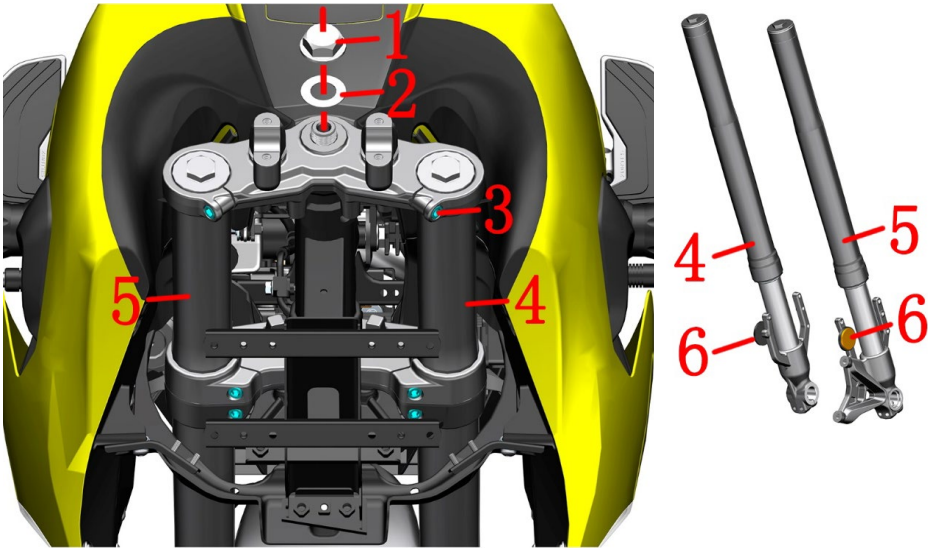
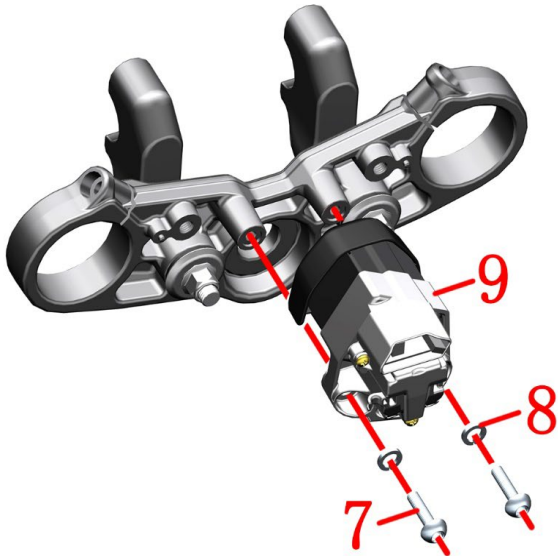
| Fig.27 FRONT FORK COMPONENT | | Front shock absorber, upper plate component | | CHK | |

- Use a flat-blade screwdriver to enlarge the gap between the upper and lower joint plates without applying excessive force to avoid damage.
- The vehicle support should be fixed during the disassembly process to prevent accidents caused by dumping.
- When replacing the main lock,left and right wiring bracket,pay attention to adjust the gap between adjacent parts.
- For the disassembly of the lower board components, see "Steering Adjustment" above, which will not be repeated here.

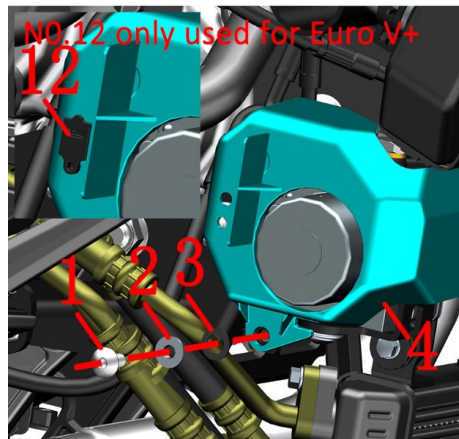
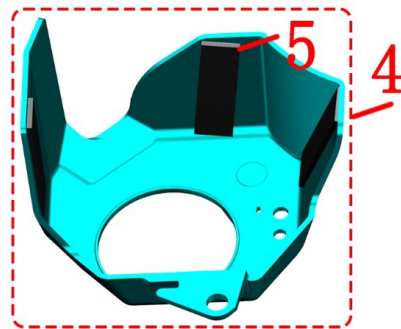
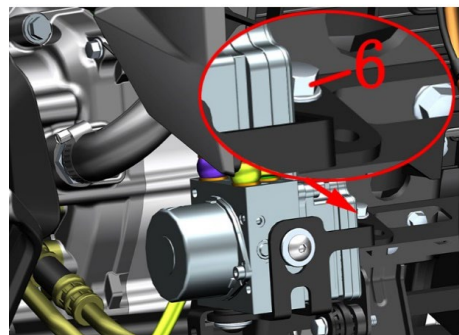
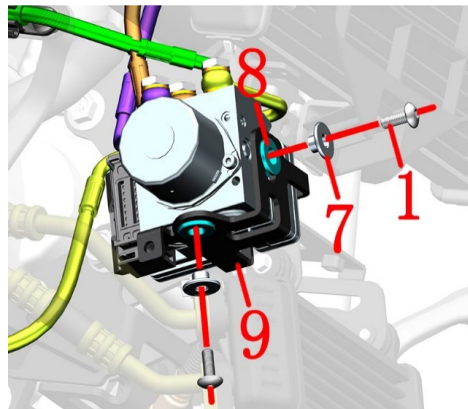
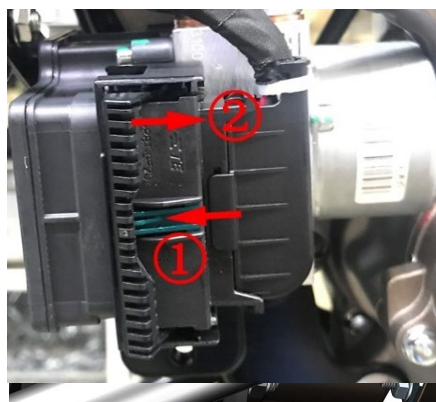
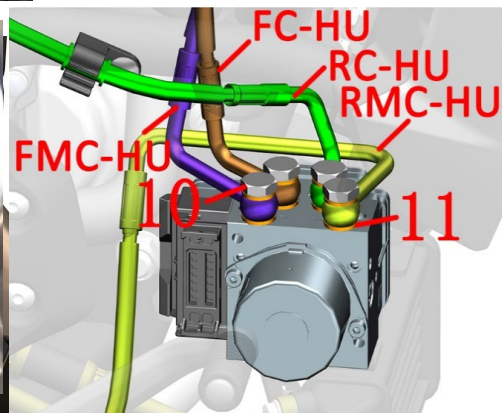
| Fig.29FRONT FORK COMPONENT | | ABS brake system-1 | CHK | |

After wearing waterproof gloves, pull out the hydraulic control unit and tilt it to the right, remove the bolts (10) with a 14# sleeve, take off the copper washer (11) and 4 pcs oil pipes. After draining the brake fluid, remove the hydraulic control unit and wipe off the oil stain. Be careful not to let the brake fluid contact the cable connector to prevent poor contact due to corrosion.

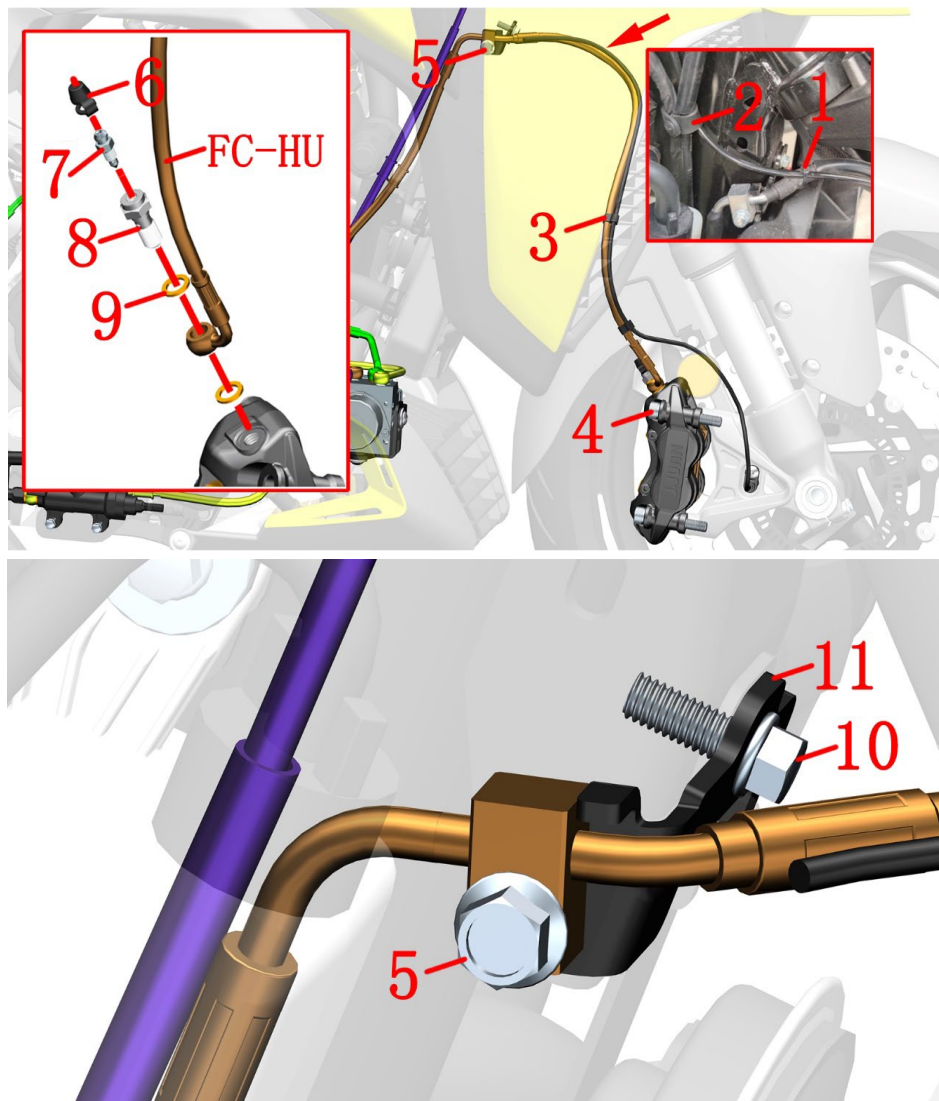
| Fig.30FRONT FORK COMPONENT | | ABS brake system-2 | CHK | |

First uncover the screw rubber cap(6), wear waterproof gloves, then remove the bolt(7) with 8# ring wrench, remove the bolt(8) with 14# ring wrench, and remove the copper washer(9).

Remove the bolt(5) with 10# sleeve,take off the FC-HU oil pipe,It need to replace the 4 pcs copper washers (9) at the same time when replacing the tubing.

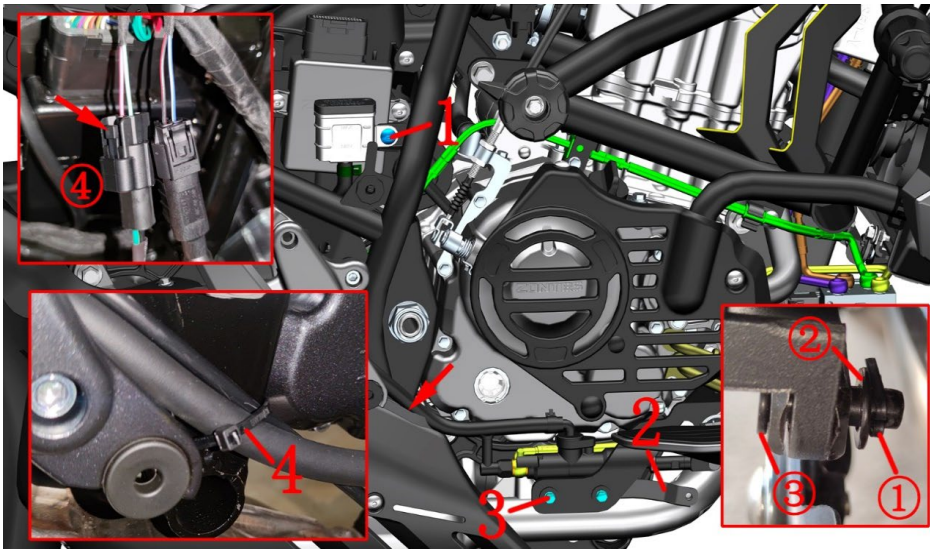
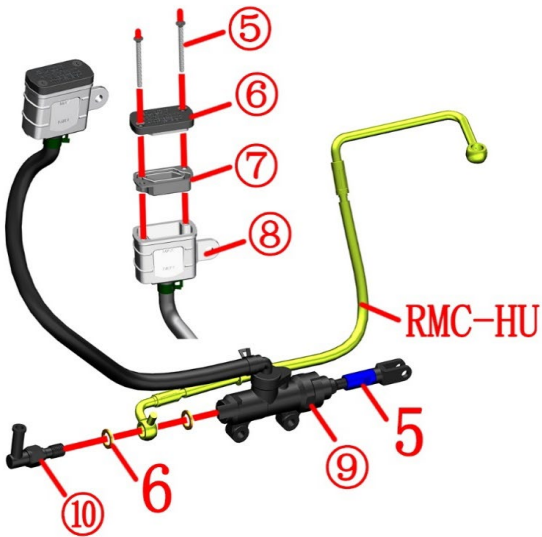
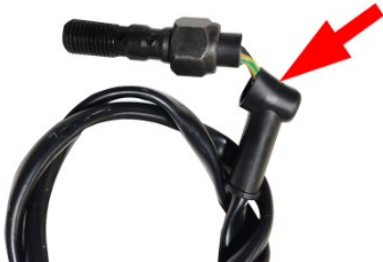
| Fig.31 FRONT FORK COMPONENT | | ABS brake system-3 | CHK | |

After wearing waterproof gloves, remove the bolt ⑤ with a cross screwdriver.

Loosen the rear brake switch nut ⑩ with 14# open-ended wrench and drain the brake fluid. Remove the hoop at the main pump with pliers and pull out the oil pipe. Remove the rear brake switch wire and the copper washer (6). Separate rmc-hu oil pipe and rear disc brake main pump body ⑨.

● It is recommended to replace the two copper washers (6) at the same time when replacing the oil pipe, rear brake switch wire or disc brake main pump.

● The rear brake switch wire is prohibited from rotating the rubber cap at the arrow indication. Replace this switch wire. Be careful not to wrap the cable around the tool.

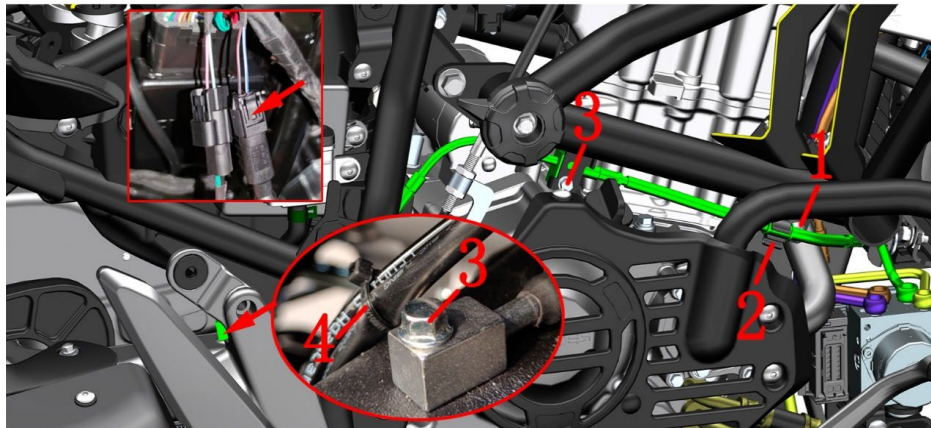
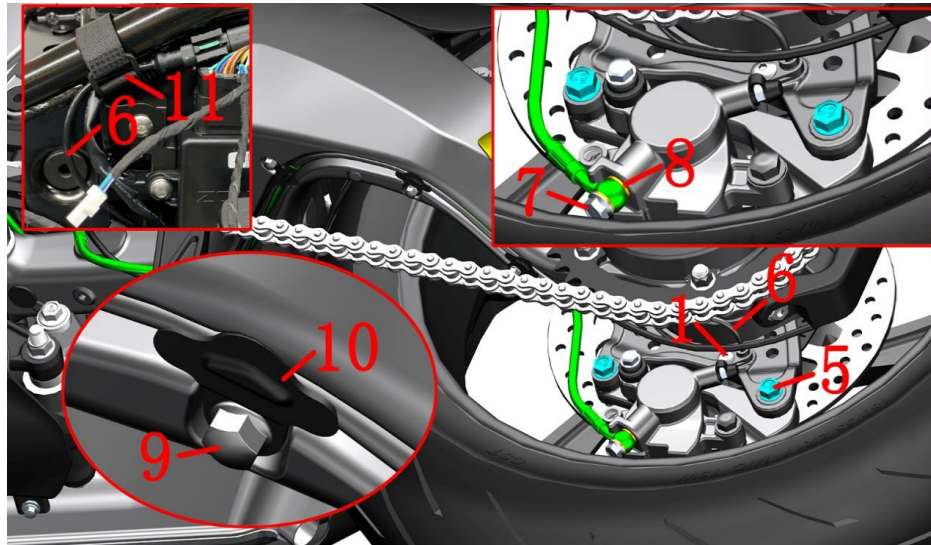
| Fig.32 FRONT FORK COMPONENT | | ABS brake system-4 | CHK | |

In the previous step, release the brake fluid. Loosen the bolt connecting the RC-HU oil pipe and the hydraulic control unit.

After wearing the waterproof gloves, remove the bolt (7) with a 12# sleeve; remove the copper washers (8), if you need to replace the RC-HU tubing, it is recommended to replace the two copper washers (8) at the same time; the bolt (7) can be replaced if they are not damaged.

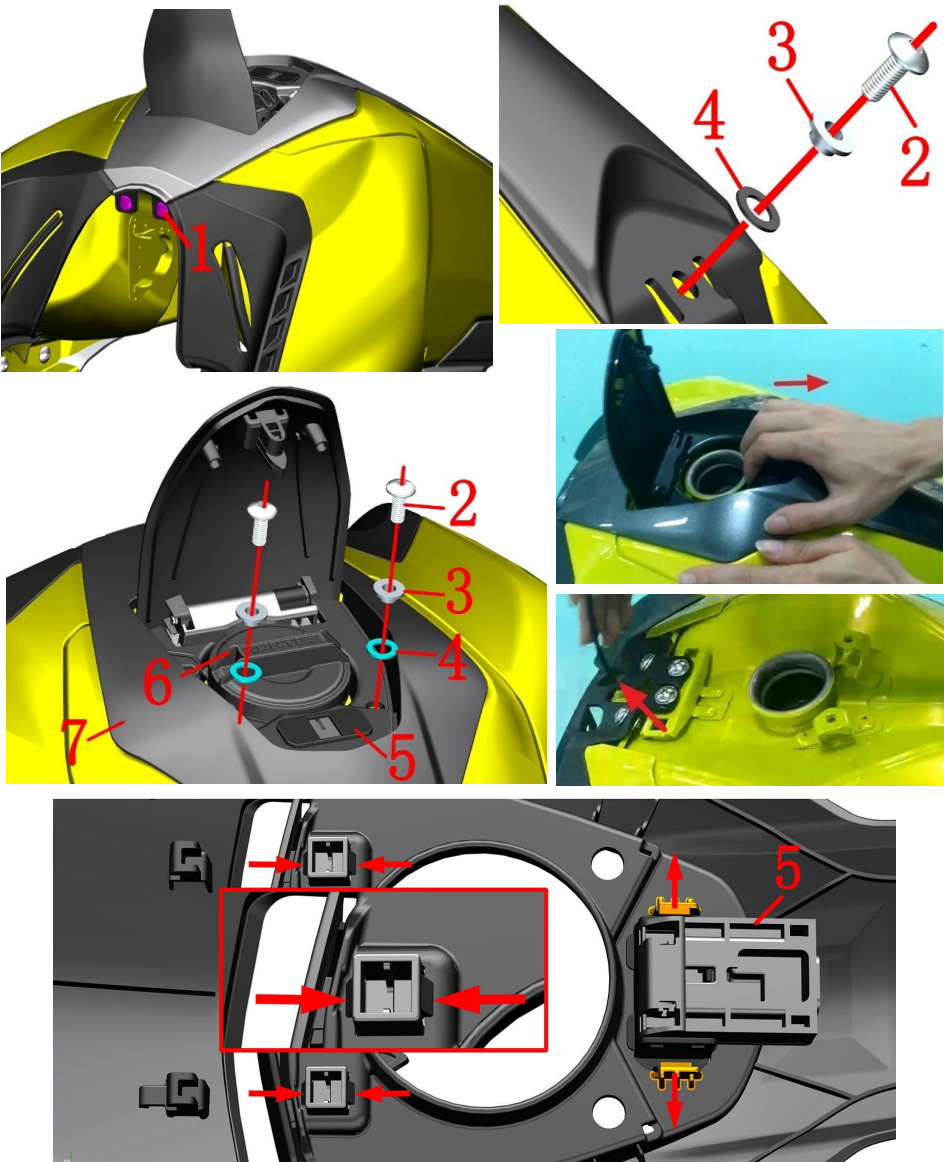
| Fig. 1 FUEL TANK COVER COMPONENT | | Fuel Tank middle cover assembly | | CHK | |

Flip to the back and use a flat-blade screwdriver to carefully open the middle cover (7) to buckle at both ends, remove the fuel tank lock (5), pay attention to the strength to prevent damage to the buckle.

Use a needle-nose pliers to clamp the buckle of the swivel bracket with a little force to clamp, remove the cover assembly, and take care of the strength to prevent damage.

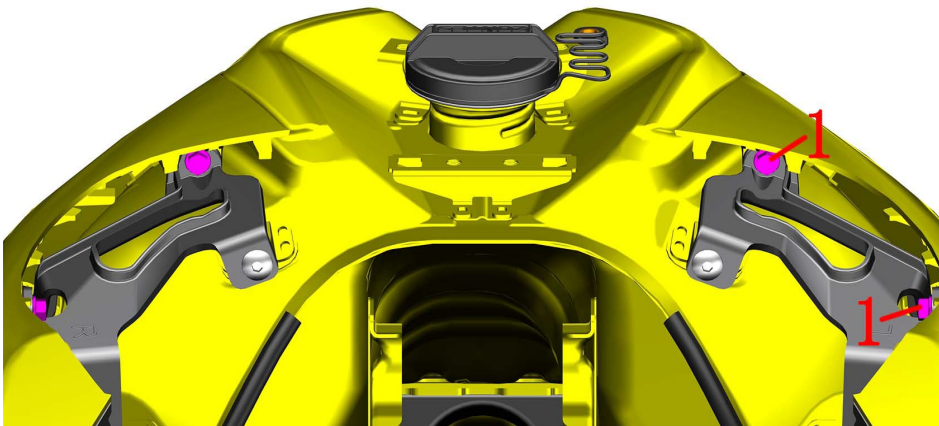
| Fig. 4 FUEL TANK COVER<br>COMPONENT | | Fuel tank trim cover assembly 1 | CHK | |

Remove the expansion nail(2) at the lower right decorative cover(3). Pull out the rear and middle of the lower right decorative cover; move it back to remove the lower right decorative cover. Pay attention to the card on the head that is inserted into the fuel tank decorative cover and cannot be pulled out directly.

Remove the lower left decorative cover (4) according to the above steps.

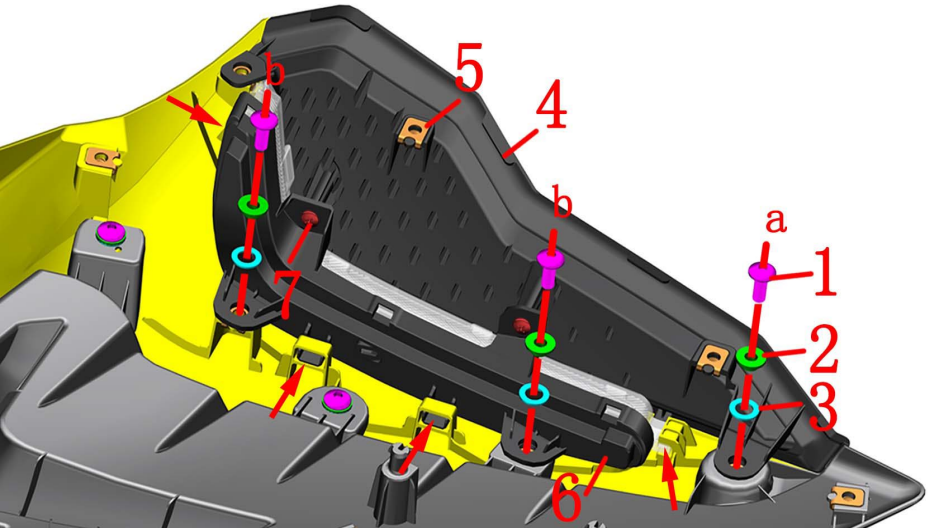
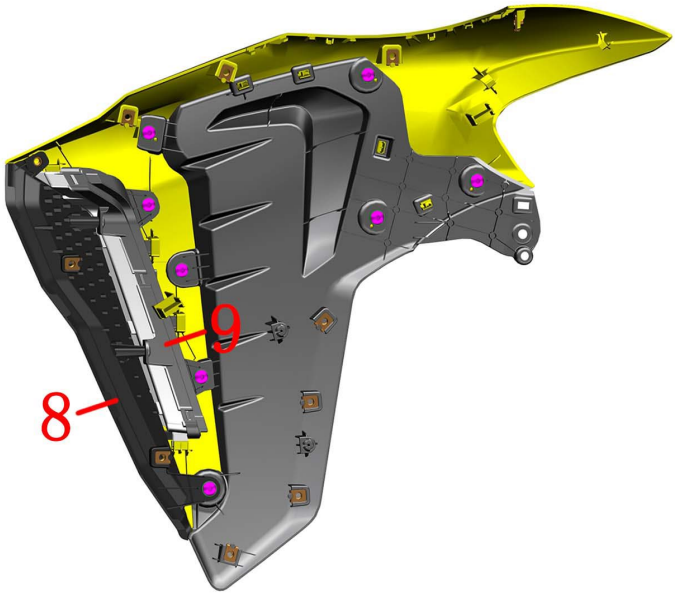
| Fig. 7 FUEL TANK COVER COMPONENT | | Fuel tank trim cover assembly 4 | | CHK | |

Use a 4# inner hexagon to remove the bolt (1) at a, and remove the bush (2) and the cushion rubber (3). Loosen the bolt (1) with a 4# inner hexagon socket b and remove the 2 self-tapping screws (7) with a cross screwdriver. Remove the left grid (4) of the decorative cover. Remove 2 pieces of splints (5) from the left grid (4).

- The parts should be protected during the disassembly process to prevent damage to the paint surface.
- When removing the buckle, pay attention to the strength to prevent damage to the buckle.
- When recovering, the screw (7) should make the screw axis perpendicular to the installation surface, and can not be tightened too tightly to prevent damage to the pin on the grid.

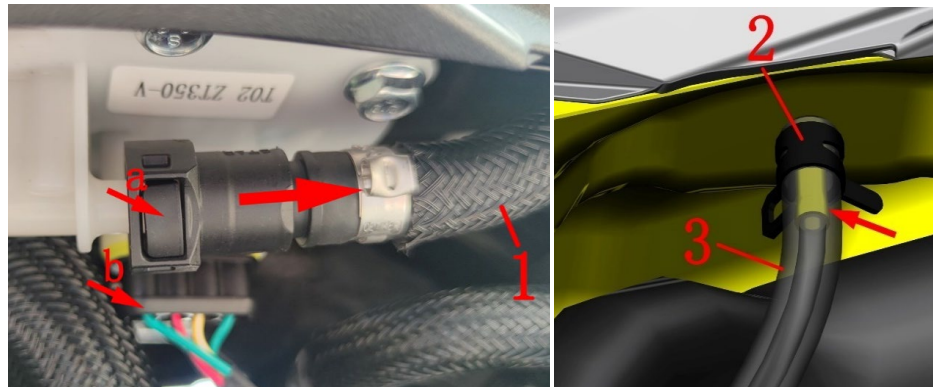
| Fig. 9 FUEL TANK COVER COMPONENT | | Fuel tank assembly | CHK | CAUTION |

Place the oil pan on the left side under the high pressure oil pipe (1), and press the limit buckle at the direction indicated by the arrow "a" at the same time, pull out the axial direction of the big arrow to the rear of the vehicle, and pay attention to the radial force so as not to damage the oil pump outlet.

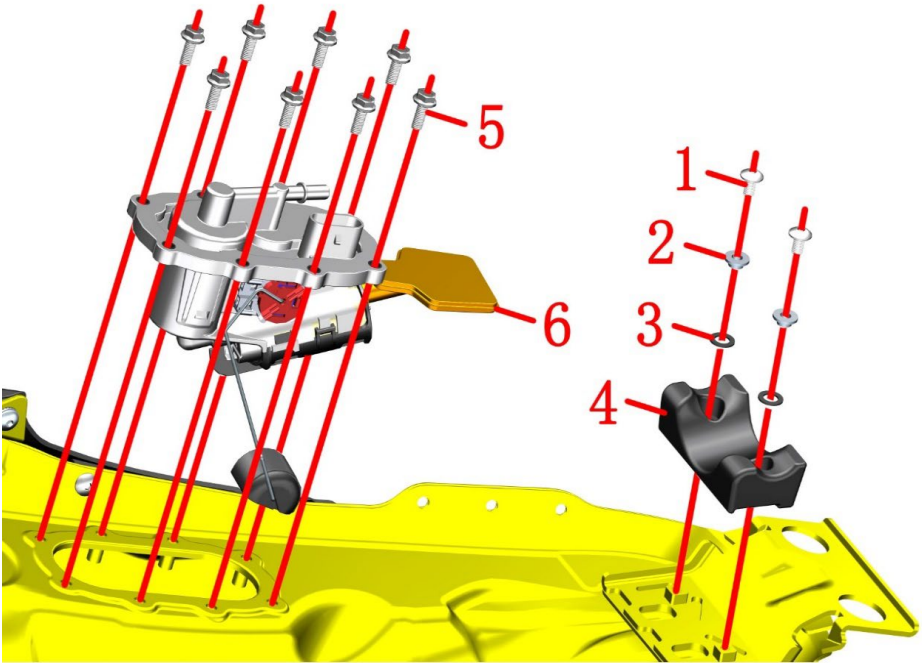
| Fig. 11 FUEL TANK COVER COMPONENT | | Oil pump | CHK | |

When the fuel pump (6) is removed, the float connecting rod cannot be bent to avoid inaccurate oil display.  
After removing the fuel pump, it is recommended to temporarily seal the oil pump port to prevent something falling into the tank.

● When reassembling the fuel pump, be sure to clean the joint surface of the fuel pump sealant and the tank liner. When locking the bolt, the position should be locked to ensure uniform deformation of the seal gasket.

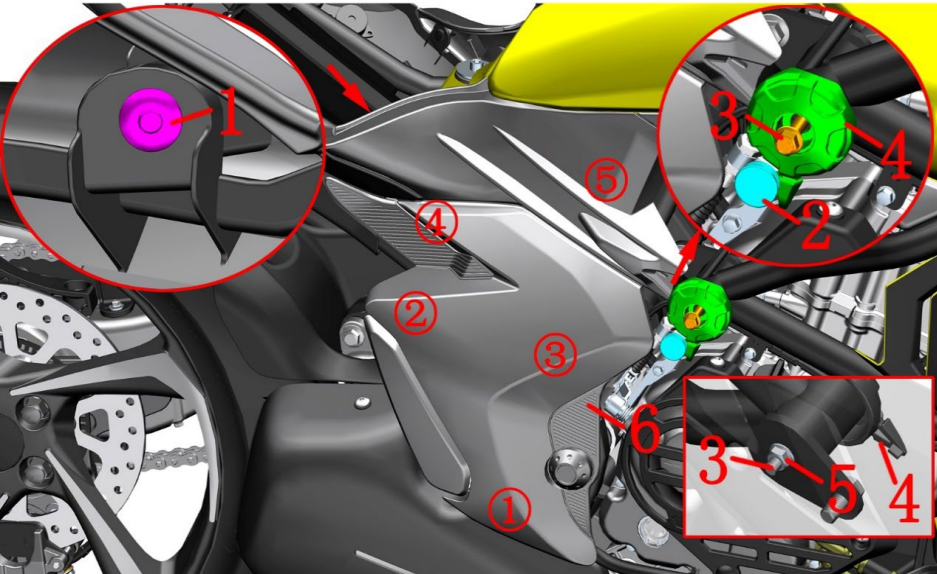
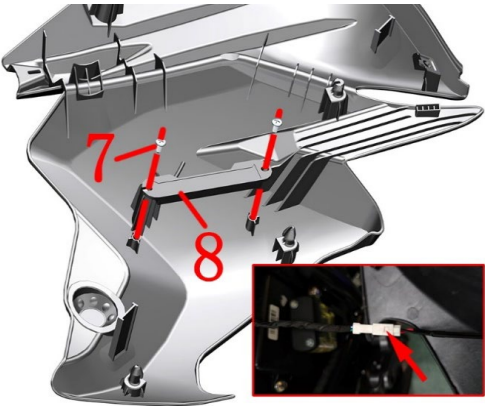
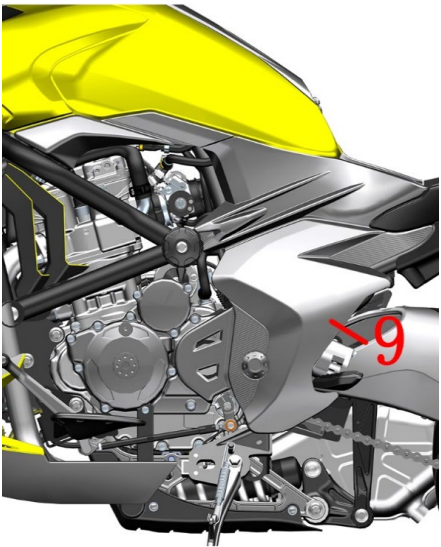
| Fig.1 SIDE COVER COMPONENT | | SIDE COVER COMPONENT | CHK | |

Remove the seat cushion first, and then remove the expansion nails (1) at the connection between the right side cover (6) and the rear cover. Remove the waterproof rubber plug (2), after holding the nut (5) with 13# plug wrench then using a 12# sleeve to loosen the bolt (3) by 5 threads, without completely removing it. Pull out the decorative ball (4) and rotate it clockwise to stagger the groove on the right side cover. Pull out the right side cover in the order of ①-②-③-④-⑤. Turn the right side cover component over to the back, find the plug of the induction antenna, pull it off and remove the right side cover component. Remove 2 pcs screws(7) then take off the antenna(8).

●When inserting, install the staples by⑤-④-③-②-①; finally install the expansion screw.

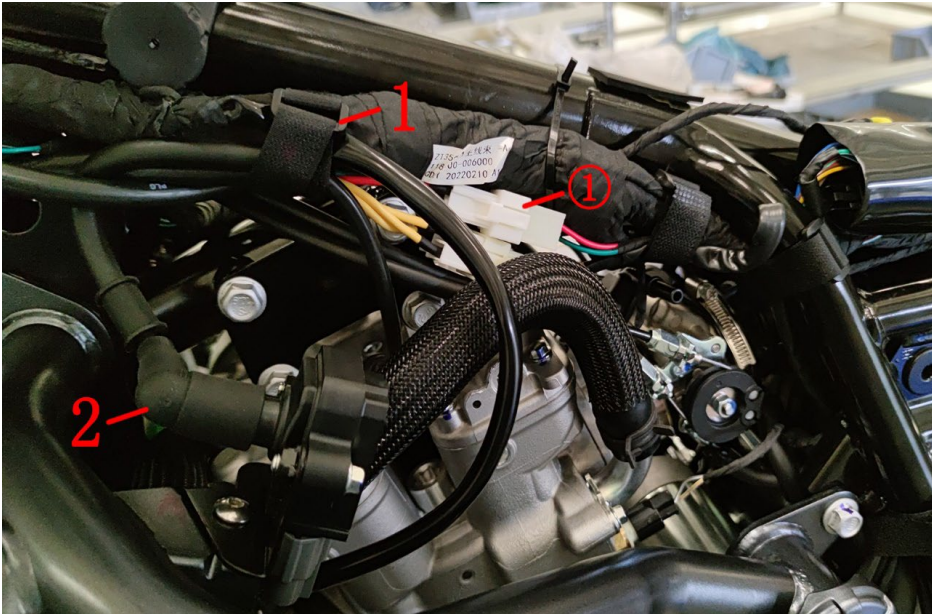
| Fig.2 GUARD BAR COMPONENT | | Guard bar assembly 2 | CHK | |

- Remove the cable tie(1)) and unplug the two plugs of the rectifier(1). Pull out the rubber cap of the high-voltage wire(2).
- Use a 14# sleeve to fix the head of the bolt (4) on the left side and remove the nut(3) with a 14# sleeve, and remove the auxiliary water tank bracket.
- Use a 14# sleeve to fix the head of the bolt (6) on the right side and remove the nut (5) with a 17# sleeve.
- After grasping the left and right guard rail assemblies, use a 14# sleeve to remove 2 bolts (7), and then remove the left and right guard guard assemblies after removing the bolts (4).

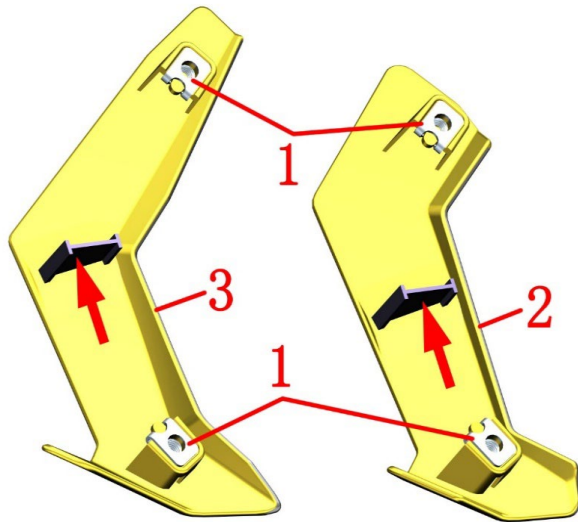
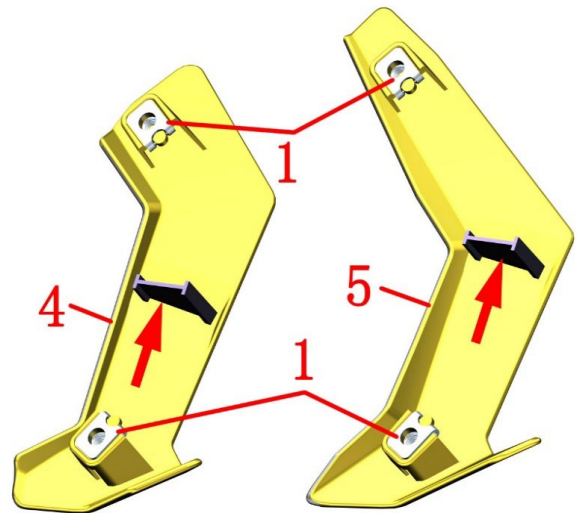
| Fig.4 GUARD BAR COMPONENT | | Engine decorative cover components | | CHK<br>ADJ<br>CAUTION |

- Protect the engine decorative cover paint to prevent scratches.
- Before replacing the engine decorative cover, check whether the clip indicated by the arrow has been cut short,if not, cut it first and then assemble it on the bumper.

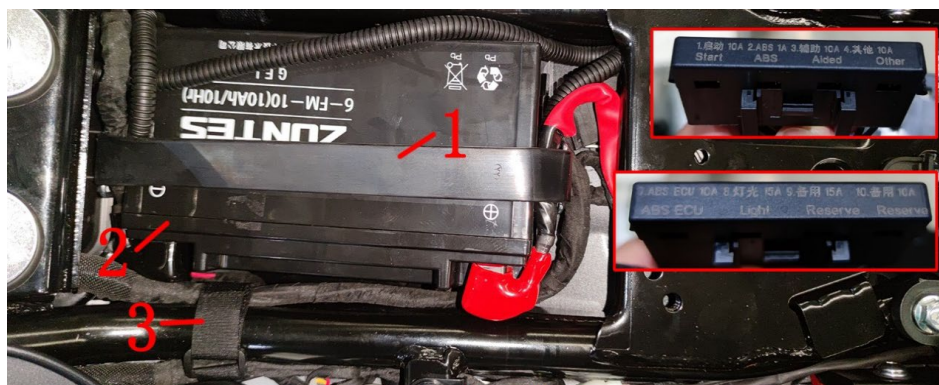
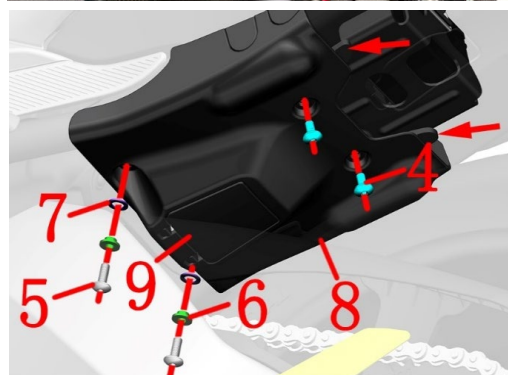
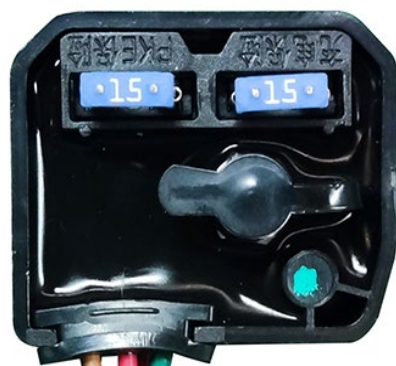
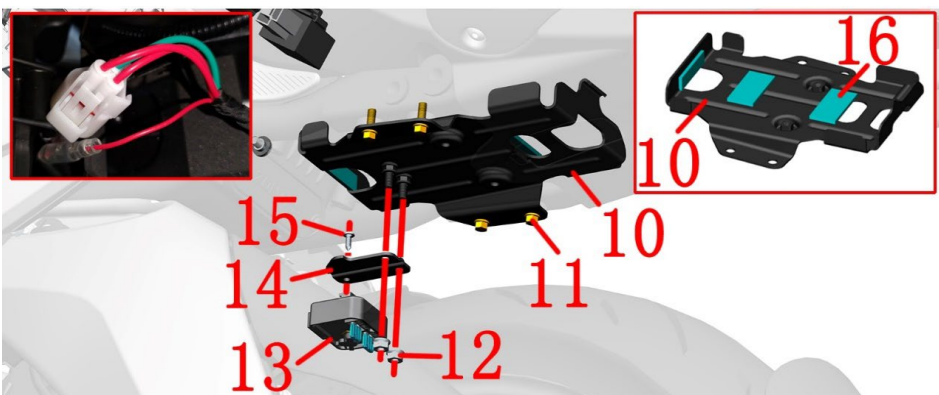
| Fig.1 REAR COVER COMPONENT | | Battery component | | CHK | CAUTION |

Pull the battery strap (1) pull down to loosen the metal buckle, remove the battery strap (1), unplug the black negative protective cap of the main wiring harness, and remove the bolts that come with the battery with a cross. Remove the battery negative wire first, and then remove the positive wire, then the battery(2) can be removed.

● Reassemble the battery or fuse, etc. Remember to reset the EFI hardware: Turn on the key-Ignition- 10 seconds After the ignition is turned off - After 10 seconds Turn on the ignition switch and repeat 2 times.

● When the vehicle does not ride for a long time or the battery feed fails to start, remove the lower cover (9), open the rubber plug and insert the original standard charger DC plug. Then plug the AC socket into the 110-220V power supply. If the battery is damaged due to the use of inferior chargers, it is not within the scope of the Three Guarantees.

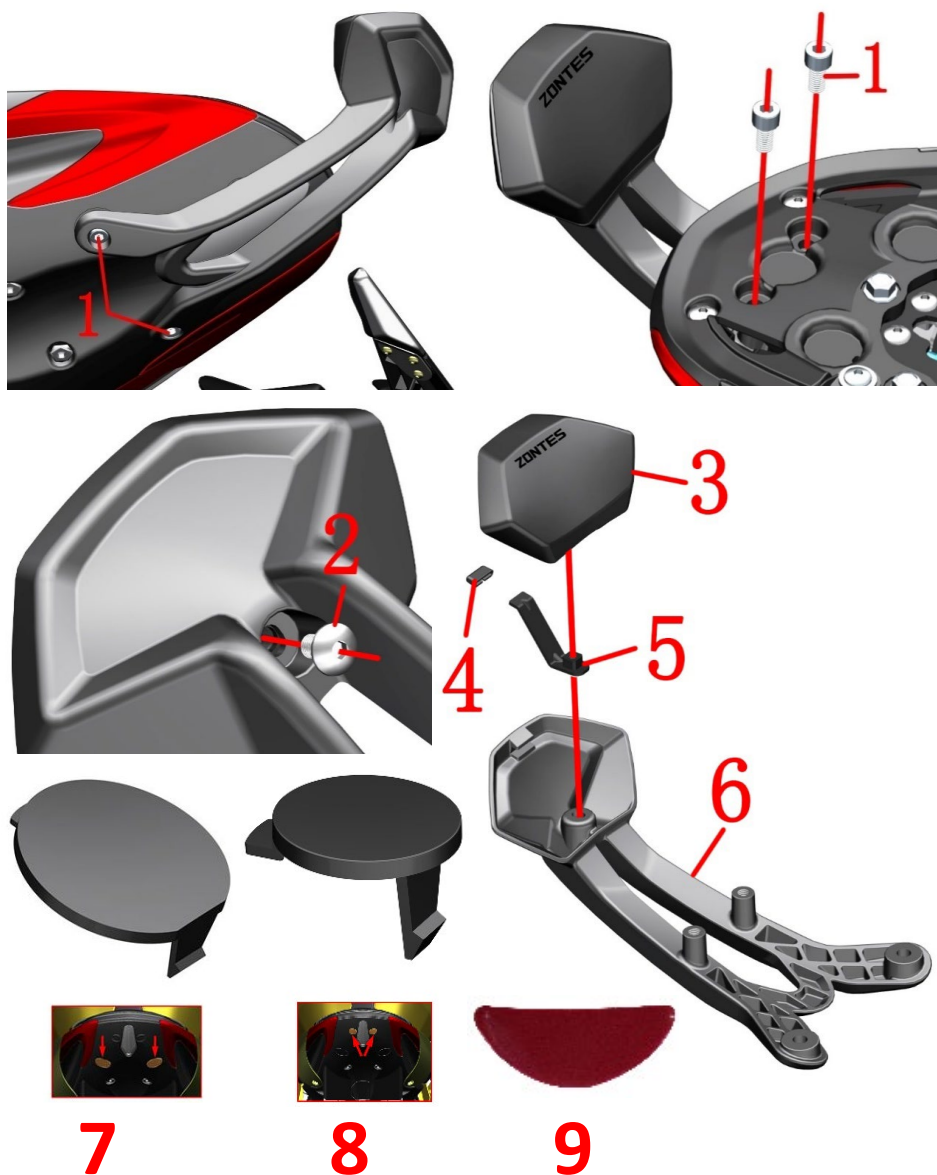
| Fig.2 REAR COVER COMPONENT | | Backrest assembly component | | CHK<br>ADJ | CAUTION |

● Remove the side cover, seat cushion, and cover decoration cover in advance.

● The material should be protected during discomponent to prevent damage to the paint.

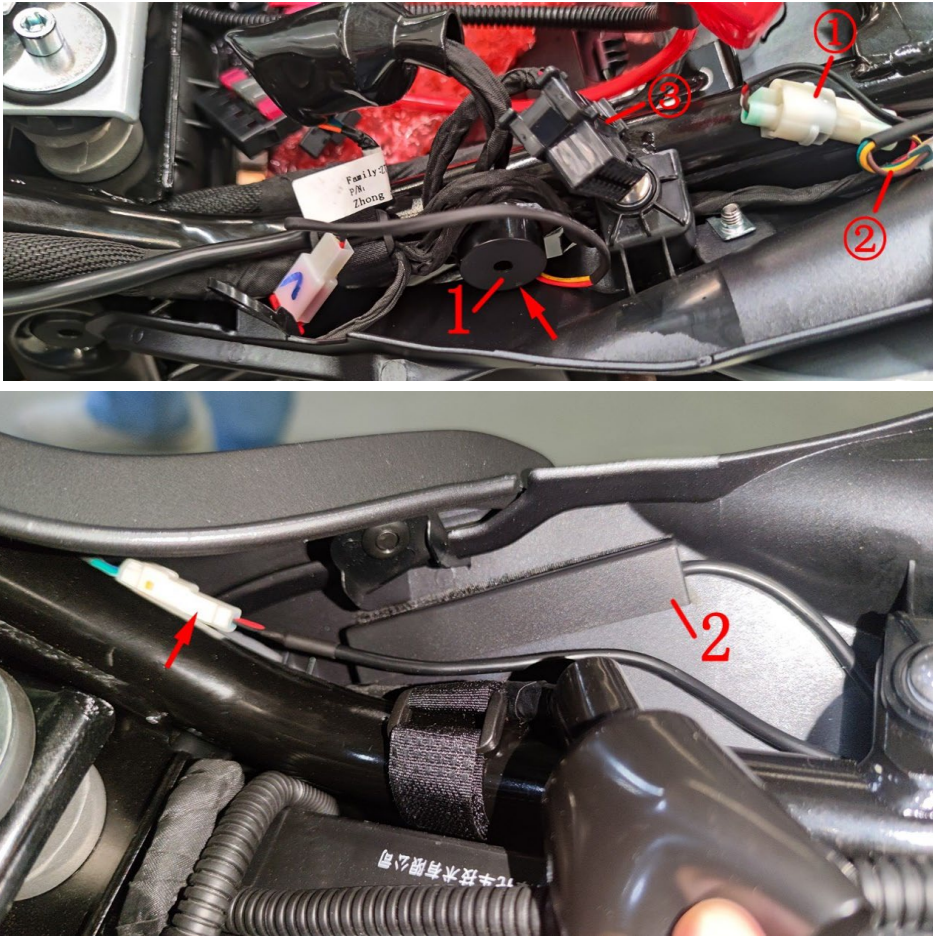
| Fig.3 REAR COVER COMPONENT | | Tail skirt taillight component 1 | | CHK | |

- Do not pull the cable directly when unplugging the plug.

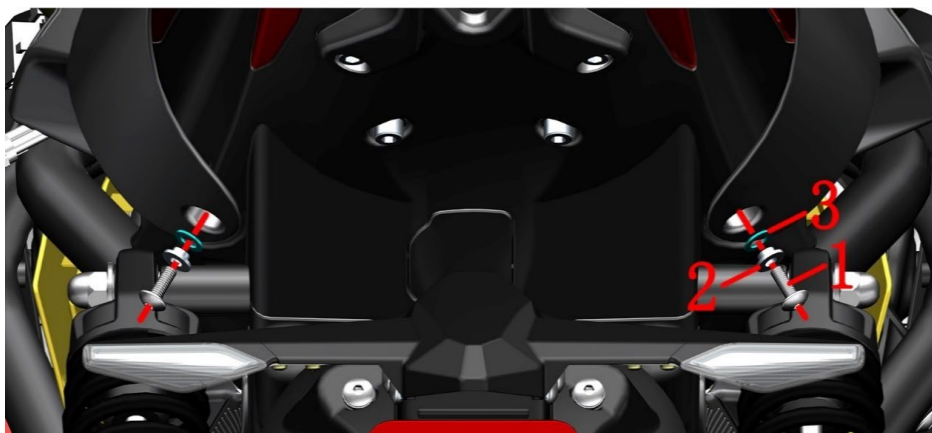
| Fig.4 REAR COVER COMPONENT | | Tail skirt taillight component 2 | | CHK | CAUTION |

● The old model uses M6×16 bolt + GB96.1  $\phi 6$  + flanging bushing buffer glue + muffler anti-ironing board bushing 2 pieces of structure. Buy 2 pieces " 1251100-375000 Hexagon socket head screw M6×16+ 8.5×5 SUS302 " instead to reduce assembly steps.

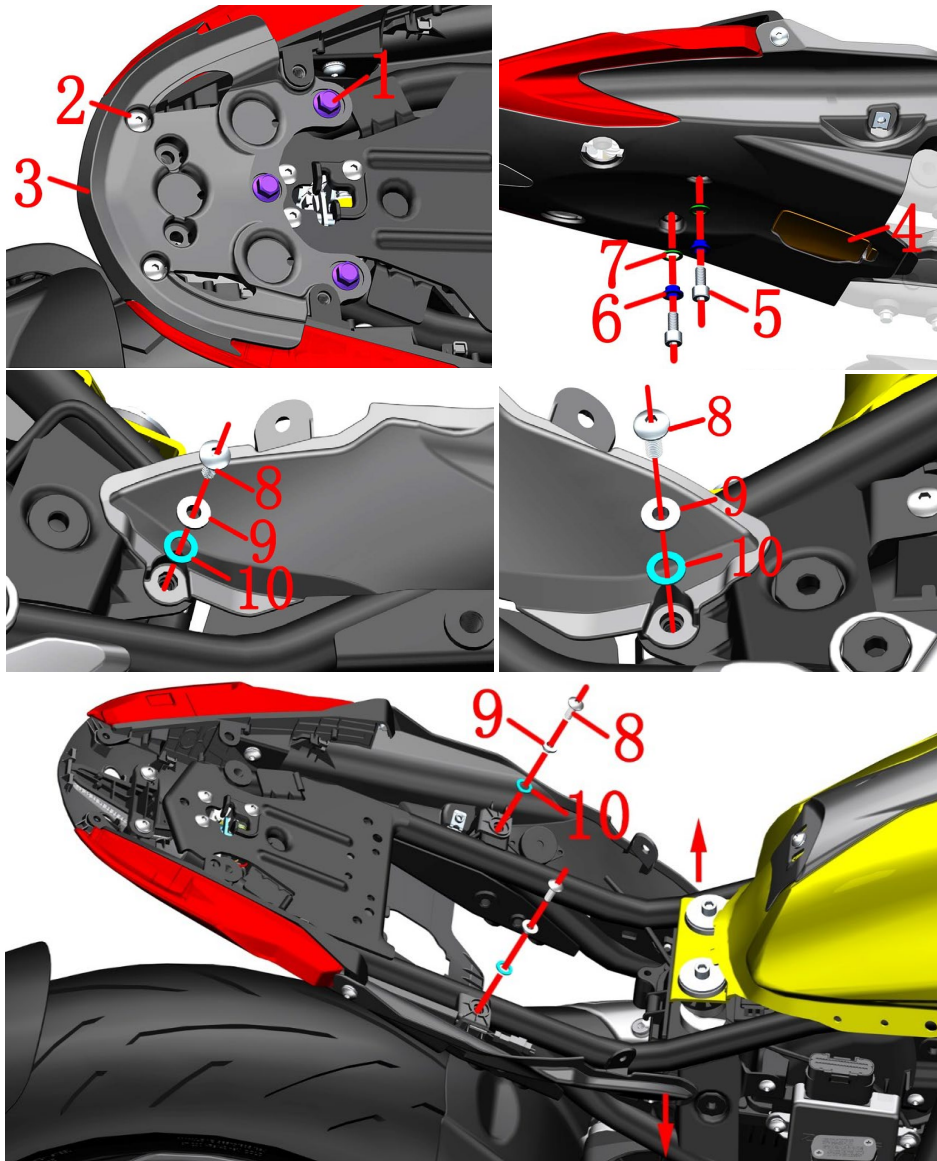
| Fig.5 REAR COVER COMPONENT | | Tail skirt taillight component 3 | | CHK | CAUTION |

- The material should be protected during discomponent to prevent scratching the lamp.
- Never pull the cable directly.

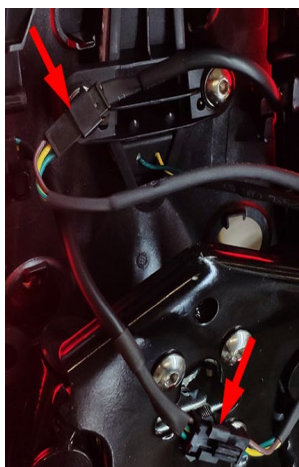
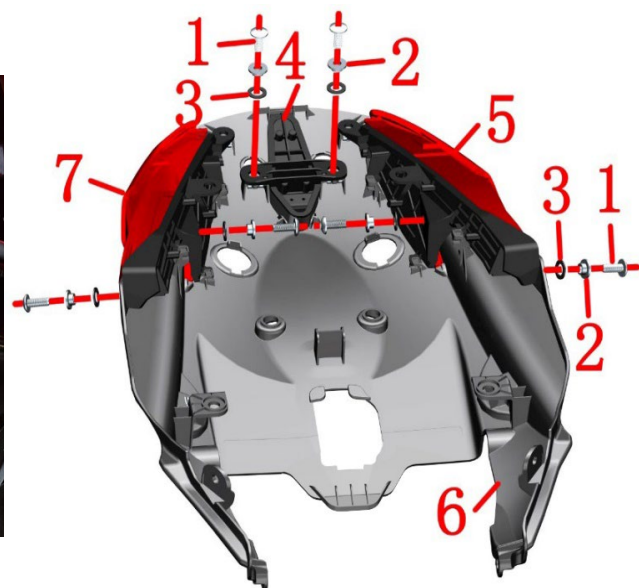
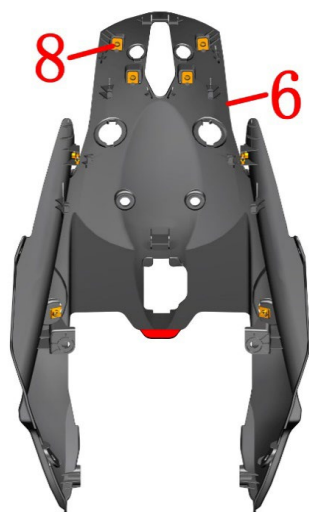
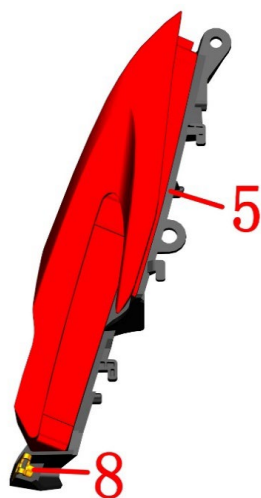
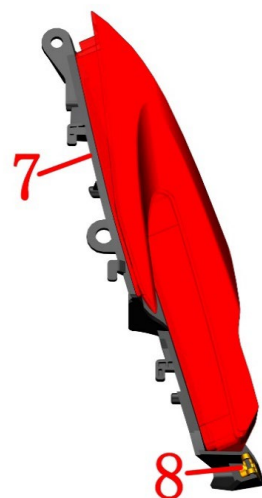
| Fig.6 REAR COVER COMPONENT | | Tail skirt taillight component 4 | | CHK | CAUTION |

- The material should be protected during discomponent to prevent scratching the lamp.
- Never pull the cable directly.

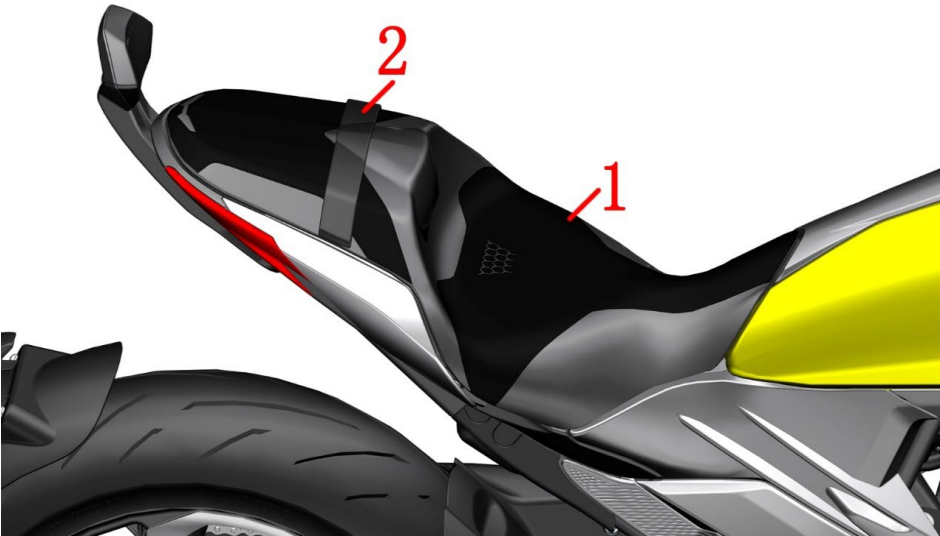
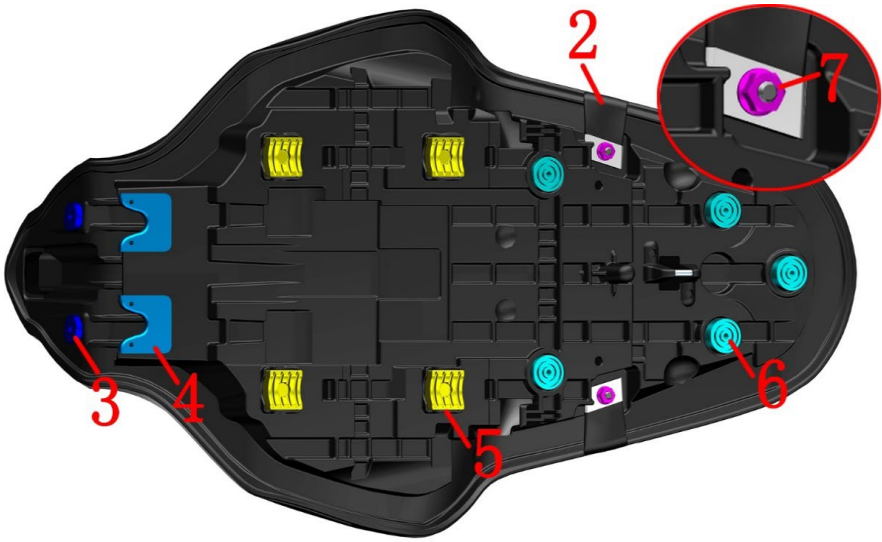
| Fig.1 CUSHION COMPONENT | | Cushion component | | CHK | |

- The motorcycle should be fixed before operation.
- Cushion(1) contains all cushion rubber and the seat belt,nuts.
- Cushion can cause accidents if it is not installed properly.

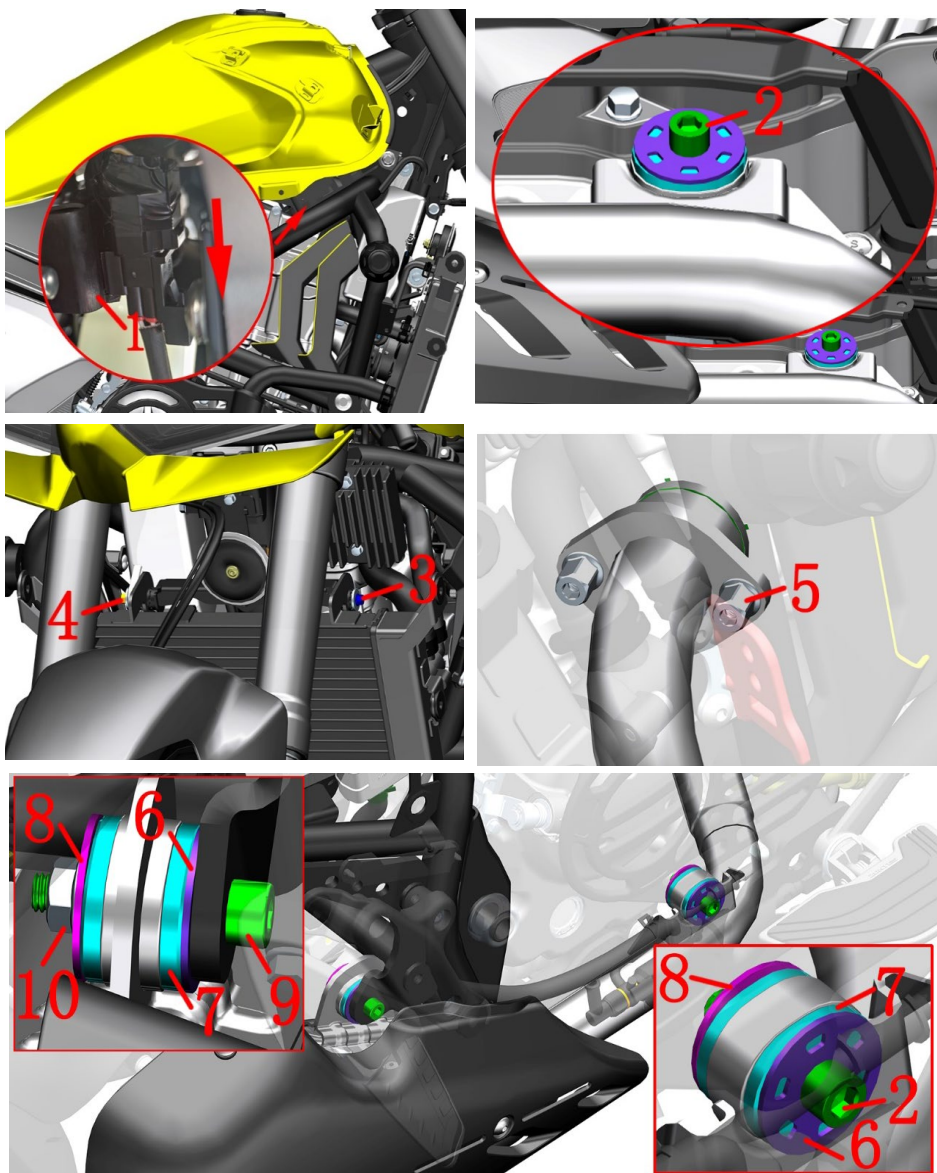
| Fig.1 MUFFLER COMPONENT | | Muffler component 1 | CHK | |

Remove the radiator grill referring to "Radiator grill" in the chapter on cooling system components. Refer to the fuel tank assembly to remove the fuel tank trim cover assembly. Loosen the bolts (3) and (4) on both sides of the main water tank with an 8# sleeve, push the radiator assembly forward to expose 2 pieces of nuts (5), and then remove them with a 6# inner hexagon.

- The material should be protected during disassembly to prevent damage to the paint.
- The muffler should be completely cooled before it is disassembled.
