# ZT350-VX (EURO V&EURO +)

Service manual

2025/04/08

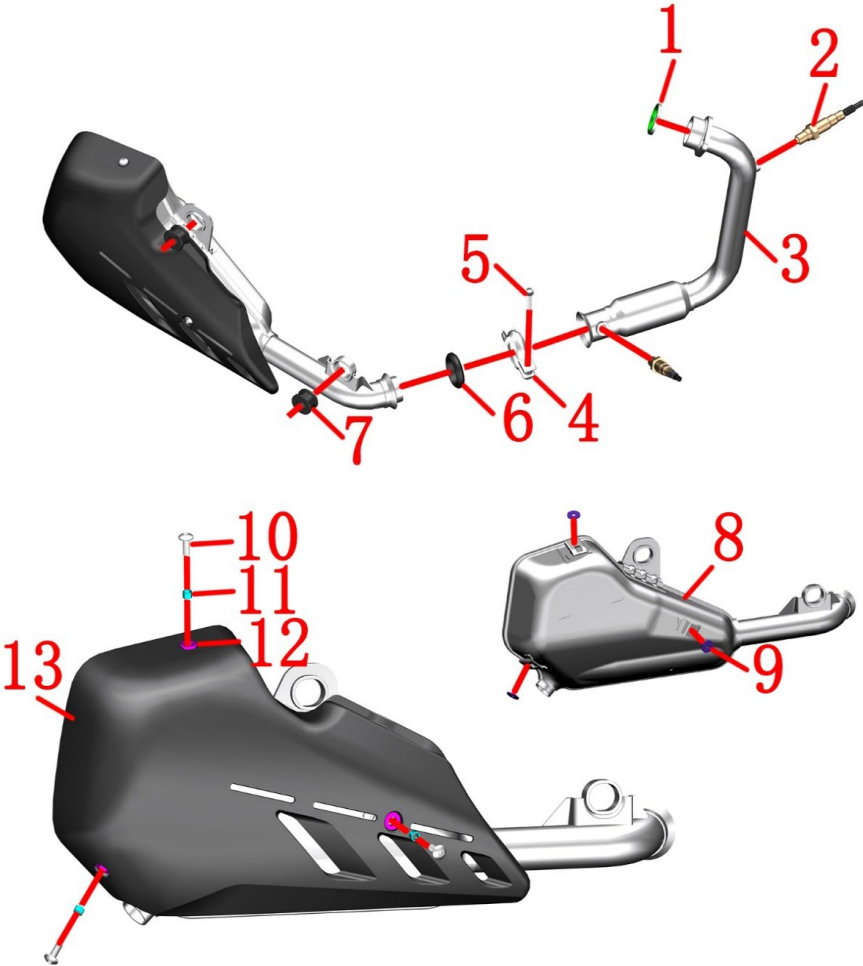
| Fig.3MUFFLER COMPONENT | | Muffler component 3 (Eruo V+) | | CHK<br>ADJ | |

- The muffler should be completely cooled before it is disassembled.
- Prevent foreign matter from entering the interior of the muffler.
- It is recommended that new seals be replaced each time the muffler front assembly is removed to prevent airleakage.

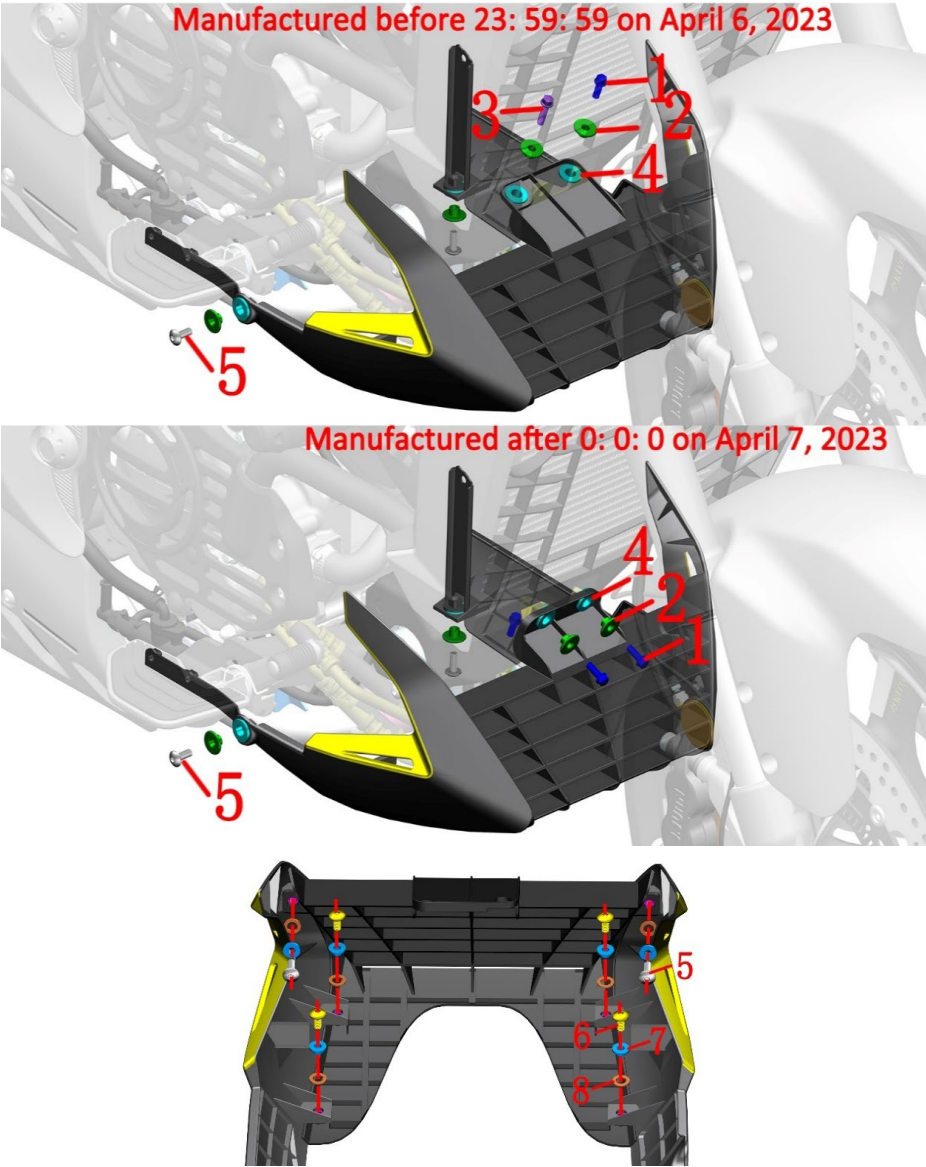
| Fig.1 LOWER SHROUD COMPONENT | | Lower shroud component-1 | | CHK | |

- The motorcycle support should be fixed during disassembly to prevent accidents caused by incline.
- The shroud should be supported during disassembly to prevent fracture due to uneven force.

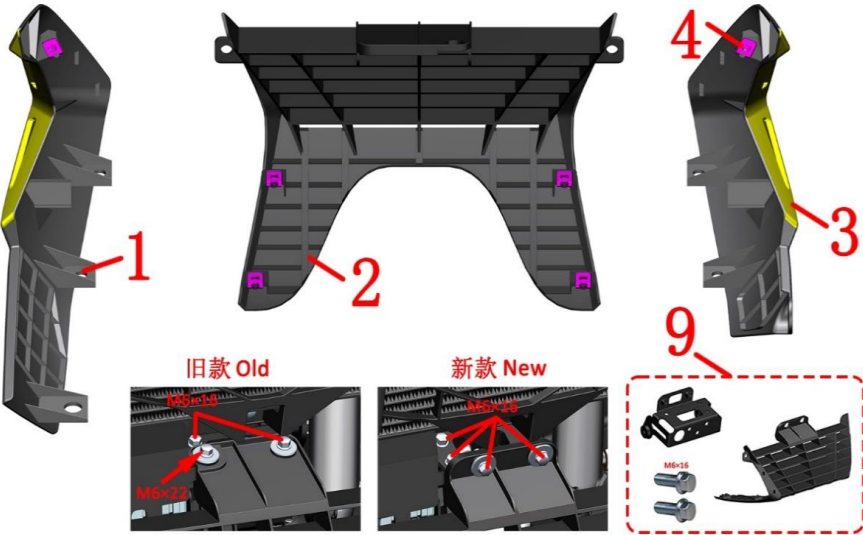
| Fig.2 LOWER SHROUD COMPONENT | | Lower shroud component 2 | | CHK | |

- The shroud should be well protected during disassembly to prevent breakage or paint scratches caused by uneven force.
- The old model is manufactured before 23: 59: 59 on April 6, 2023 and the new model starts at 0: 00 on April 7. The old model can not be interchanged,the old model if you need to replace the middle or bracket need to buy " 40443-02-526000ZT 350-V 1 lower middle shroud after-sales kit", otherwise can not be installed.
