ZT350-S (EURO V&EURO V+)

Service manual

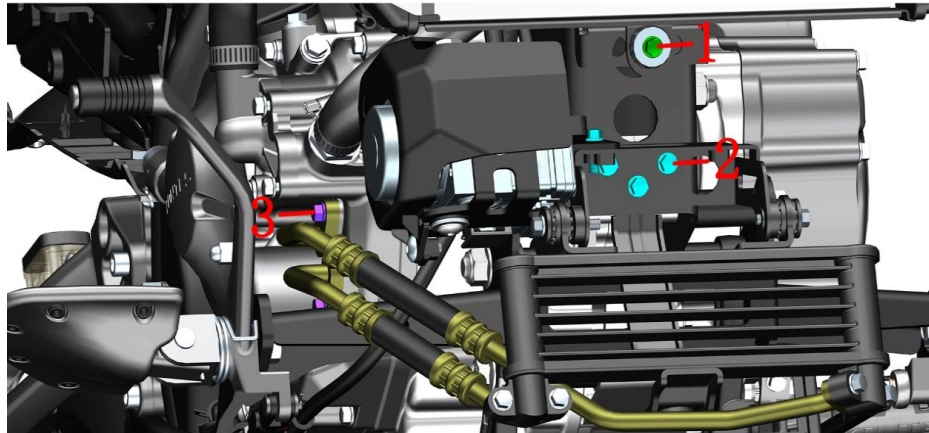
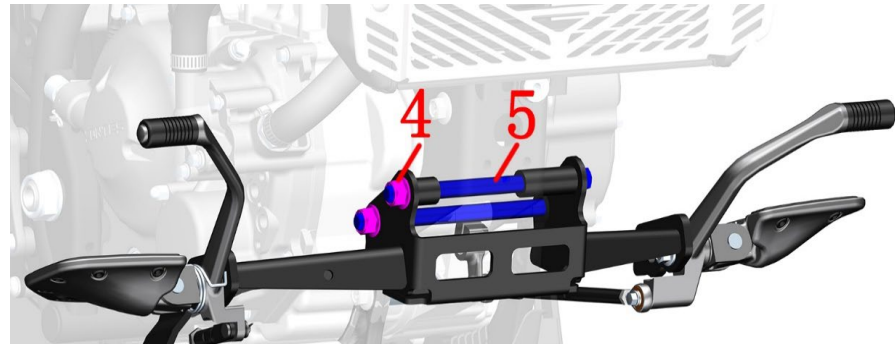
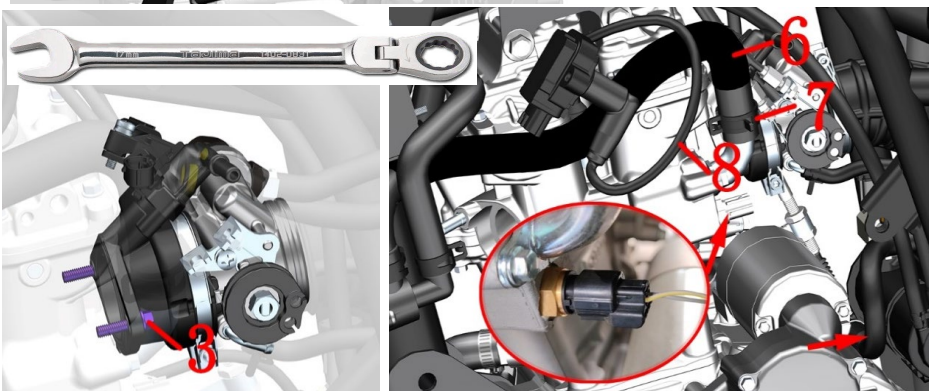
| Fig.3 FRAME&ENGINE | | FRAME&ENGINE 2 | | CHK | |

It is recommended to cover the front pedal support with waterproof and oil-resistant plastic cloth, and then remove the two bolts(3) on the right side with 8# sleeve and pull out the two oil pipes.

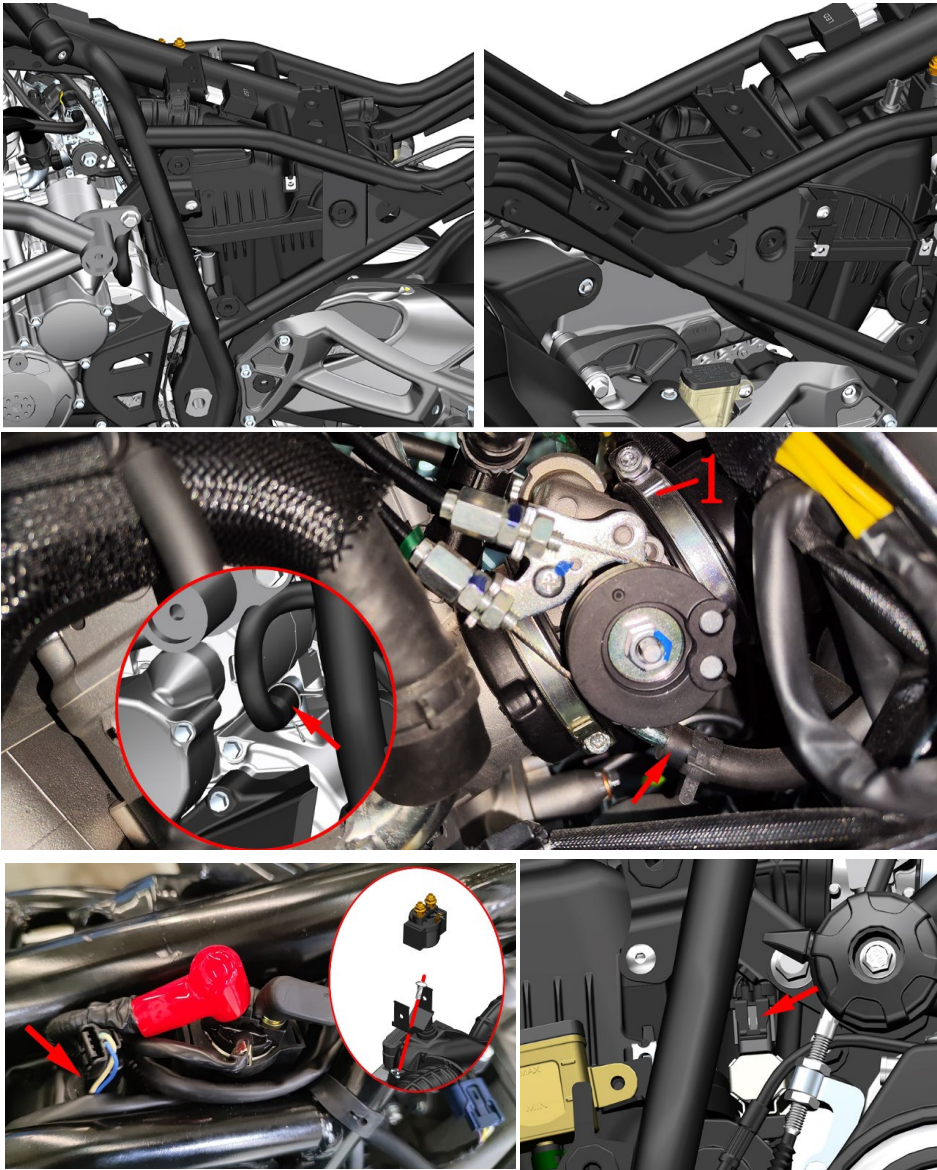
| Fig.1 INTAKE SYSTEM COMPONENT | | Air filter components 1 | CHK | |

Unplug the desorption tube and exhaust tube on the left side. After loosening the clamp (1), pull out the air outlet pipe from the throttle valve body.

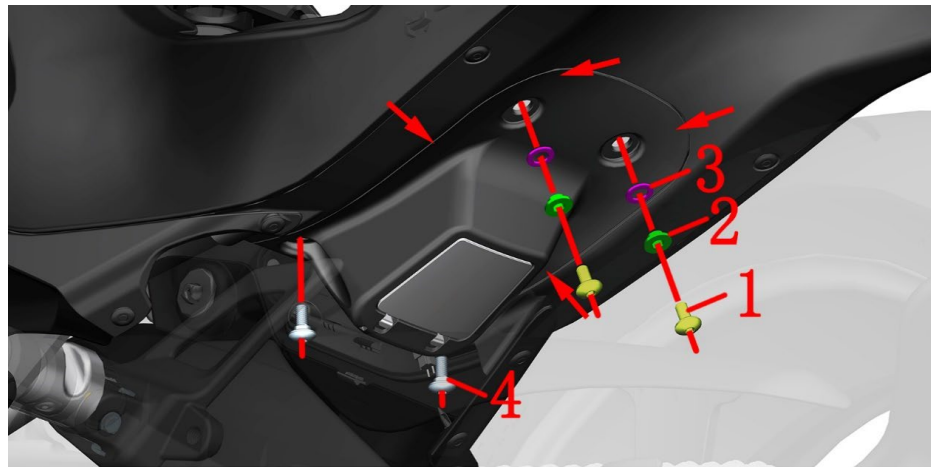
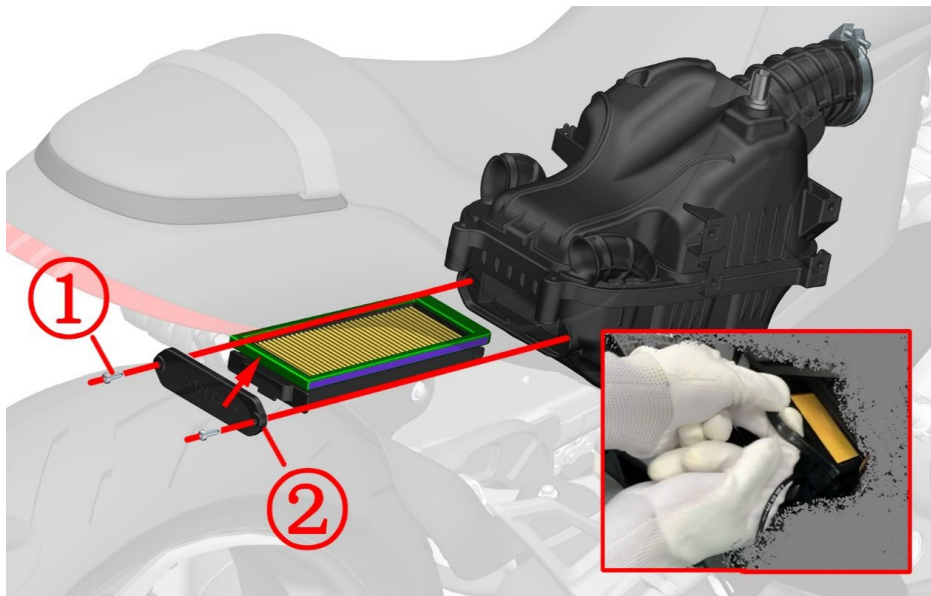
| Fig.4 INDUCTION SYSTEM COMPONENT | | Replace the air filter element | CHK | |

- The sealing ring must be assembled in place. Leakage or assembly may not cause dust to enter the engine. In severe cases, the internal parts of the engine may be damaged.
- Note that the torque should not be too large when locking the Phillips bolt to prevent damage to the parts.
- When flushing the vehicle, be careful not to allow water to enter the air filter. If a small amount enters, remove the oil pipe and release it. Make sure that there is no water inside the air filter to start the vehicle.

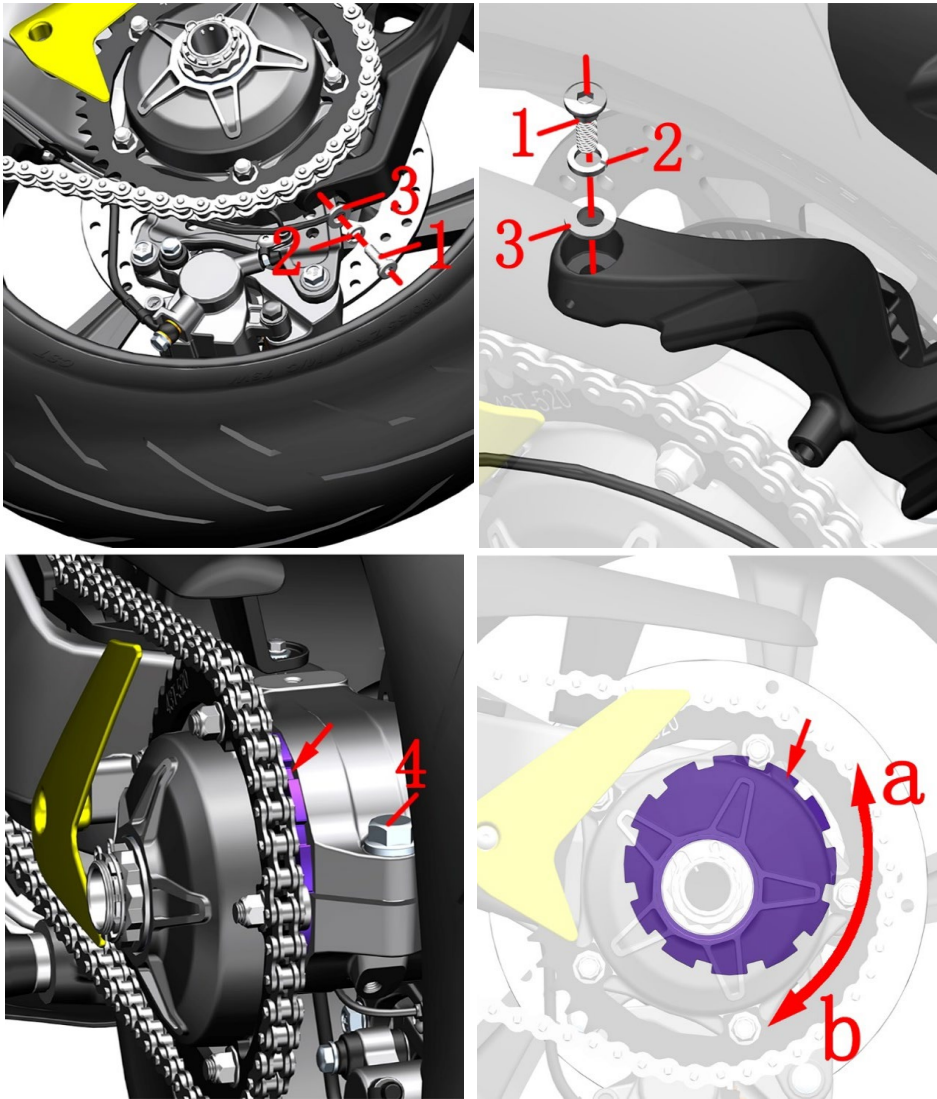
| Fig.1 Rear wheel, swinging arm assembly | | Adjustment chain | CHK | |

Use a 21# sleeve to loosen the bolt (4).

Use a special hook wrench to turn the eccentric chain adjuster at the arrow indication. The counterclockwise direction is to tighten the chain, and the clockwise b direction is loose.

The chain sag is 18~25mm. If it is too large, it will cause the chain to be accidental or damage the engine. If it is too small, it will aggravate the wear of the chain and sprocket.

- The upper bolt can only be removed after holding the rear mud plate assembly; Do not pull the cable
- The torque of the bolt (4) is 100N.m.
- The chain must be checked regularly for excessive wear; the chain should be cleaned and properly lubricated regularly.

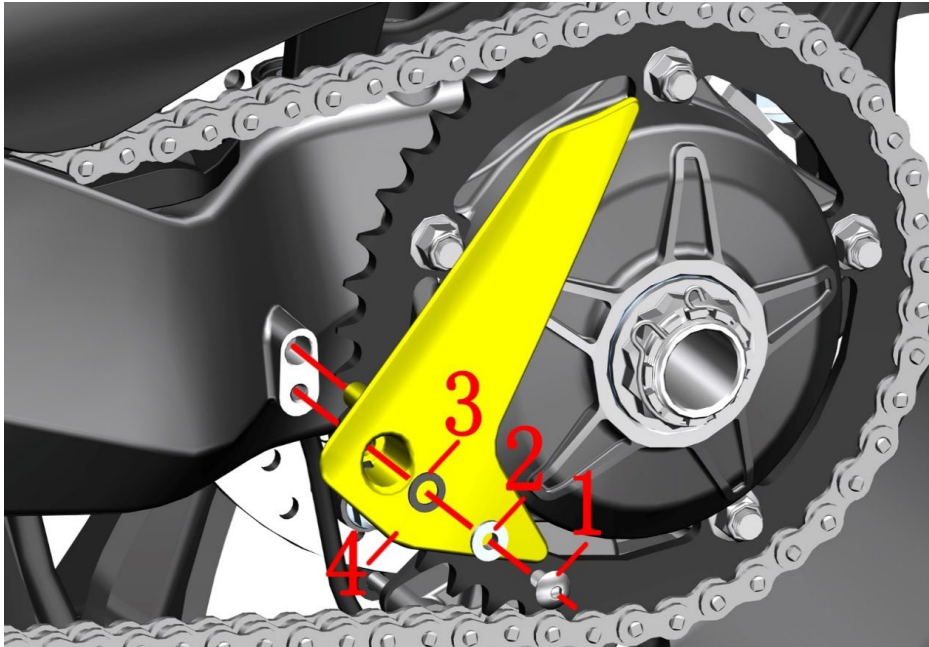
| Fig.2 Rear wheel, swinging arm assembly | | Sprocket baffle | CHK | |

Use the No. 21 sleeve to loosen the bolt(4) without removing it.

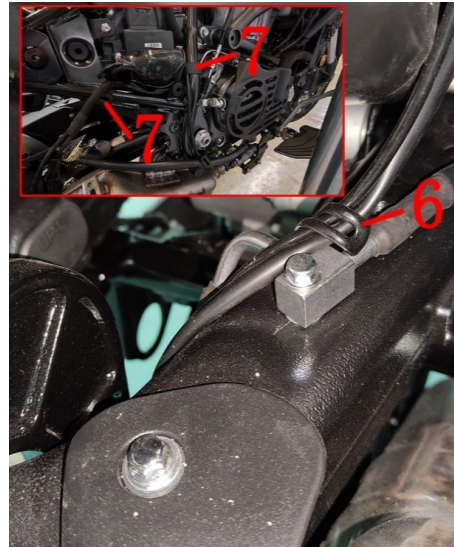
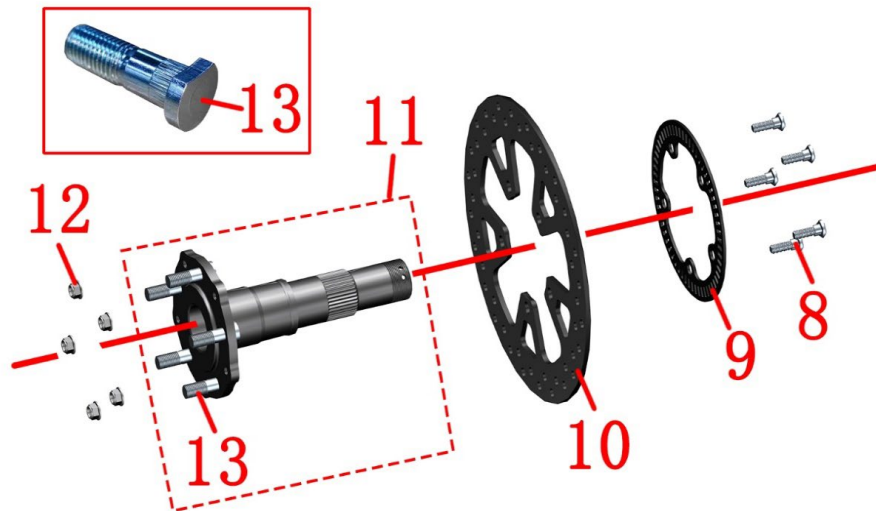
| Fig.6 Rear wheel, swinging arm component | | Rear axle assembly | CHK | |

The rear axle assembly(11) already includes the rear axle and 5 bolts(13). The bolts(13) and the single rocker rear axles have an interference fit. If the bolts are removed and replaced separately, the connection must be firm and reliable, otherwise it may loosen and cause accidents. The bolt heads of the early production models are round and can be replaced directly with the trimmed state of the later production.

●The replacement of the bolts (13) separately must be secure and reliable.

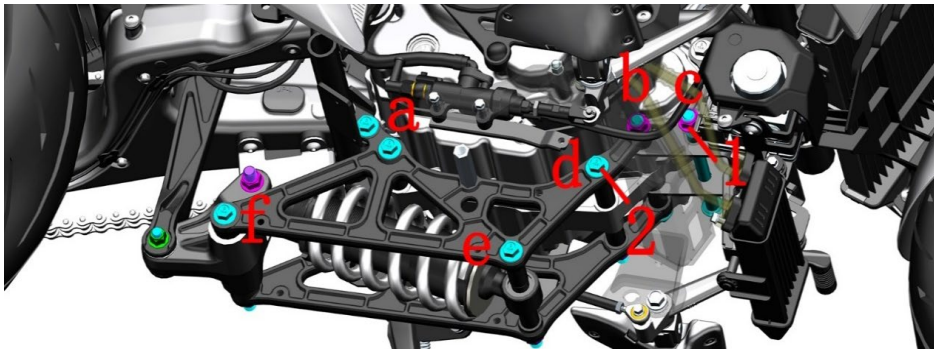
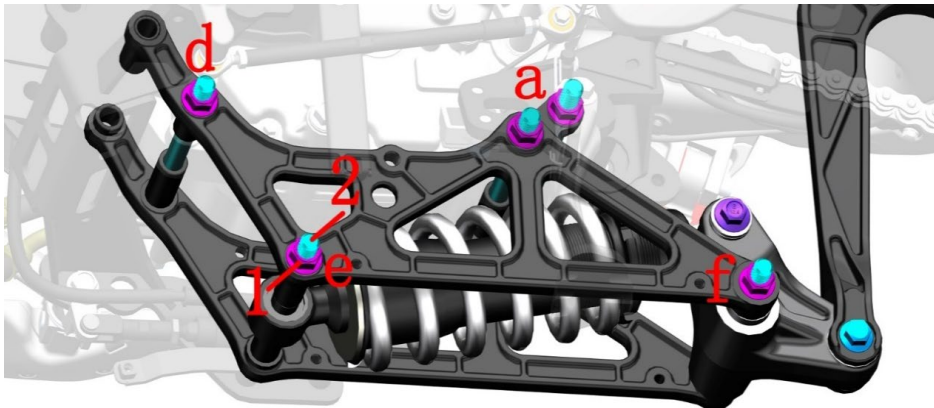
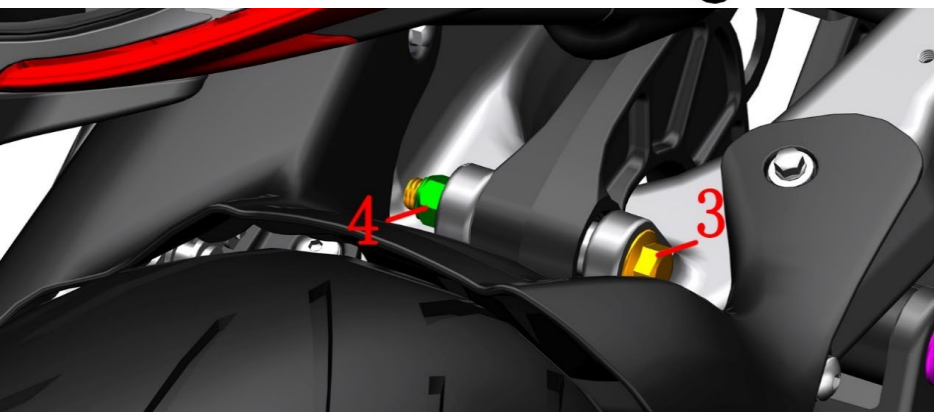
| Fig.14 Rear wheel, swinging arm component | | Rear shock absorption 1 | CHK | |

● Removing the rear shock absorber assembly will cause the rear flat fork assembly to be unable to support the entire vehicle, so do not support it on the rear flat fork.

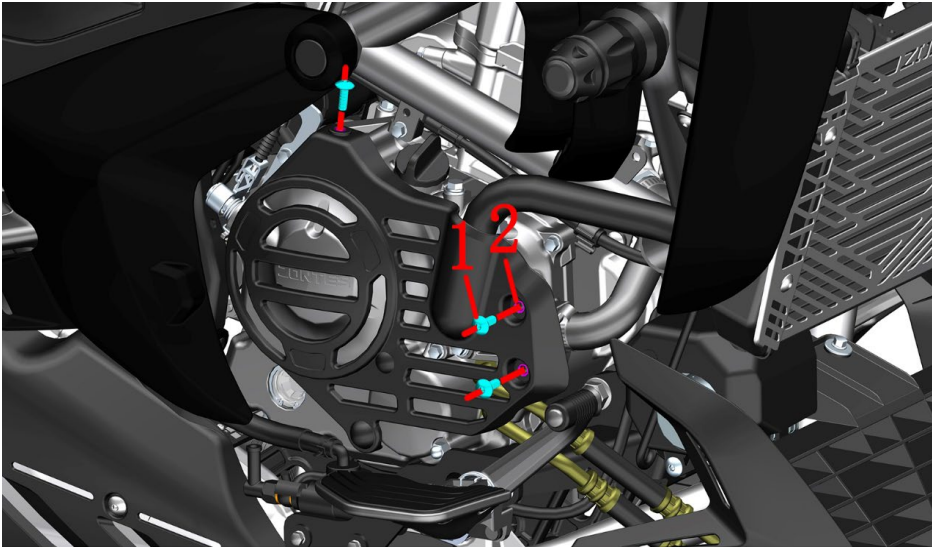
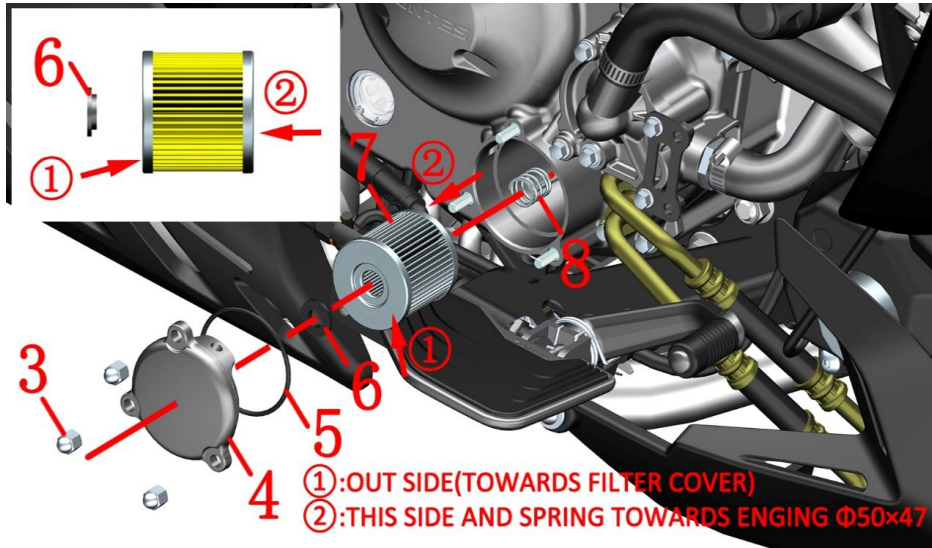
| Fig.2 COOLING SYSTEM COMPONENT | | Change engine oil filter | | CHK | CAUTION |

- Ensure every component is well assembled.
- To change engine oil filter and seal ring(5) at the same time is suggested.
- Engine oil filter can not be turned over when assembling.
- Note that the seal ring (6) is facing the fine filter with the “OUT SIDE (TOWARDS FILTER COVER)” side. It is forbidden to install reverse or leak.
- 【1】 The ZT184 refined filter seal component already included oil filter、 55×2.5 O-ring (5) and ZT180MN Engine oil refined filter seal ring(6) .

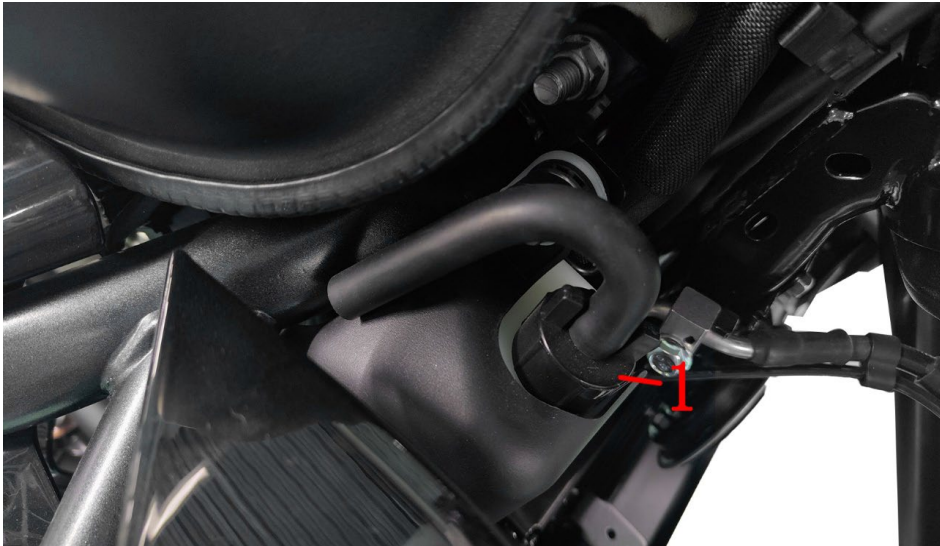
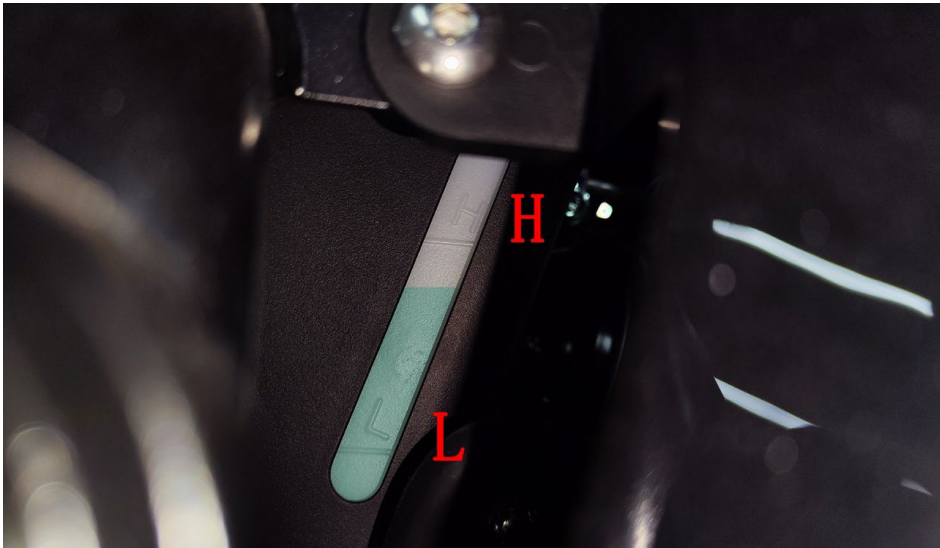
| Fig.3 COOLING SYSTEM COMPONENT | | Add coolant | CHK | |

- Total volume of cooling liquid is 1580ml.
- Cooling liquid might damage the coating of motorcycle. Be careful while adding. If it is spilt in small quantity, please clean it immediately with soft cloth.

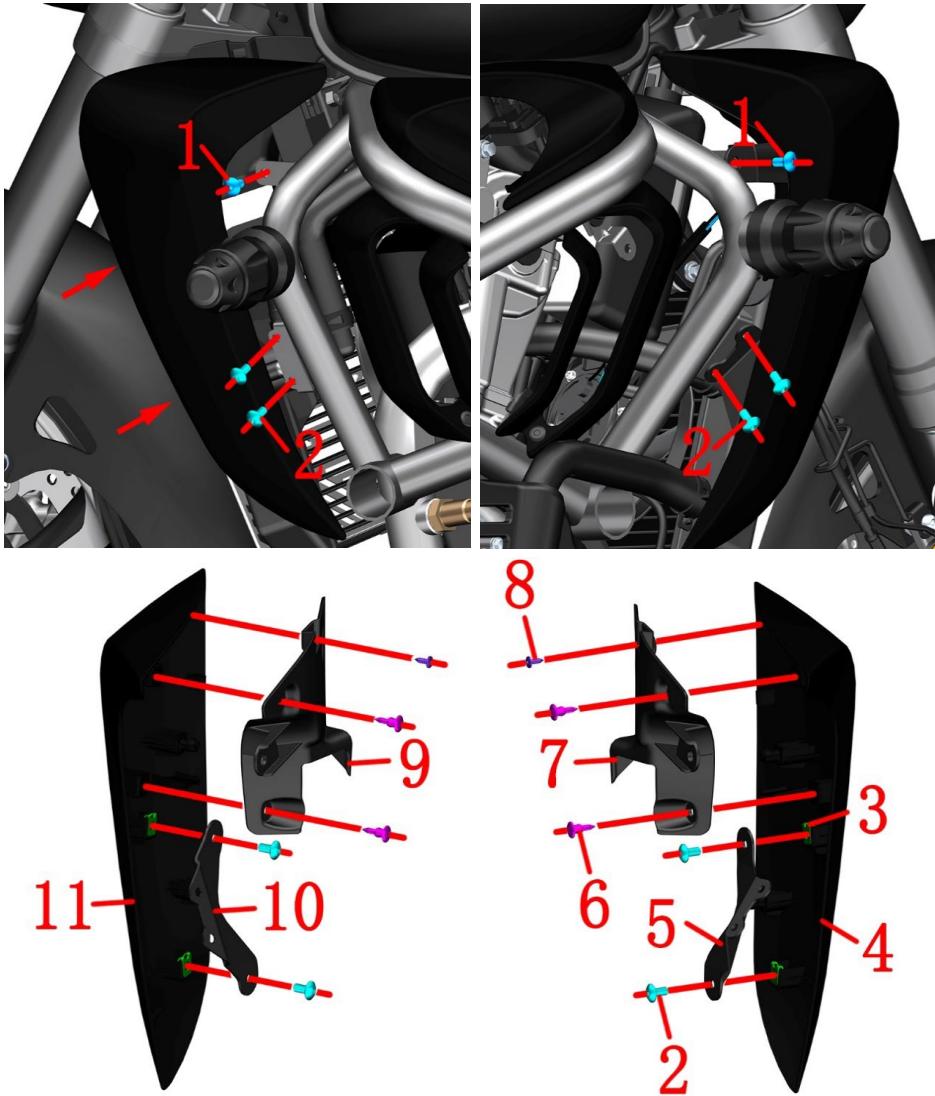
| Fig.4 COOLING SYSTEM COMPONENT | | Water tank decoration cover component | | CHK | CAUTION |

- Pull out hard directly when pulling out, and do not shake it to the sides to prevent damage to the staples.
- Pay attention to the surface of the material.
- Disassemble the engine and radiator after they have been completely cooled.
- When reassembling, be careful to first set the self-tapping screws perpendicular to the mounting surface and not to use excessive torque.
- 【1】 If the part code is empty, it indicates that the part has multiple states or colors. For specific states, please find the corresponding state or color in the official website parts. Only the disassembly and assembly steps are explained here, and the color and status do not affect the disassembly and assembly process. This description will not be added if there is such a situation later in this manual.

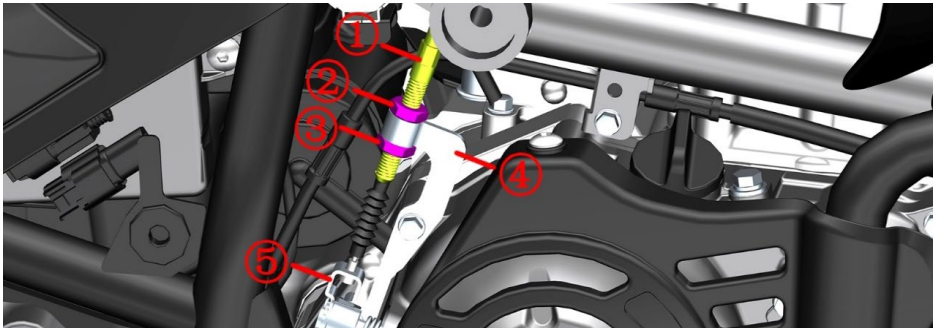
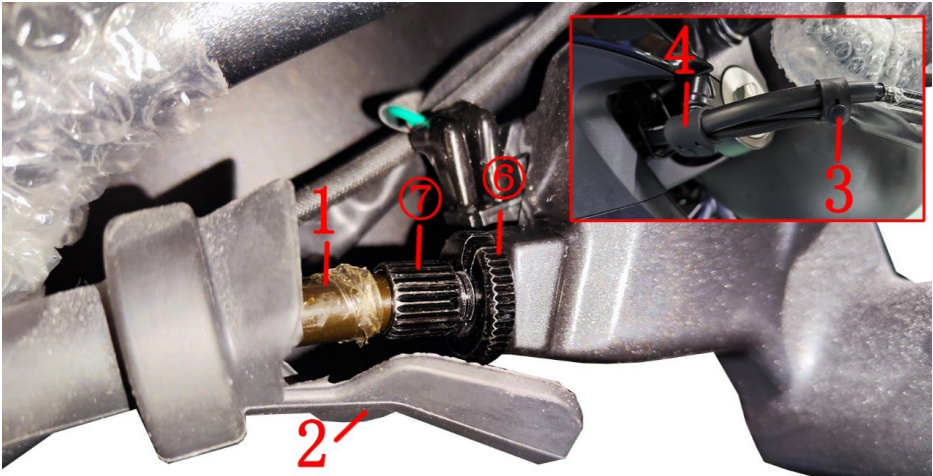
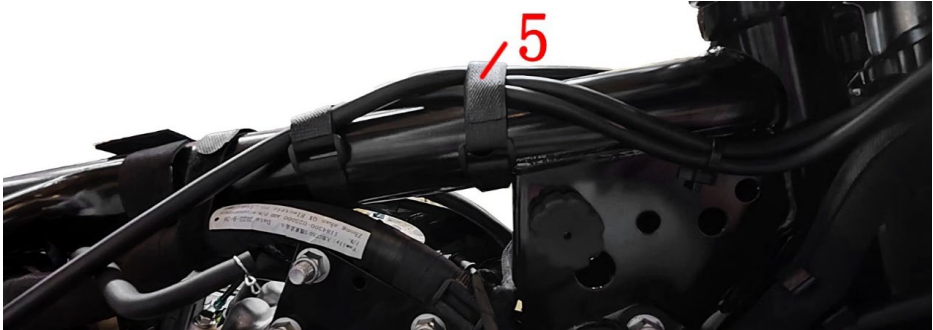
| Fig.3 FRONT FORK COMPONENT | | Replacement clutch cable | | CHK | |

● Before replacing the clutch line, it is necessary to disassemble the seat cushion, fuel tank, liner, side cover, etc.

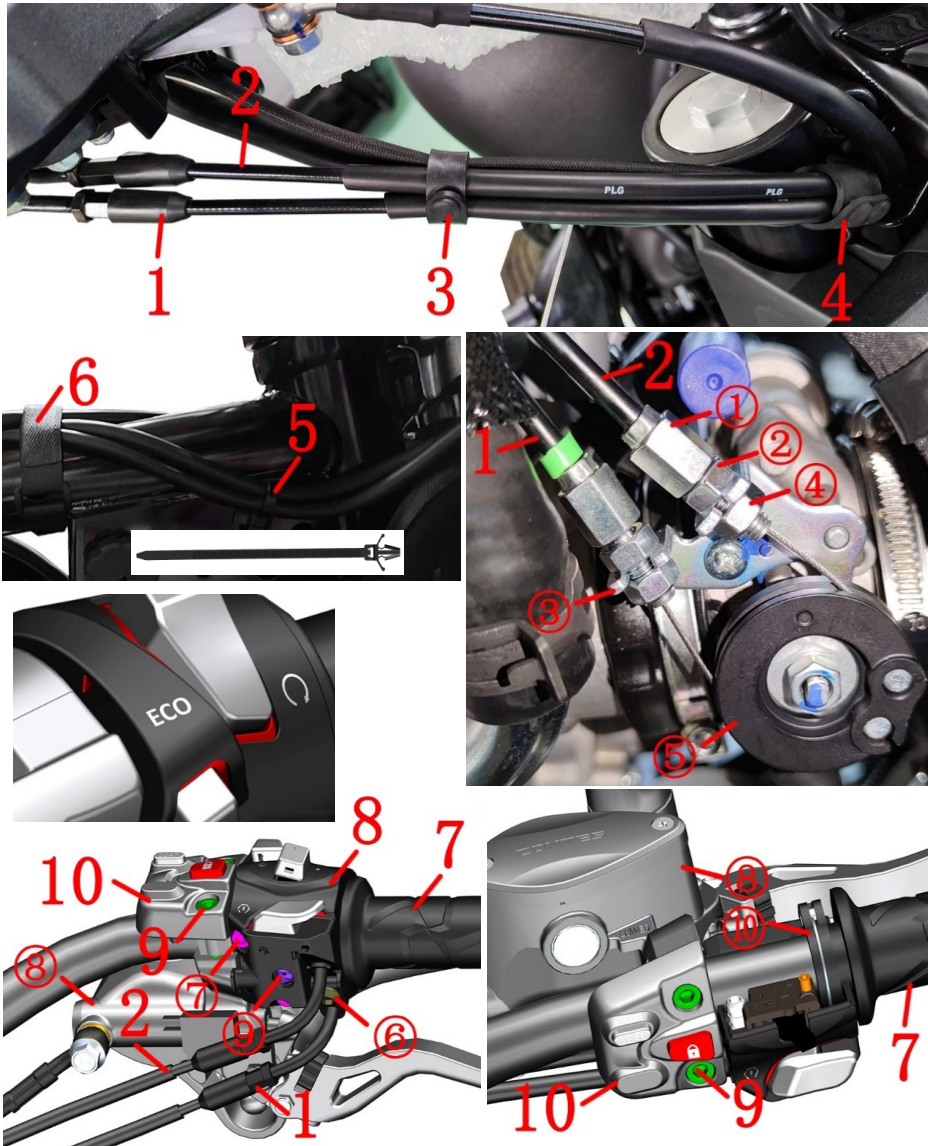
| Fig.4 FRONT FORK COMPONENT | | Replace the throttle line | | CHK | |

Lock nuts (2) and (4).

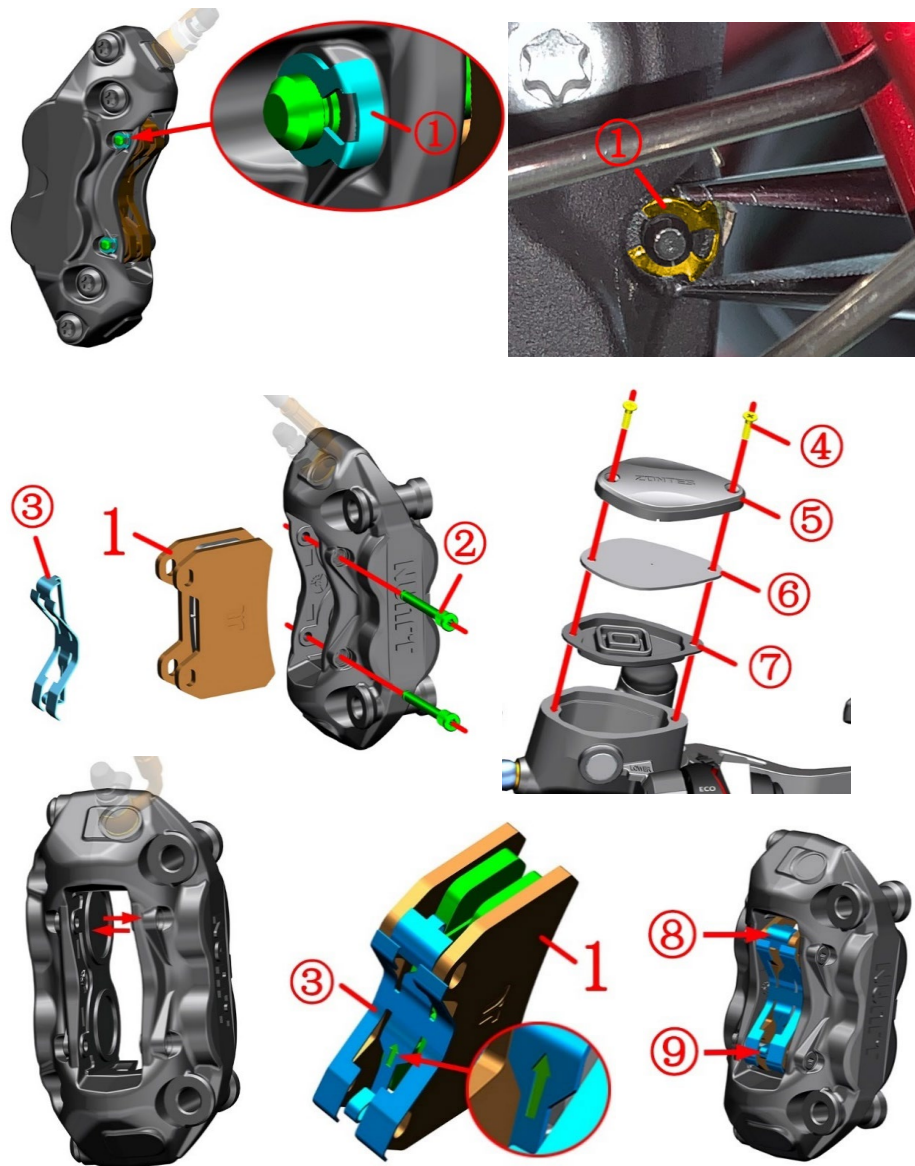
| Fig.7 FRONT FORK COMPONENT | | Replace the front brake pads | | CHK | CAUTION |

● It is recommended to replace brake pads in pairs with qualified maintenance units.

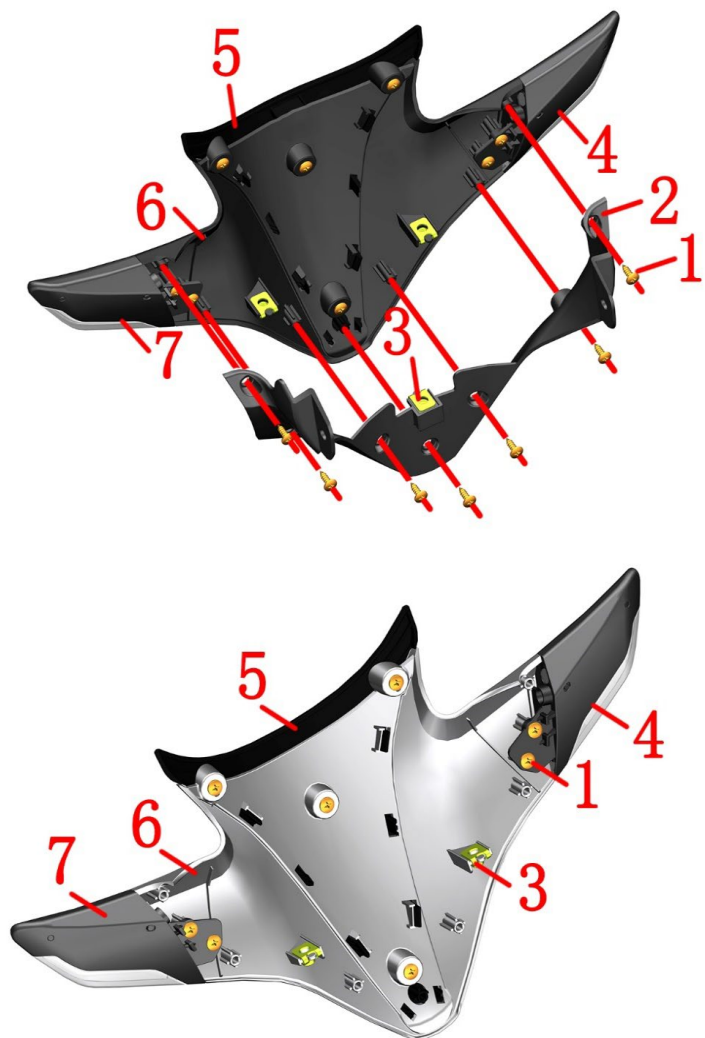
| Fig.12 FRONT FORK COMPONENT | | Headlights assembly 3 | CHK | |

● Note that the positioning boss on the turn signal corresponds to the slot on the bracket.

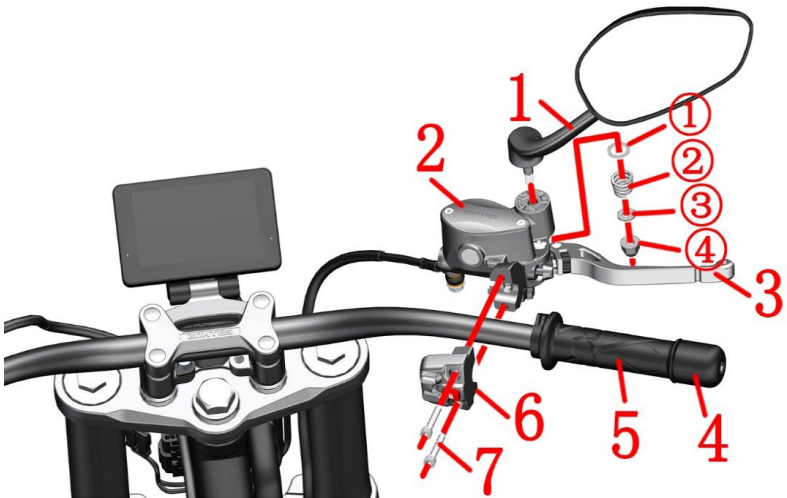
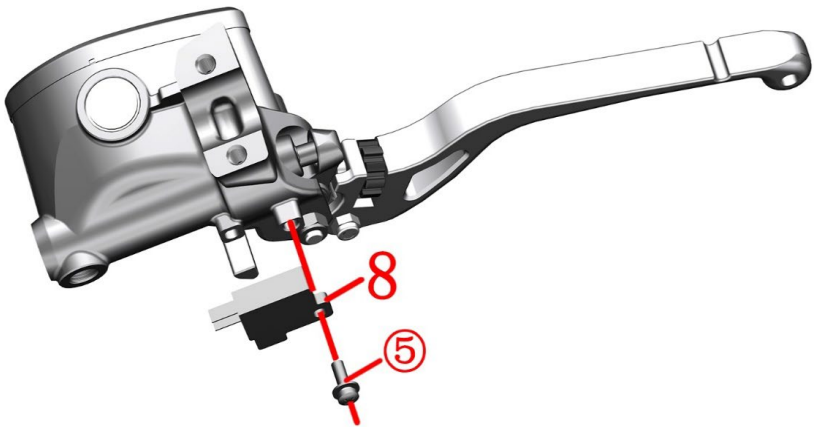
| Fig.13 FRONT FORK COMPONENT | | Right handlebar component | CHK | |

- The motorcycle should be fixed after horizontal support.
- Periodically check that the fluid level of the brake fluid is between 3/4 of the observation window.
- Do not flush the cup directly with high pressure water.
- When assembling the balance block, align the protruding parts at both ends of the shrapnel with the fixing holes on the handle and then insert the direction into the holes.
- The small spacer of the rear view mirror anti-rotation limit slot needs to be aligned with the slot on the mirror bar bolt.
- The right handlebar refers to the switch to replace the throttle line.
- The joint between the front disc brake main pump and the switch should be aligned with the right hand to match the triangle on the switch.

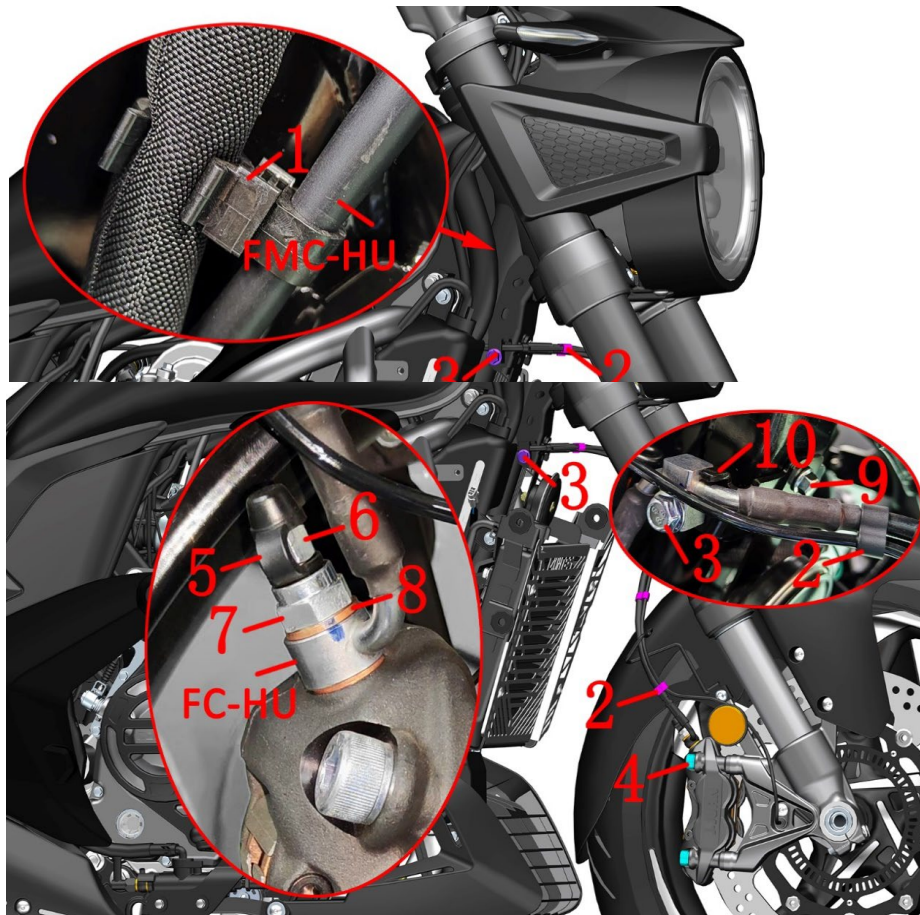
| Fig.19FRONT FORK COMPONENT | | ABS brake system-2 | CHK | |

● The rear brake switch wire is prohibited from rotating the rubber cap at the arrow indication. Replace this switch wire. Be careful not to wrap the cable around the tool.
